Roaring Fork Transportation Authority *Rio Grande Trail Restoration Seeding Plan*

Mile Post 360 -382

Glenwood Springs to Emma

**JANUARY
2022**

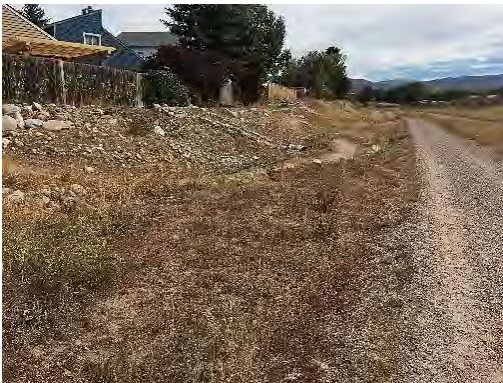
Figure 2 - Significant impairment conditions (MP 372.5) Figure 3 - Moderate impairment conditions (MP 369) Figure 4 - Low impairment conditions (MP 371)

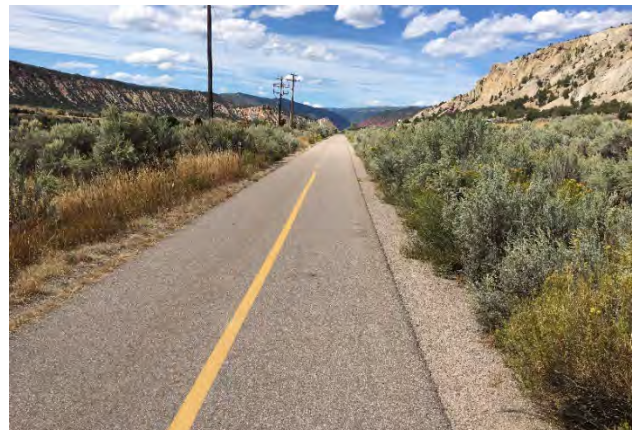
Figure 5 - View looking at well-established sagebrush shrubland community

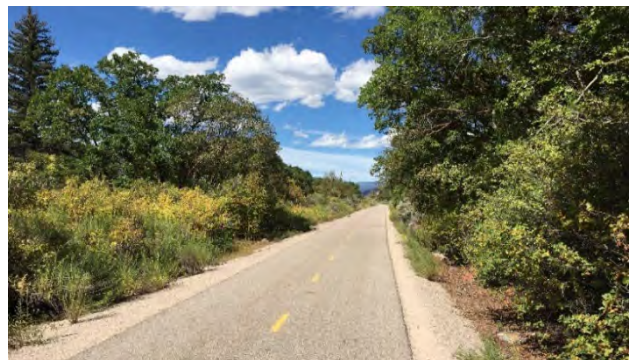
Figure 6 - View looking at well-established mixed mountain shrubland community

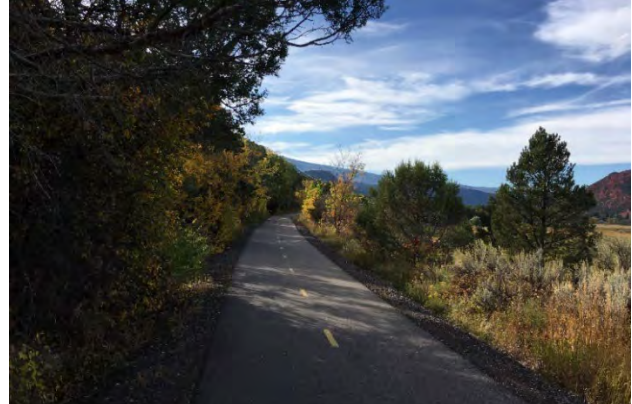
Figure 7 - View looking at well-established pinyon-juniper woodland community

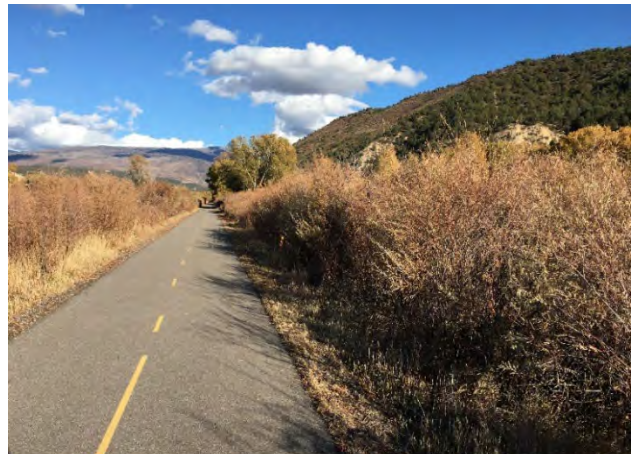
Figure 8 - View looking at representative scrub-shrub wetland community

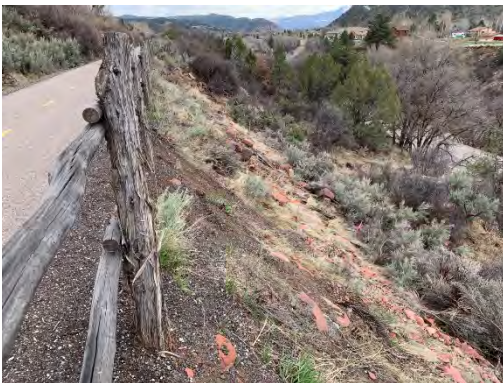
Figure 2 - Significant impairment conditions (MM 365.75)

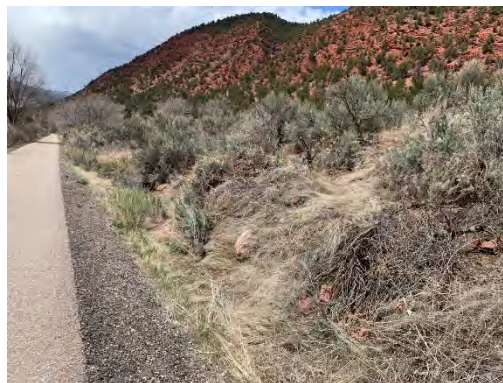
Figure 3 - Moderate impairment conditions (MM 366.5)

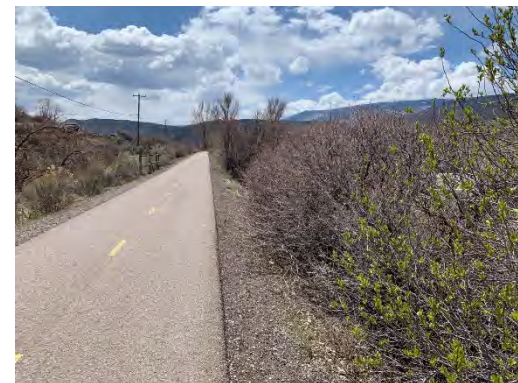
Figure 4 - Low impairment conditions (MM 363.5)

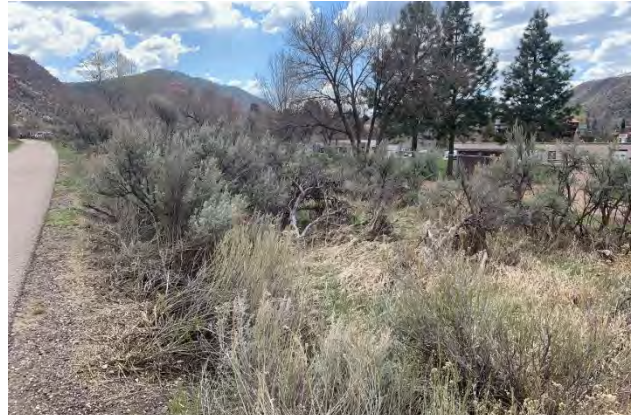
Figure 5 - View looking at well-established sagebrush shrubland community

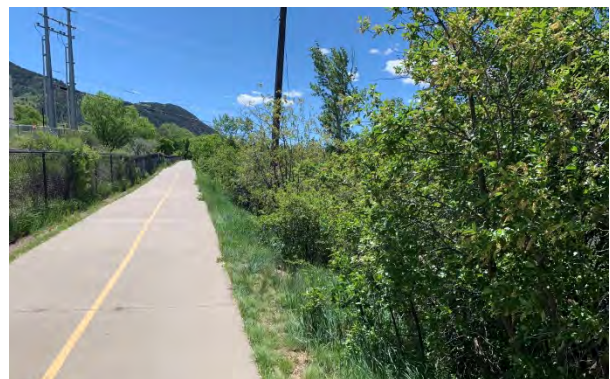
Figure 6 - View looking at well-established mixed mountain shrubland community

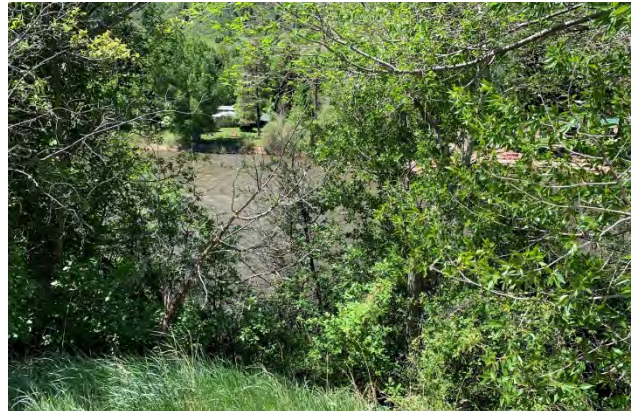
Figure 7 - View looking at representative forested riparian community

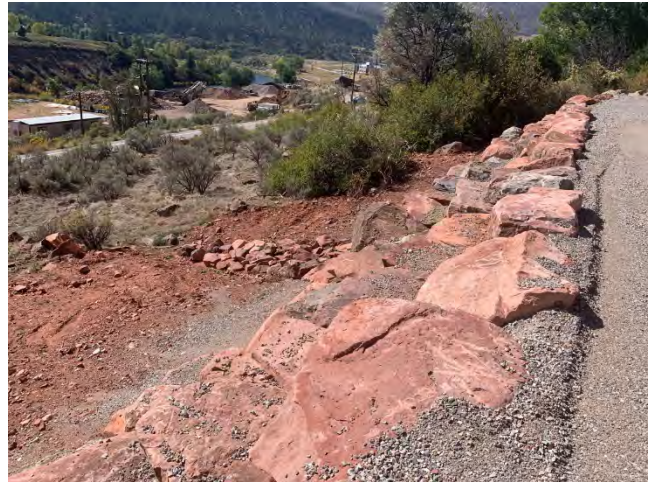
Figure 9 View looking NW at Priority 1. Bare soils from construction disturbances

5. Universally apply seed via hydroseeding method using provided seed mix # 4 at a rate of 33 lbs./acre.
6. Stabilize seeded slope using either erosion control blanket or Hydraulic mulch and tackifier.

7. Protect seeded areas from foot traffic and wildlife, installing temporary fencing until vegetation is well established
8. Continue to monitor site and maintain free of competing weedy vegetation.

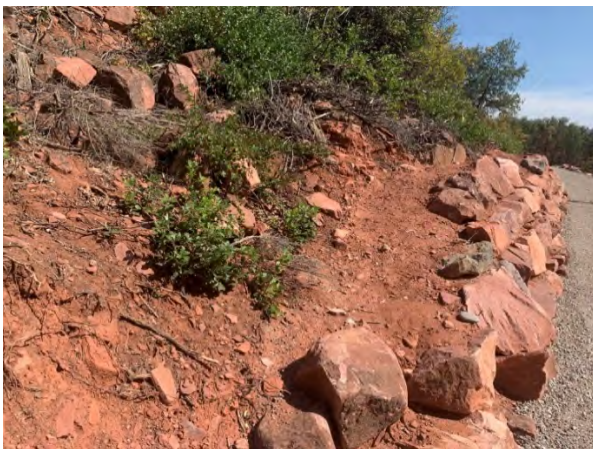
Figure 10. View looking East at Priority 1.

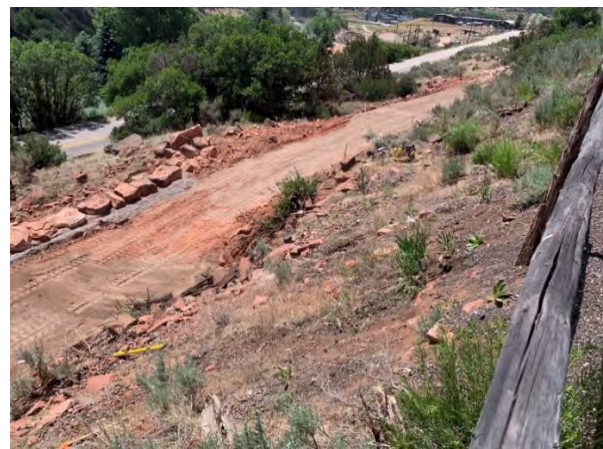
Figure 11. View looking NW at steep slope between trails.

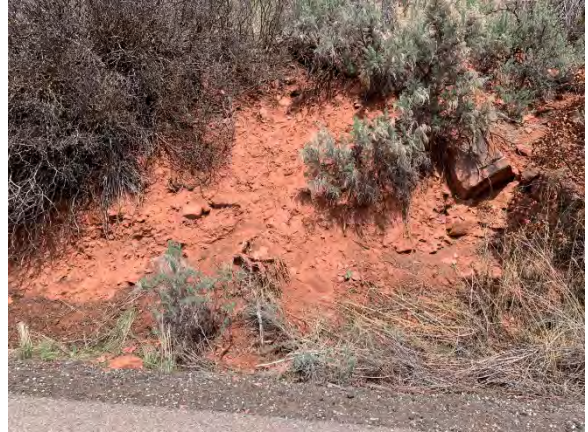
Figure 12. View looking N at bare soil on steep slope

5. Universally apply seed via hydroseeding method using provided seed mix # 4 at a rate of 33 lbs./acre.
6. Stabilize seeded slope using either erosion control blanket or Hydraulic mulch and tackifier.

7. Protect seeded areas from foot traffic and wildlife, installing temporary fencing until vegetation is well established
8. Continue to monitor site and maintain free of competing weedy vegetation.

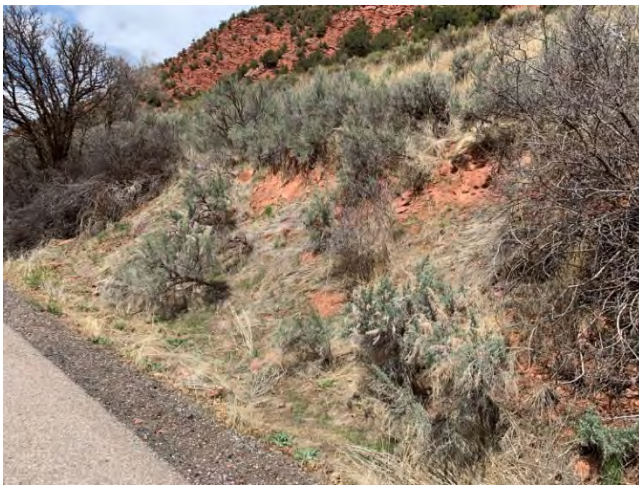
Figure 13. View looking NW at area of poor vegetation on steep slope

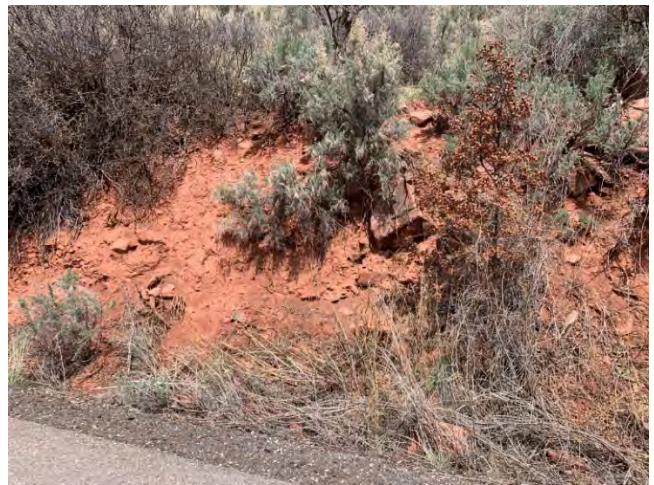
Figure 14. View Looking N at area of bare soil on steep slope

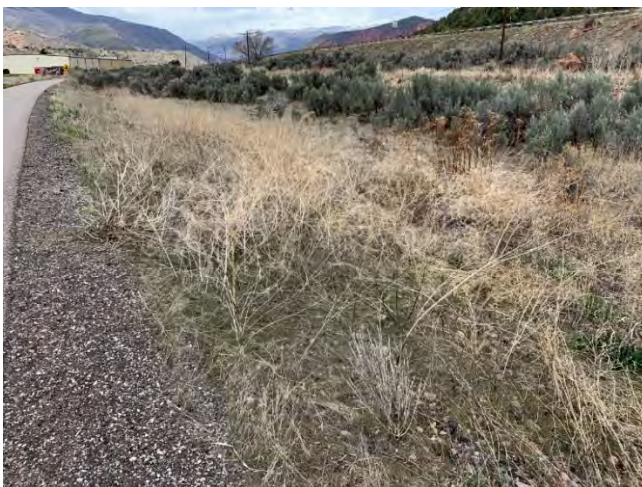
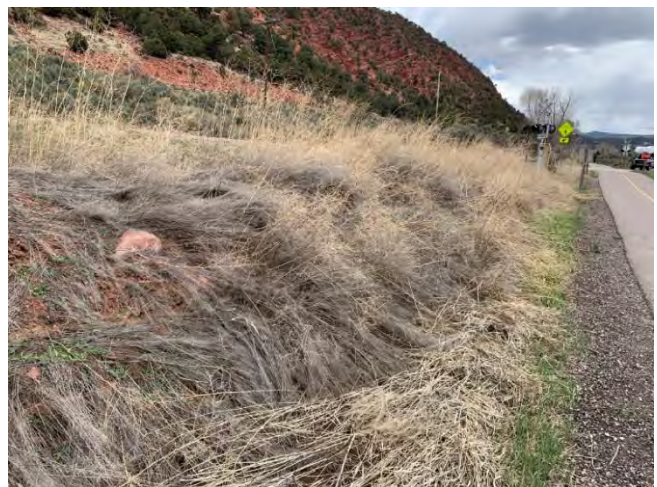
Figure 15. View Looking NW at area of high density weedy vegetation. Figure 16. View looking SE at high density weedy vegetation

7. Apply organic tackifier at rate of 150 lbs./acre to completely cover weed free straw mulch immediately following installation of mulch.
8. Protect seeded areas from foot traffic and wildlife, installing temporary fencing until vegetation is well established

9. Continue to monitor site and maintain free of competing weedy vegetation.

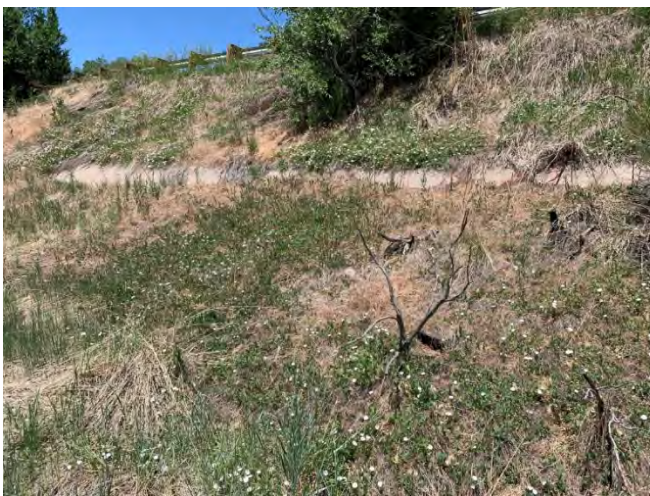
Figure 17. View looking N at area of high density Field Bindweed.

9. Apply organic tackifier at rate of 150 lbs./acre to completely cover weed free straw mulch immediately following installation of mulch.
10. Install straw wattles perpendicular to the slope.

11. Protect seeded areas from foot traffic and wildlife, installing temporary fencing until vegetation is well established
12. Continue to monitor site and maintain free of competing weedy vegetation.

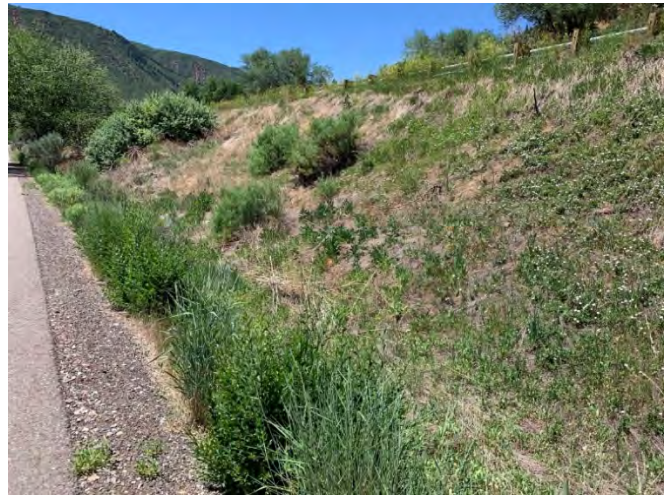
Figure 18. View looking NW at restoration Priority 4.

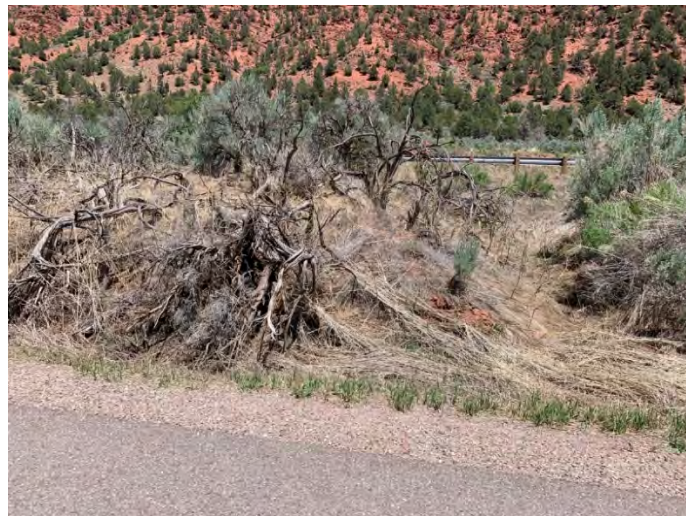
Figure 19. View looking N at area of dead sagebrush vegetation.

9. Apply organic tackifier at rate of 150 lbs./acre to completely cover weed free straw mulch immediately following installation of mulch.
10. Protect seeded areas from foot traffic and wildlife, installing temporary fencing until vegetation is well established

11. Continue to monitor site and maintain free of competing weedy vegetation.

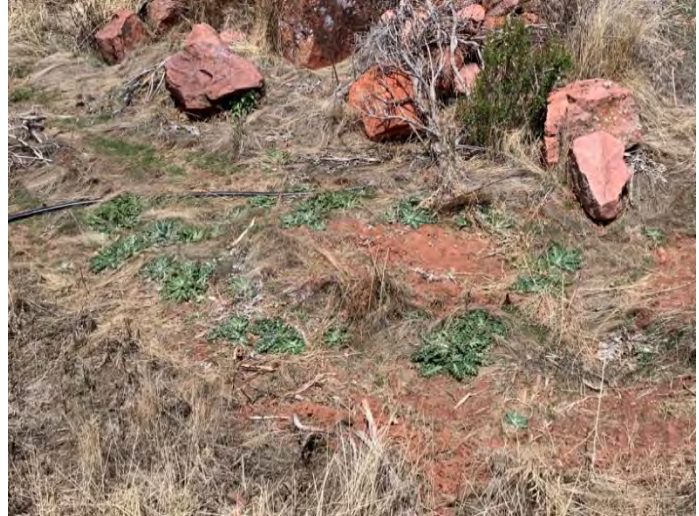
Figure 20. View looking N at compacted soils and high density scotch thistle.

8. Apply organic tackifier at rate of 150 lbs./acre to completely cover weed free straw mulch immediately following installation of mulch.
9. Protect seeded areas from foot traffic and wildlife, installing temporary fencing until vegetation is well established

10. Continue to monitor site and maintain free of competing weedy vegetation.

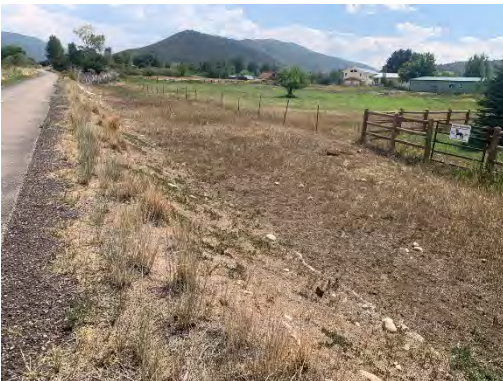
Figure 2 - Significant impairment conditions (MM 381.5)

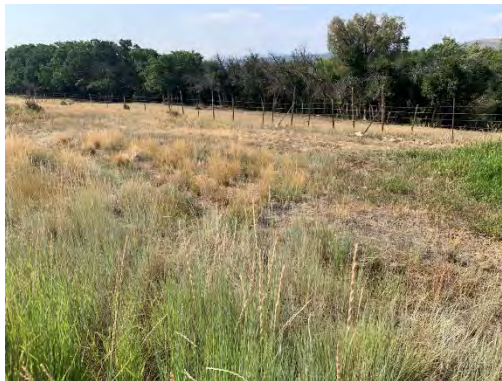
Figure 3 - Moderate impairment conditions (MM 381.1)

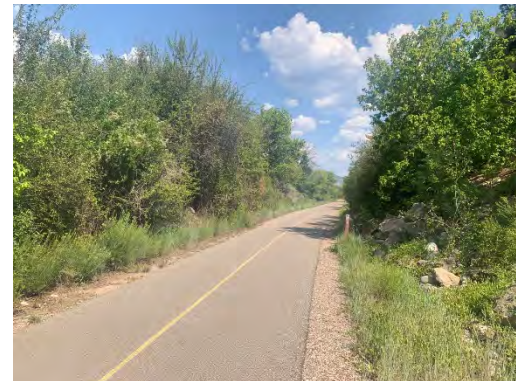
Figure 4 - Low impairment conditions (MM 377.1)

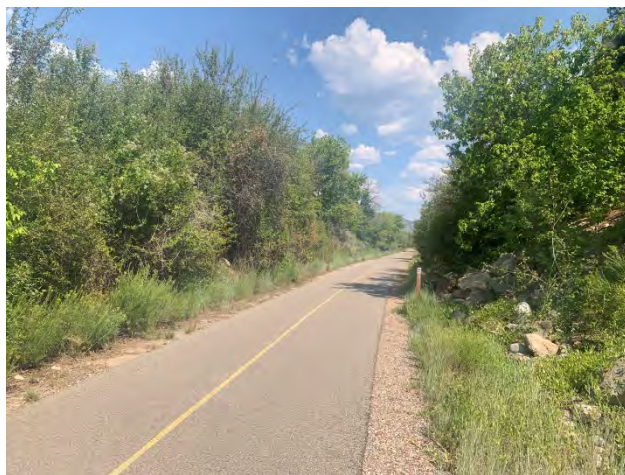
Figure 5 - Mixed shrubland community, with a well-established and healthy shrub community comprised of a diversity of native species.

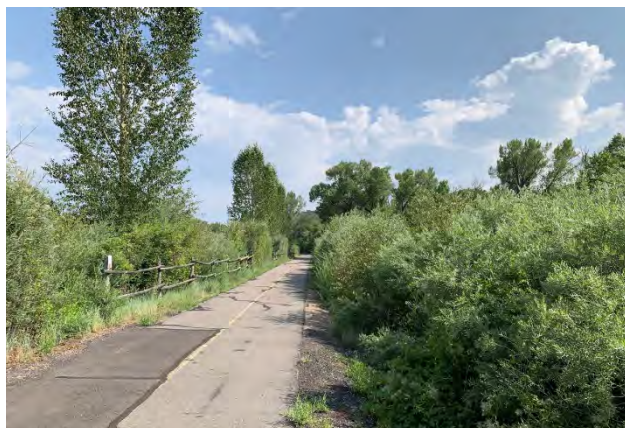
Figure 6 - forested riparian community along the Roaring Fork River, evident by overstory cottonwood trees and willow dominant shrub layer.

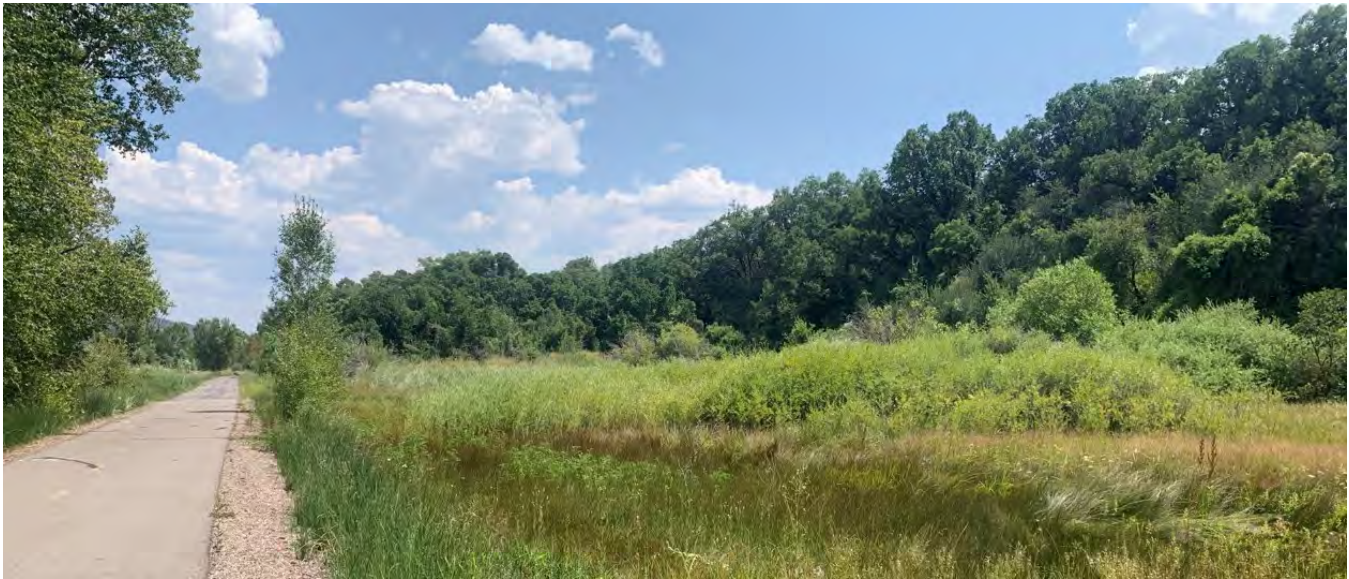
Figure 7 - scrub shrub and emergent wetland complex found in larger Riparian extent at mm 378.7.

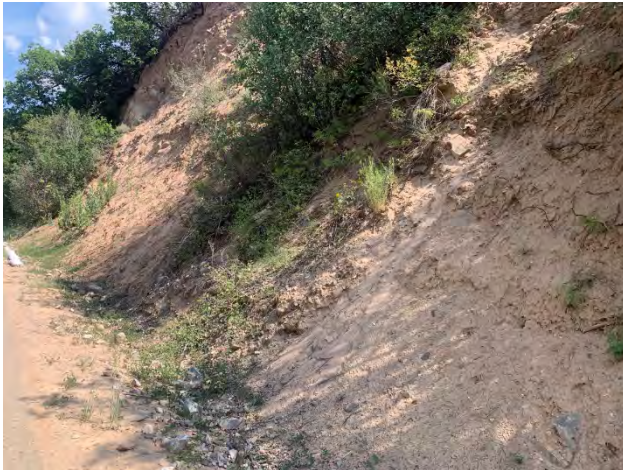
Figure 8 – View looking east (up valley) at priority area 1.

5. Universally apply seed via hydroseeding method using provided seed mix # 4 at a rate of 33 lbs./acre.
6. Stabilize seeded slope using Hydraulic mulch and tackifier.

7. Protect seeded areas from foot traffic and wildlife, installing temporary fencing at the foot of the slope until vegetation is well established.
8. Continue to monitor site and maintain free of competing weedy vegetation.

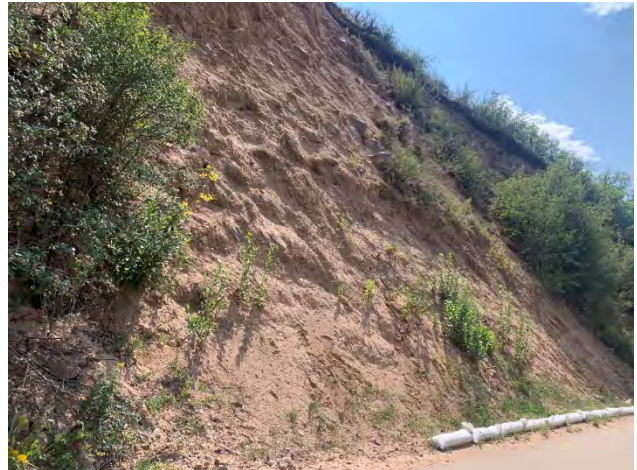
Figure 9 - View looking west (down valley) at priority area 1.

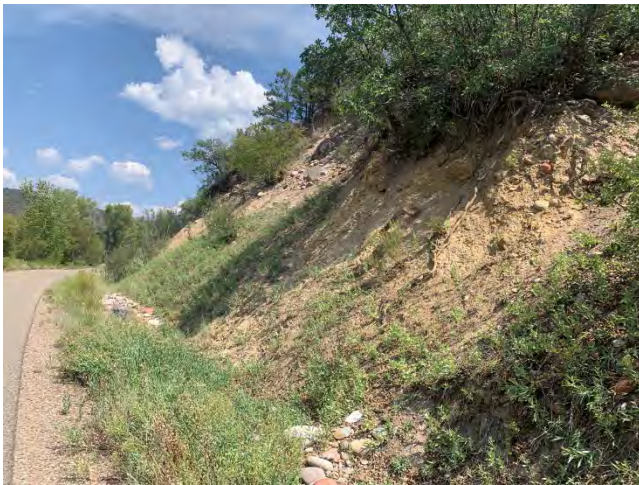
Figure 10 - View looking east (up valley) at priority area 2.

5. Universally apply seed via hydroseeding method using provided seed mix # 4 at a rate of 33 lbs./acre.
6. Stabilize seeded slope using Hydraulic mulch and tackifier.

7. Protect seeded areas from foot traffic and wildlife, installing temporary fencing at the foot of the slope until vegetation is well established
8. Continue to monitor site and maintain free of competing weedy vegetation.

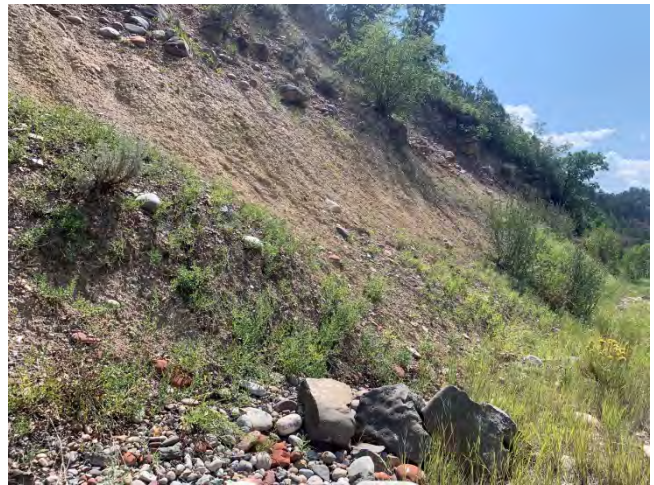
Figure 11 – View looking west (up valley) at priority area 2.

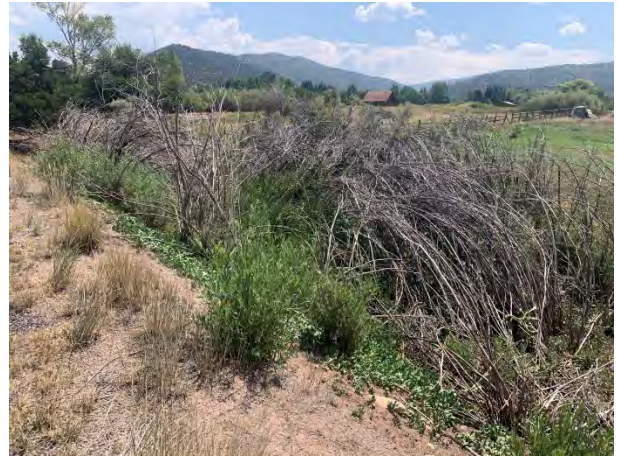
Figure 12 - dead willow stand to removed (south side of trail).

8. Apply organic tackifier at rate of 150 lbs./acre to completely cover weed free straw mulch immediately following installation of mulch.
9. Protect seeded areas from foot traffic and wildlife, installing temporary fencing until vegetation is well established.

10. Continue to monitor site and maintain free of competing weedy vegetation.

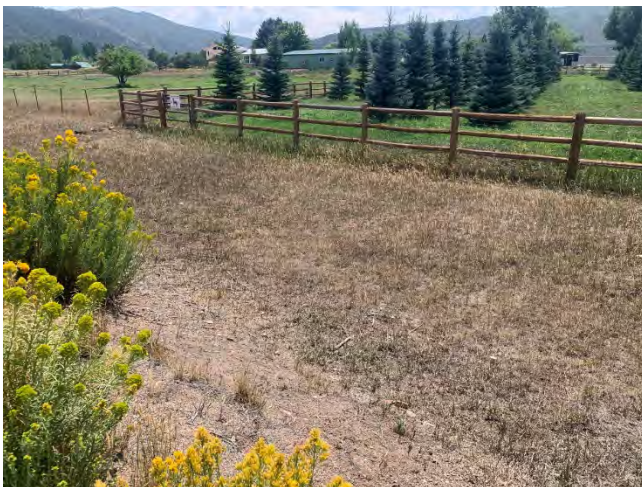
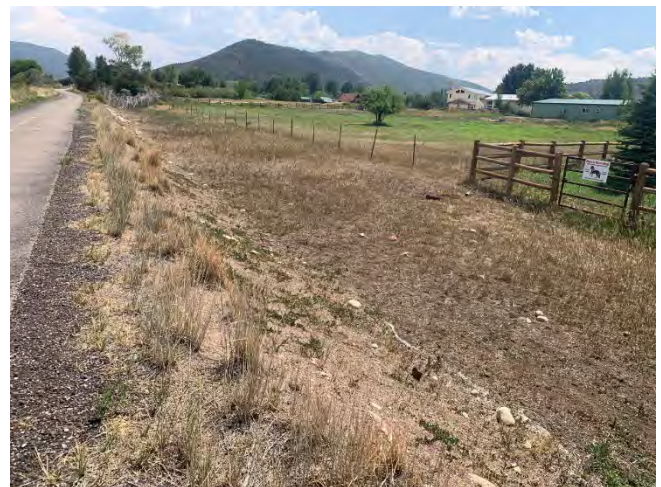
Figure 13 & 14 - View Looking SE at high density smooth brome with native rabbit brush pockets along the trail edge.

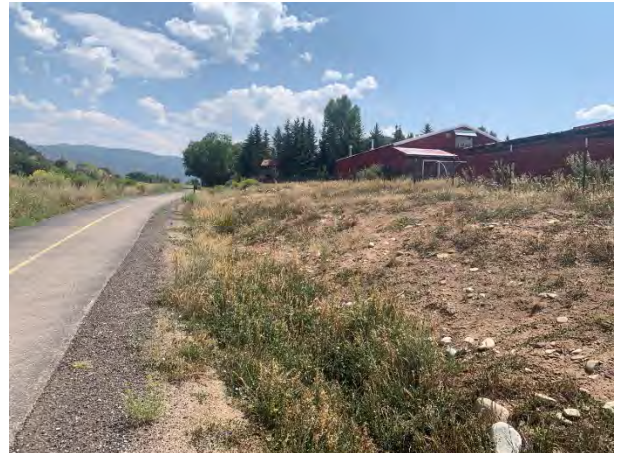
Figure 15 - view southside of trail, with moderate slope and noxious and weedy vegetation.

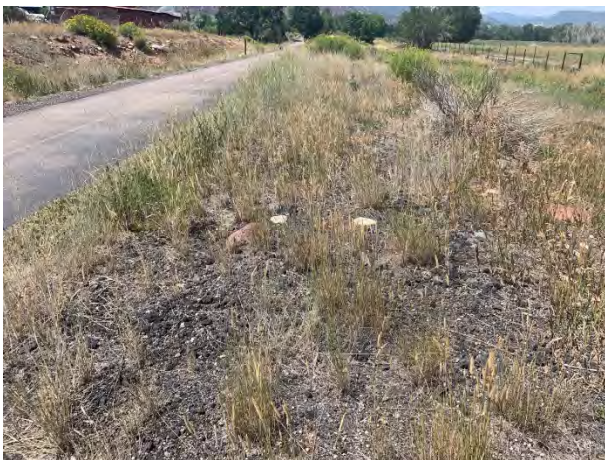
Figure 16 - View looking west (down valley) and north side of trail.

- Substitutions may be made based upon differing needs from site specific soil test results.
5. Universally spread seed using hand broadcast seeding methods and seed mix #2 at a rate of 18 lbs./acre.
 6. Immediately following seeding and fertilization, disperse certified weed free straw, uniformly covering the area without any major gaps.
 7. Apply organic tackifier at rate of 150 lbs./acre to completely cover weed free straw mulch immediately following installation of mulch.

9. Continue to monitor site and maintain free of competing weedy vegetation.

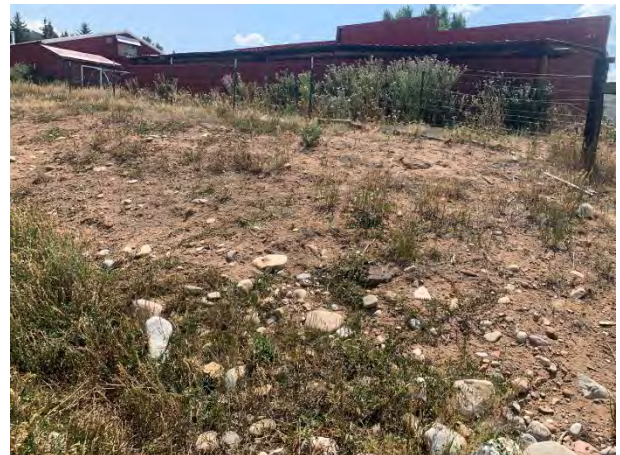
Figure 17 - View of southern slope and surrounding of priority 4.

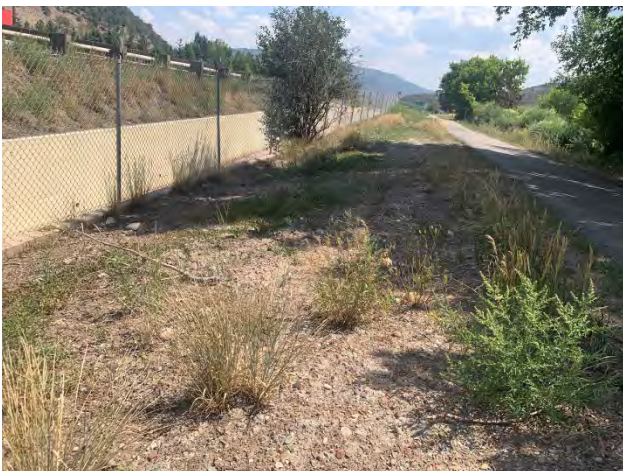
This 0.39-acre area is located at mile-marker 381.7, on either side of the bridge spanning Sopris Creek. The areas immediately adjacent to and above the creek are in a ruderal condition with poor vegetation establishment. Yellow sweet clover is the dominant vegetation and shrub establishment is nonexistent. Establishing native vegetation, including shrub species, will help stabilize the banks to the creek and reduce runoff in the area. Additionally, the native vegetation will provide many aesthetical and ecological benefits. The following means/methods are recommended specific to this site:

Figure 18 - flat, upland expanse above Sopris Creek (view to the E.

3. Remove large rocks to greatest extent possible.
4. Loosen and scarify soil to a minimum depth of 2 inches, using a combination of hand tools or lightly tilling using an ATV with a tiller or drag chain harrow connection on the flat section above the creek and utilizing hand tools on the slopes and areas adjacent to the creek.

5. Apply soil amendments, recommended fertilizer for all seeding activities is ***Biosol Forte 7-2-1*** applied at rate of 50-60 lbs./acre. Substitutions may be made based upon differing needs from site specific soil test results.

8. Install straw waddles along the moderate banks to the creek to control runoff and water velocity during rain events.
9. Apply organic tackifier at rate of 150 lbs./acre to completely cover weed free straw mulch immediately following installation of mulch.

10. Protect seeded areas from foot traffic and wildlife, installing temporary fencing until vegetation is well established
11. Continue to monitor site and maintain free of competing weedy vegetation.

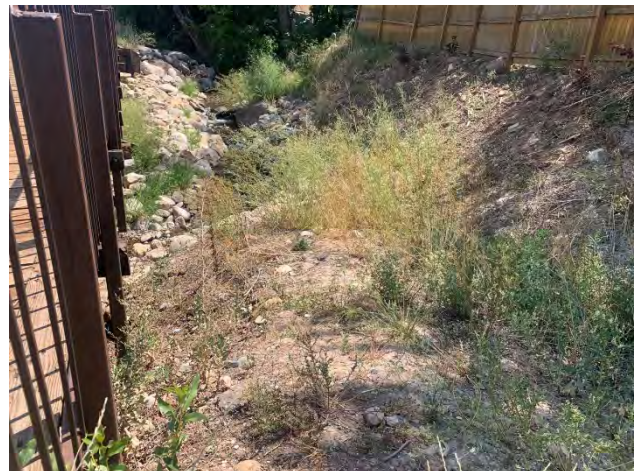
Figure 19 –View of slope to western bank of Sopris Creek.

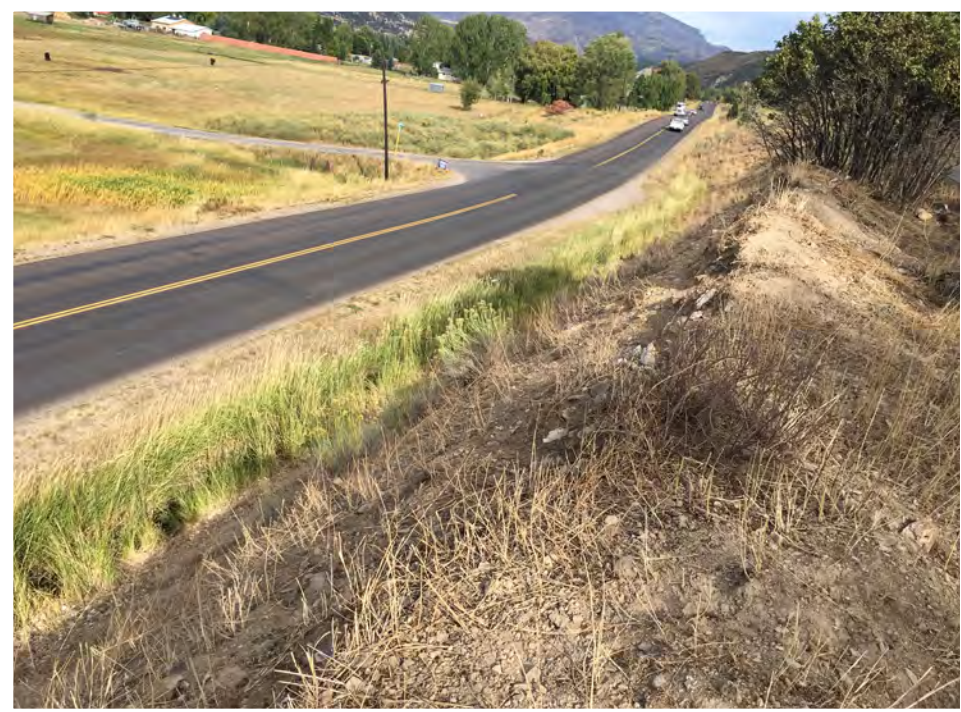
View looking east along restoration priority area 1, MP 374. Recommended restoration objectives include grading of the top of the slope to level out the unnecessary berm, amending soils as outlined in document and stabilizing slopes with Hydraulic erosion control product.

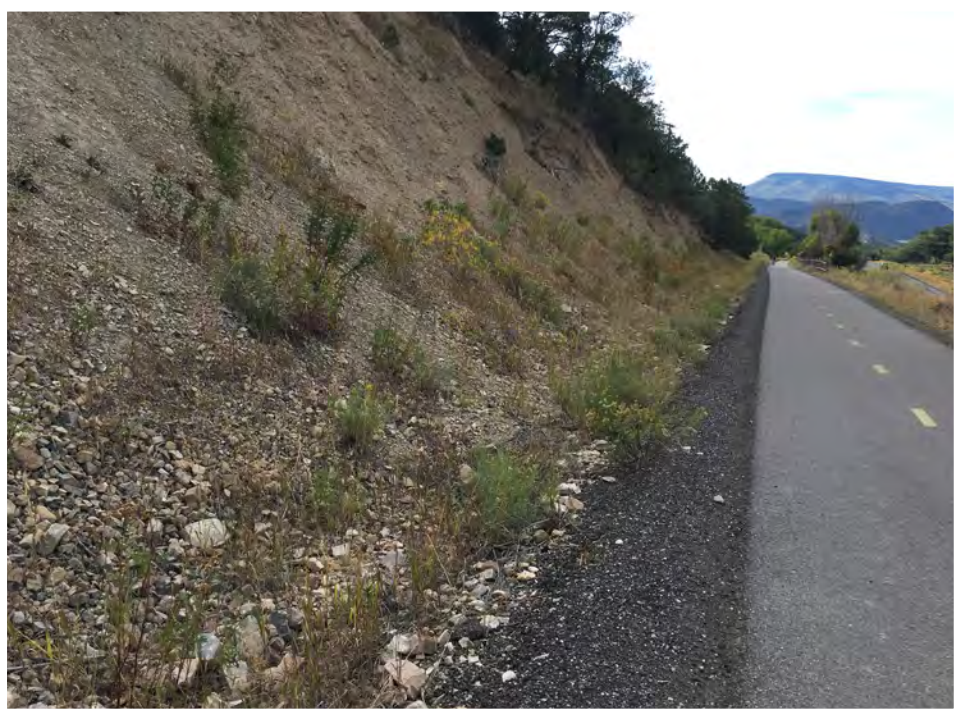
View looking west along restoration priority area 1, MP 374. Steep slopes and lack of vegetation with evidence of severe erosion activity. Recommended restoration activities include using the aggressive erosion control seed mix 4 on the slopes with a Hydraulic erosion control product to stabilize slopes. The toe of the slope should be seeded using the #2 seed mix for sagebrush shrublands.

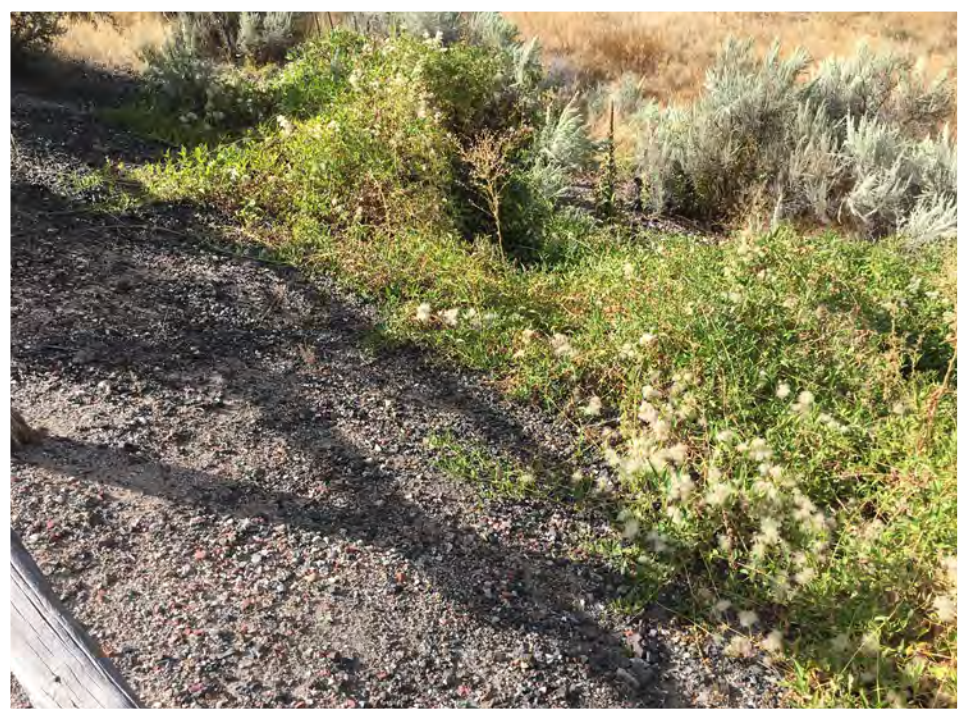
Photo 1. View looking west long restoration priority area 2, MP 368.1. Steep slope and lack of under-story vegetation with high potential for erosion. Recommended restoration activities include control of clematis, removal of gravel and preparation of topsoil, broadcast seeding effort and erosion control measures.

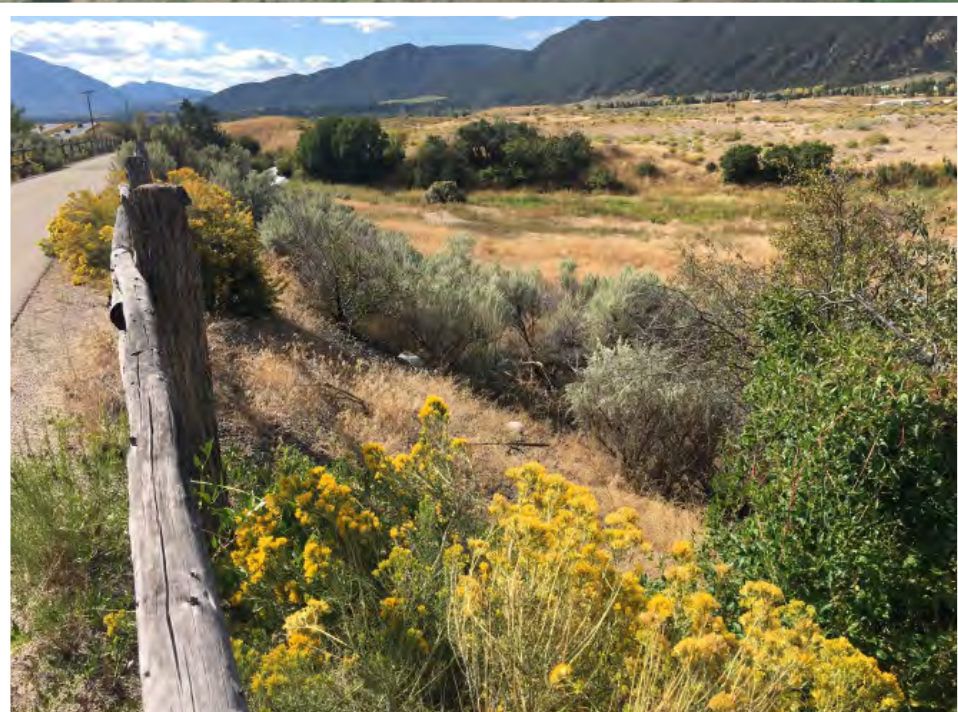
Photo 2. View looking south along restoration priority area 2, MP 368.1. Recommended restoration objectives include retention of shrub layer and control of cheatgrass in addition to previously stated restoration activities.

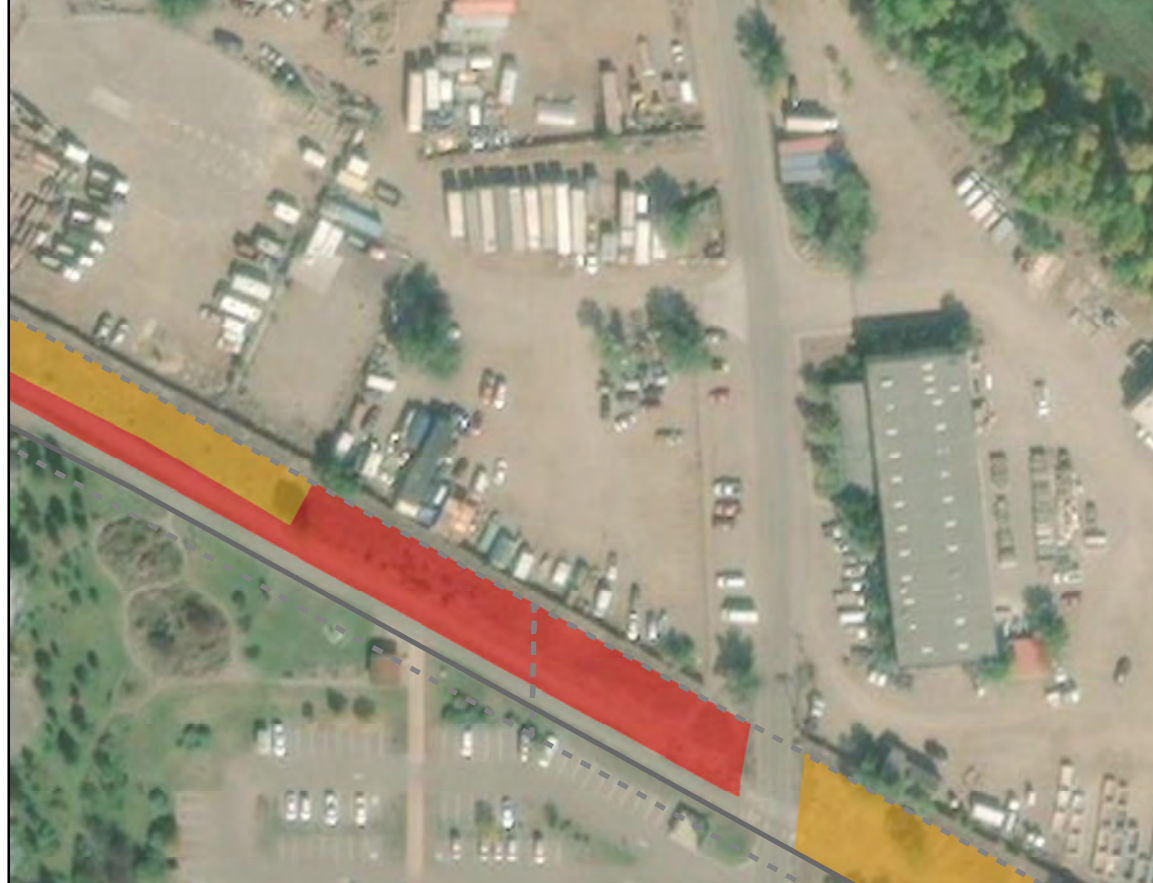
Photo 1. View looking N along 2020 restoration priority area 3, MP 373. Recommended restoration objectives include control of annual weedy vegetation, removal of gravel/cobble for soil preparation and to improve soil contact with seed, seed area with *Seed Mix 1. Grass and Forb Mix*.

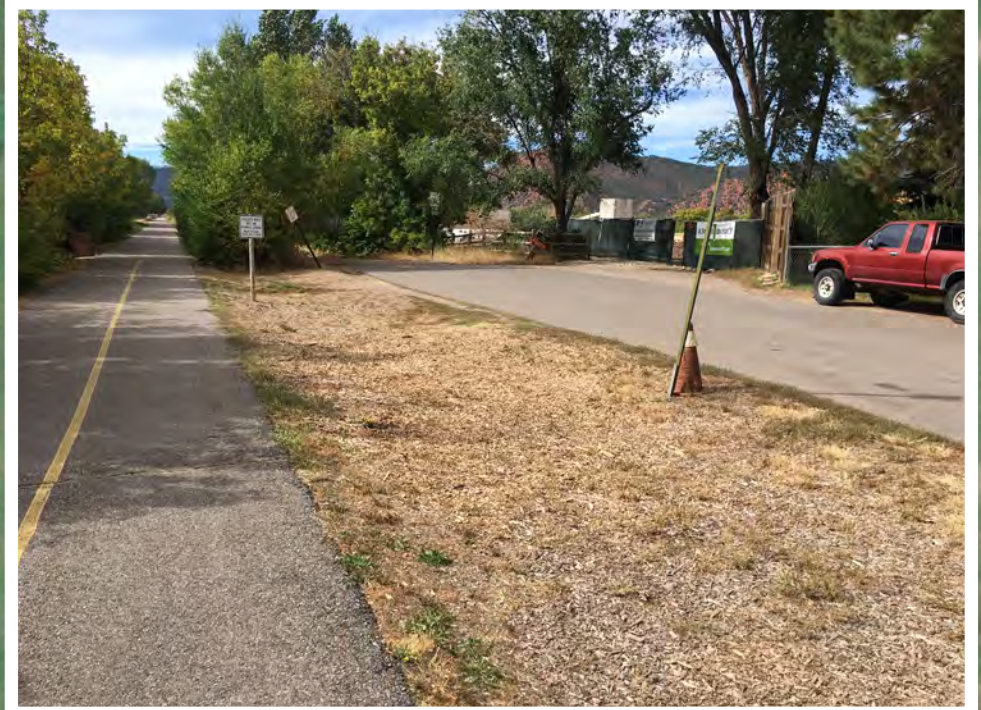
Photo 2. View looking NW along 2020 restoration priority area 3, MP 373. Recommended restoration objectives include control of annual weedy vegetation, removal of gravel/cobble for soil preparation and to improve soil contact with seed, seed area with *Seed Mix 1. Grass and Forb Mix*.

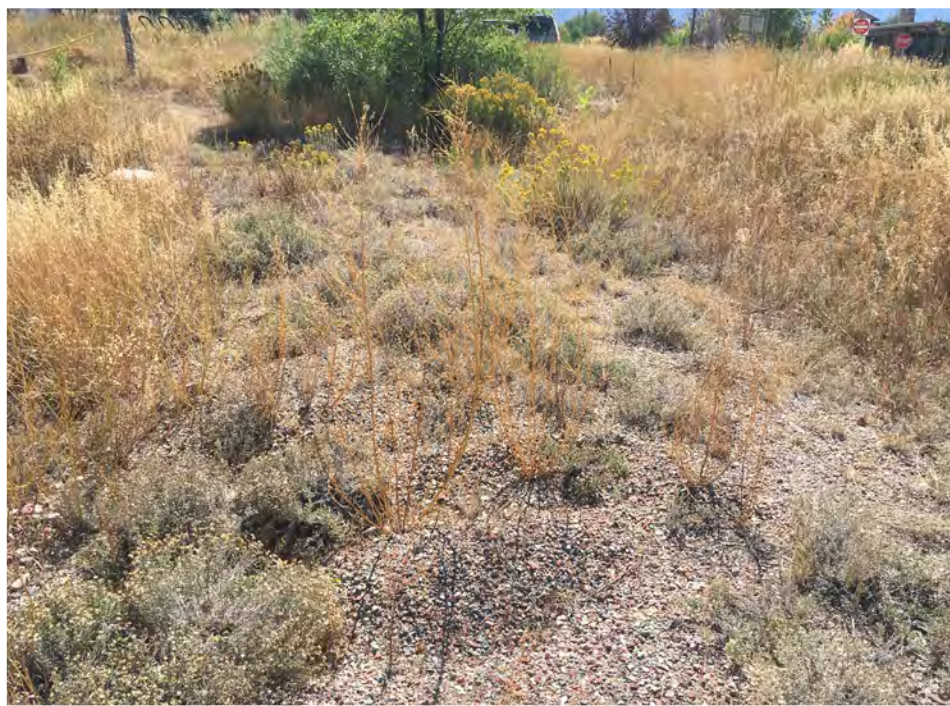
Photo 1. View looking N along 2020 restoration priority area 3, MP 373. Recommended restoration objectives include control of annual weedy vegetation, removal of gravel/cobble for soil preparation and to improve soil contact with seed, seed area with *Seed Mix 1. Grass and Forb Mix*.

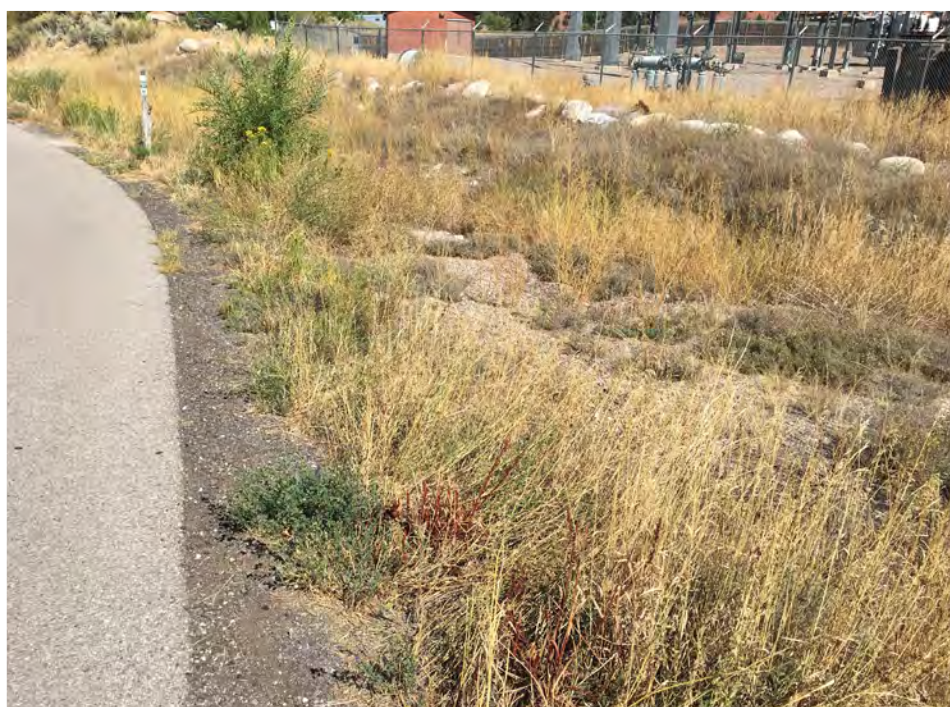
Photo 2. View looking NW along 2020 restoration priority area 3, MP 373. Recommended restoration objectives include control of annual weedy vegetation, removal of gravel/cobble for soil preparation and to improve soil contact with seed, seed area with *Seed Mix 1. Grass and Forb Mix*.

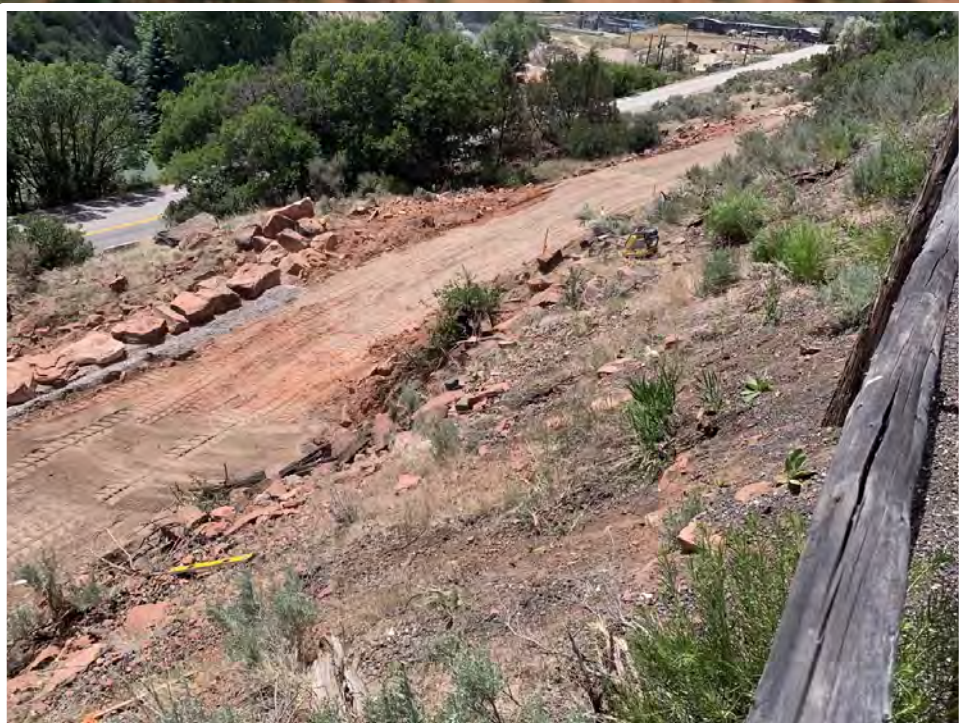
View looking NW at Restoration Priority Area 1 from Rio Grande trail. Establishing native grasses along the poorly vegetated bank using seed mix #4 will help prevent erosion and provide aesthetical and ecological benefits.

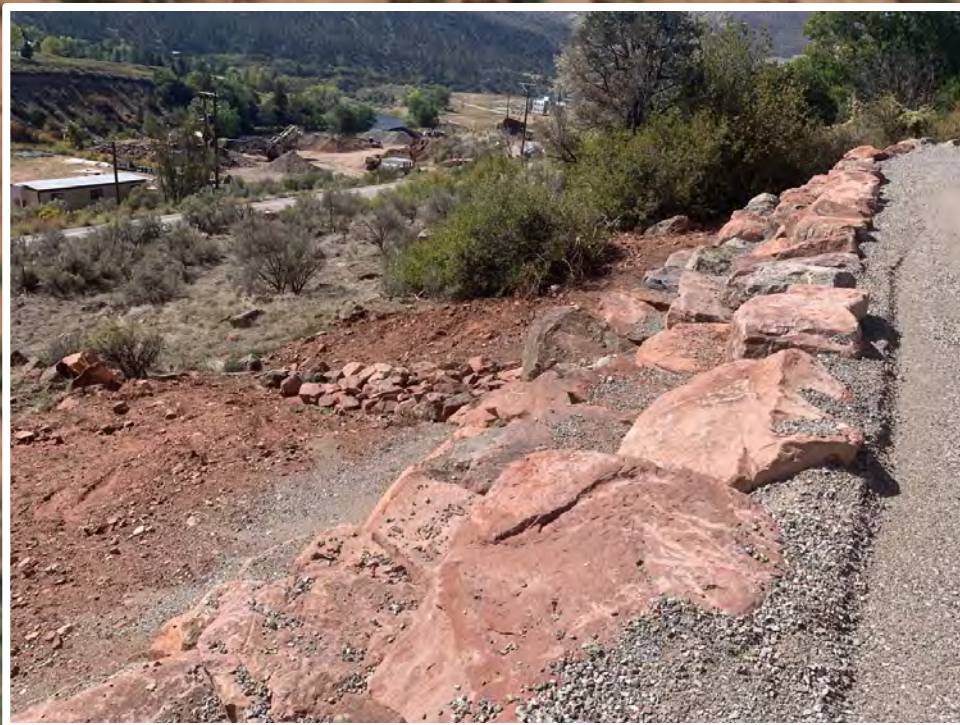
View Looking NW at Restoration Priority Area 1 for newly constructed trail. Bare soil areas should be seeded with seed mix #4 to provide quick establishment of native grasses to compete with noxious vegetation and to stabilize the soil.

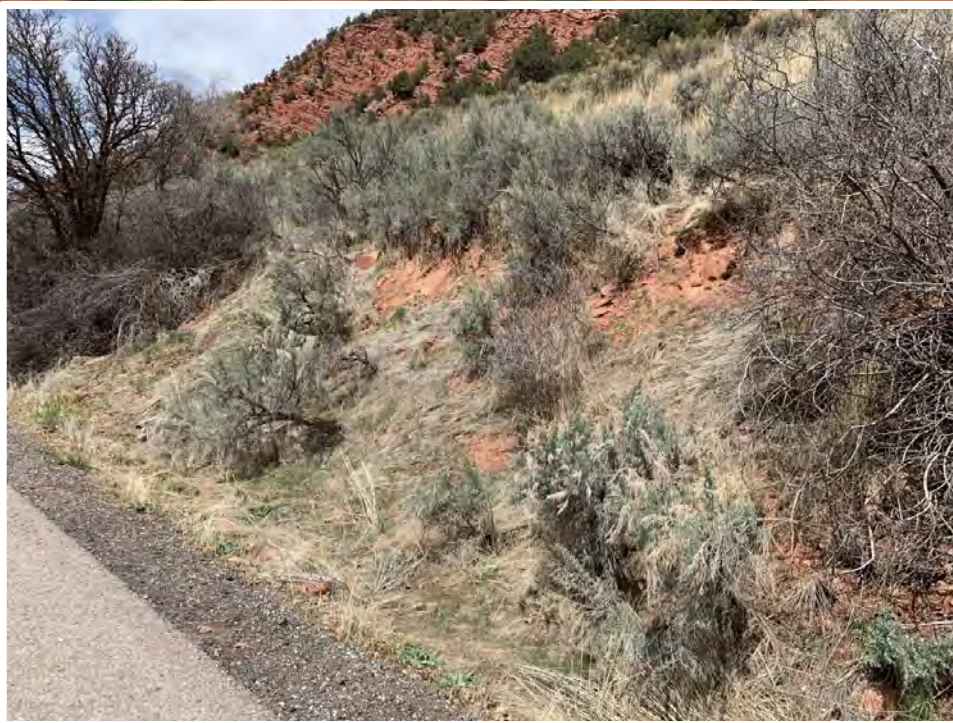
View looking NW at Restoration Priority Area 2 from Rio Grande trail. Managing cheatgrass and establishing native grasses along the poorly vegetated bank using seed mix #4 will help prevent erosion along the steep bank between the Glenwood Ditch and Rio Grande Trail.
