Roaring Fork Transportation Authority *Rio Grande Trail Restoration Seeding Plan*

Mile Post 360 -382

Glenwood Springs to Emma

**JANUARY
2022**

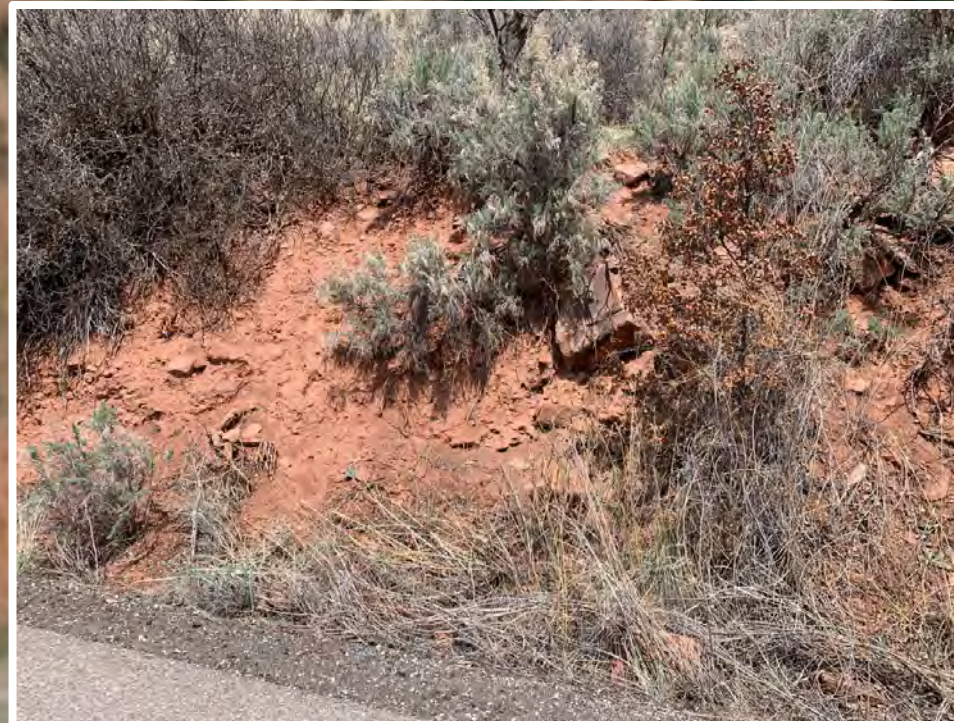
View looking N at Restoration Priority Area 2 from Rio Grande trail. Establishing native grasses along large, bare areas on steep slopes using seed mix #4 will help prevent erosion along the steep bank between the Glenwood Ditch and Rio Grande Trail.

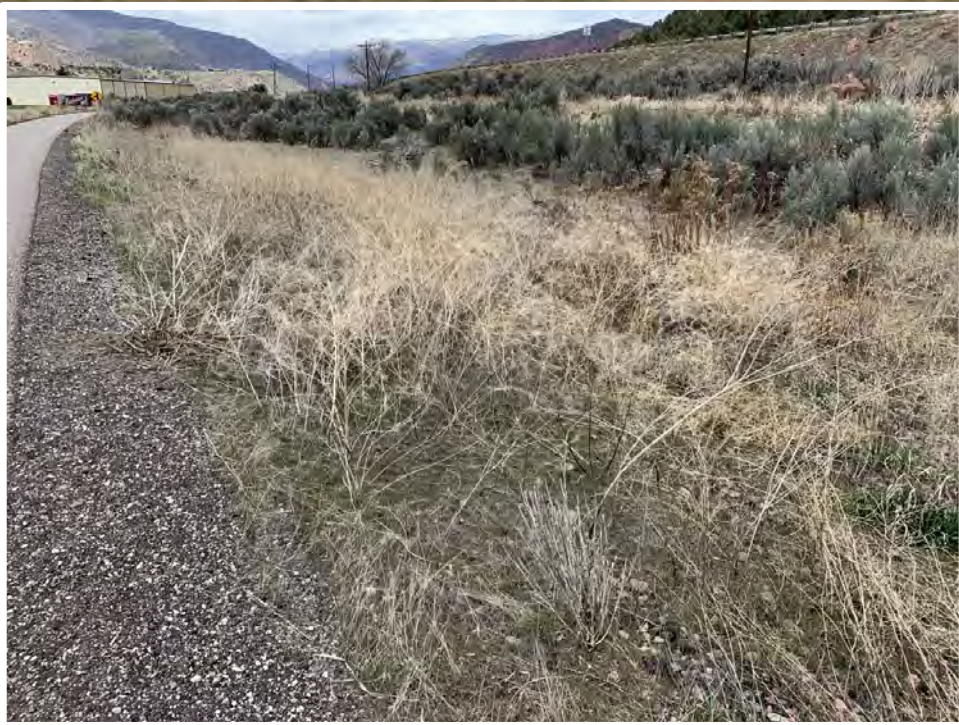
View looking NW at Restoration Priority Area 3 from Rio Grande trail. Highly disturbed area with high densities of non-native vegetation amongst sagebrush community. Manage non-native vegetation and seed area using seed mix #2 to improve vegetative conditions.

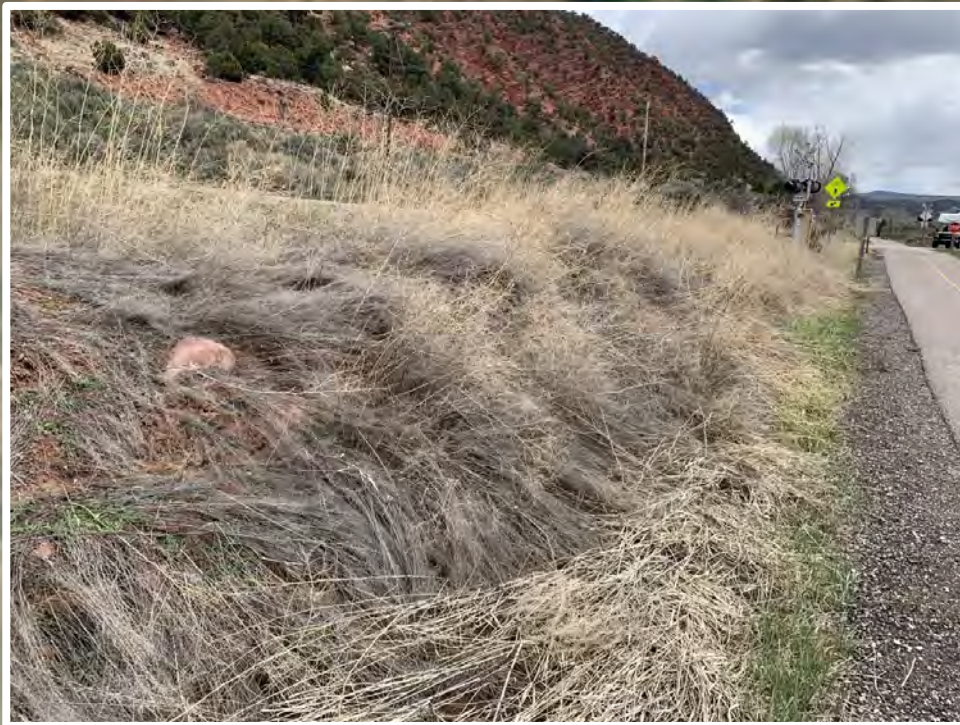
View looking E at Restoration Priority Area 3 from Rio Grande trail. Highly disturbed area with high densities of non-native vegetation, managing the non-native vegetation and seeding area with seed mix #2 will improve vegetative conditions.

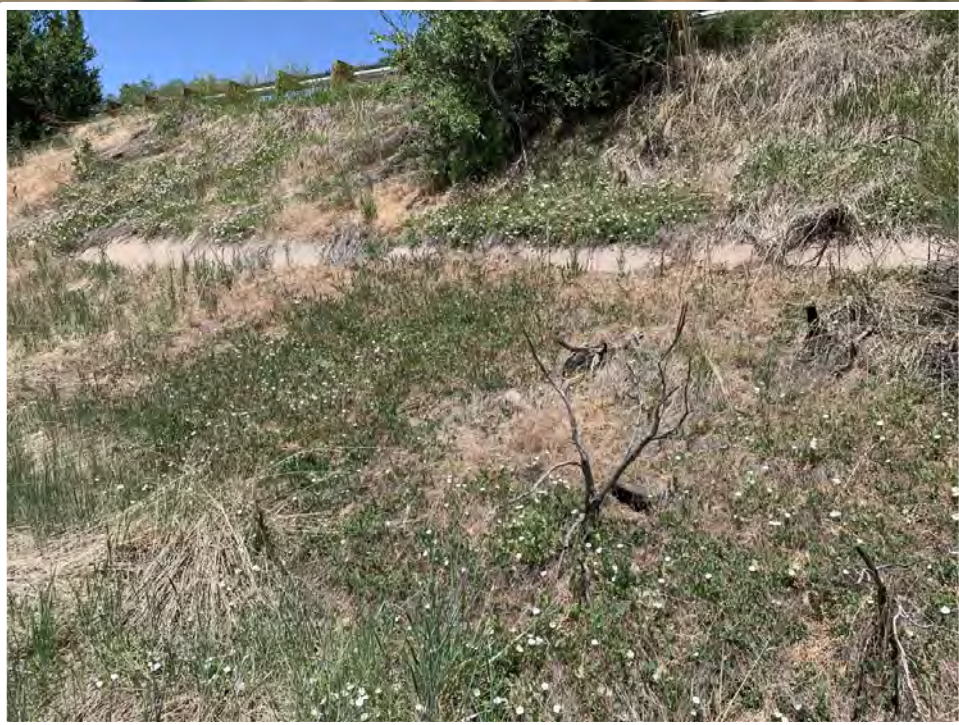
View looking N at Restoration Priority Area 4 from Rio Grande trail. Highly disturbed area with high densities of non-native vegetation amongst sagebrush community on moderate slope between HWY 82 and trail. Manage non-native vegetation and seed area using seed mix #2 to improve vegetative conditions.

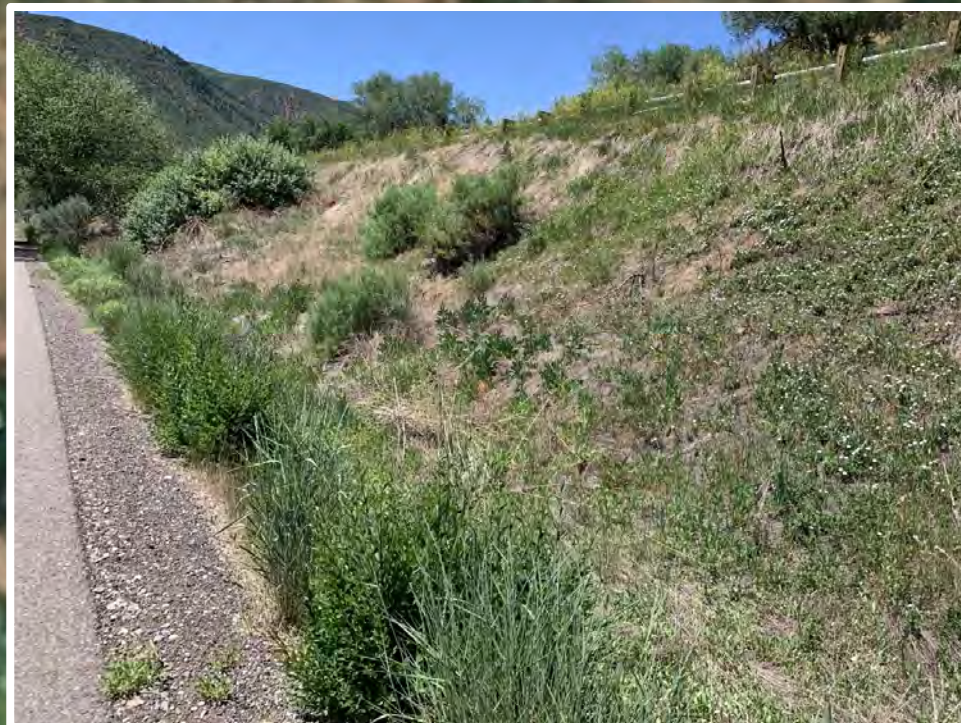
View looking NW at Restoration Priority Area 4 from Rio Grande trail. Highly disturbed area with high densities of non-native vegetation amongst sagebrush community on moderate slope between HWY 82 and trail. Manage non-native vegetation and seed area using seed mix #2 to improve vegetative conditions.

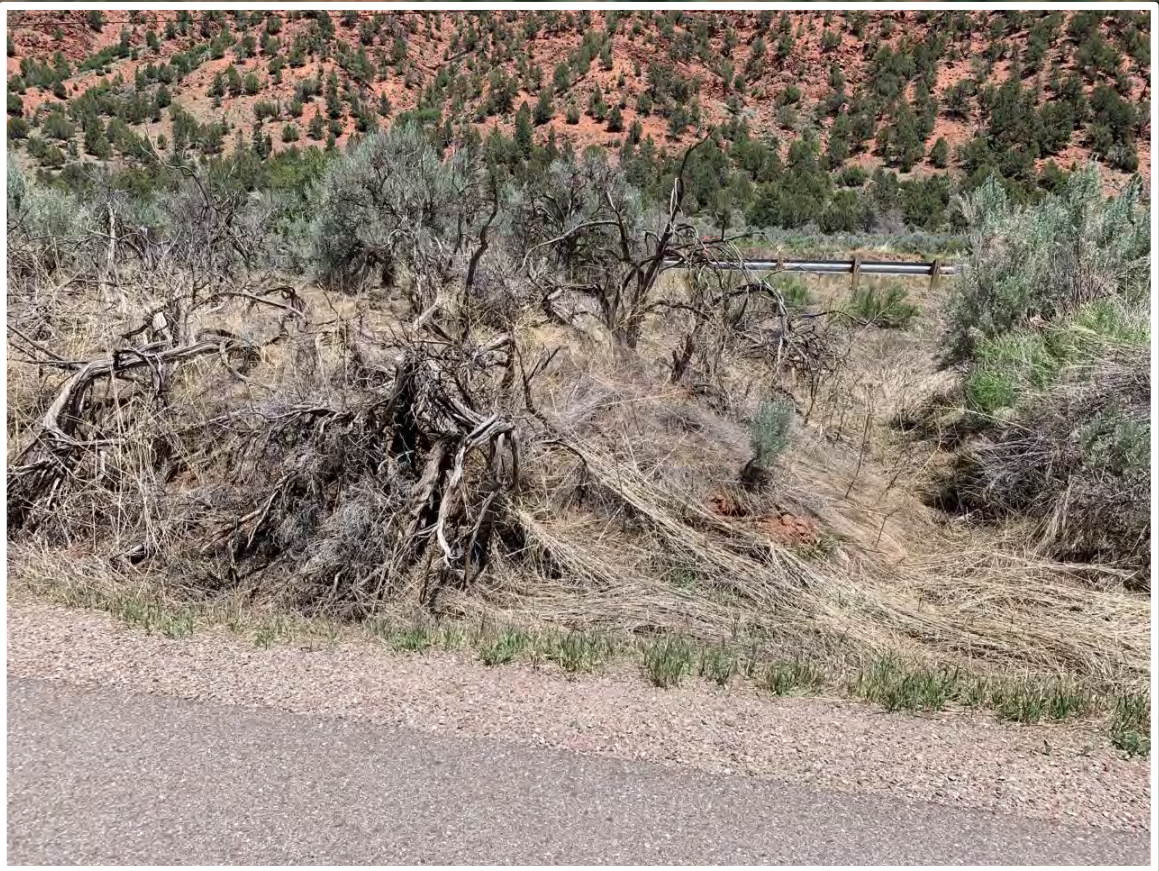
View looking N at Restoration Priority Area 5 from Rio Grande trail. Disturbed area with significant die-back of sagebrush vegetation and high densities of non-native understory species. Prior to seeding, further assess surroundings and soil conditions. Remove all dead vegetation and manage non-native weeds. Seed with seed mix #2.

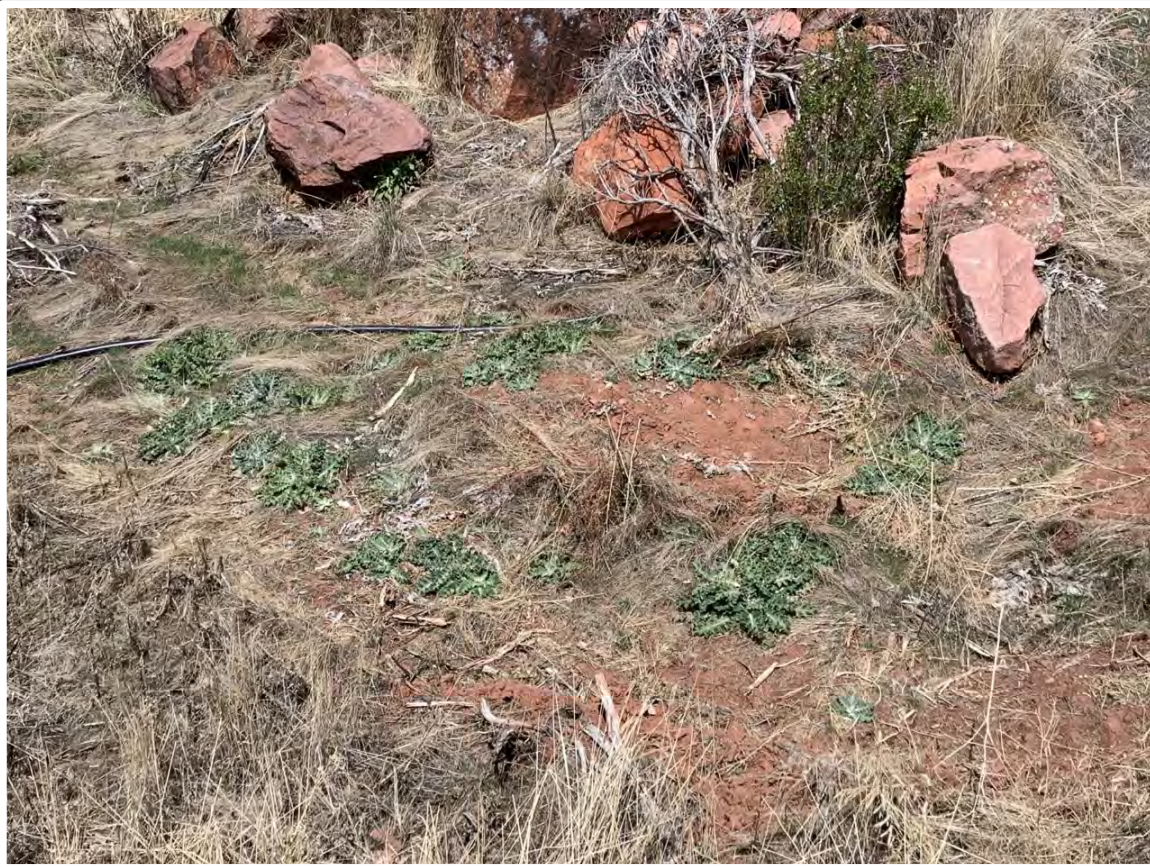
View looking N at Restoration Priority Area 6 from Rio Grande trail. Disturbed area with compacted soils and high densities of noxious vegetation from access to the Glenwood Ditch. Coordinate efforts with ditch owners. Manage noxious vegetation and lightly till compacted soil prior to seeding area with seed mix #4.

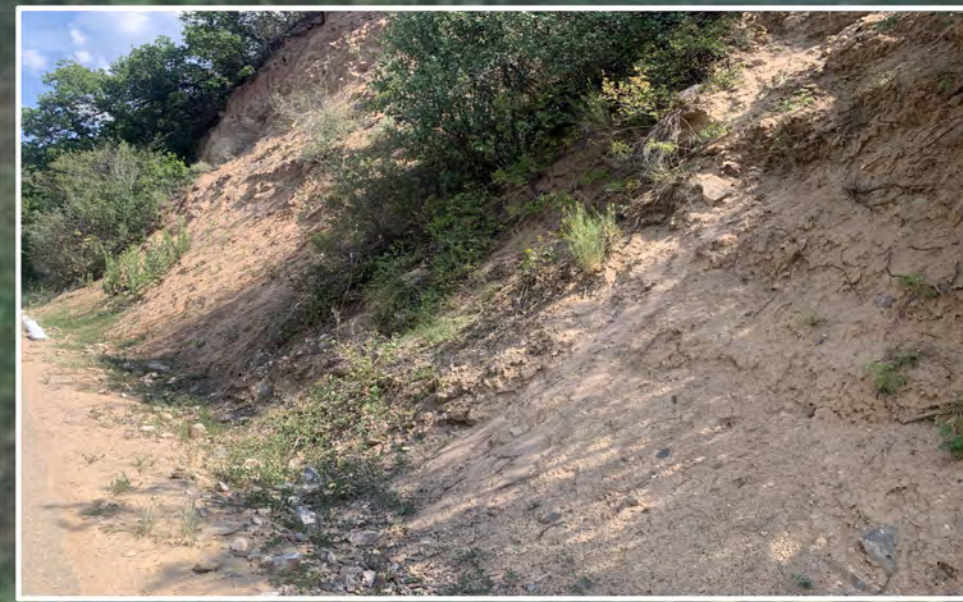
View Looking east (up valley) at restoration priority area 1, MM 376.2. Steep slopes and poor vegetation establishment with potential for sever erosion activity. Recommend using the aggressive erosion control seed mix #4 with Hydraulic erosion control to stabilize slopes

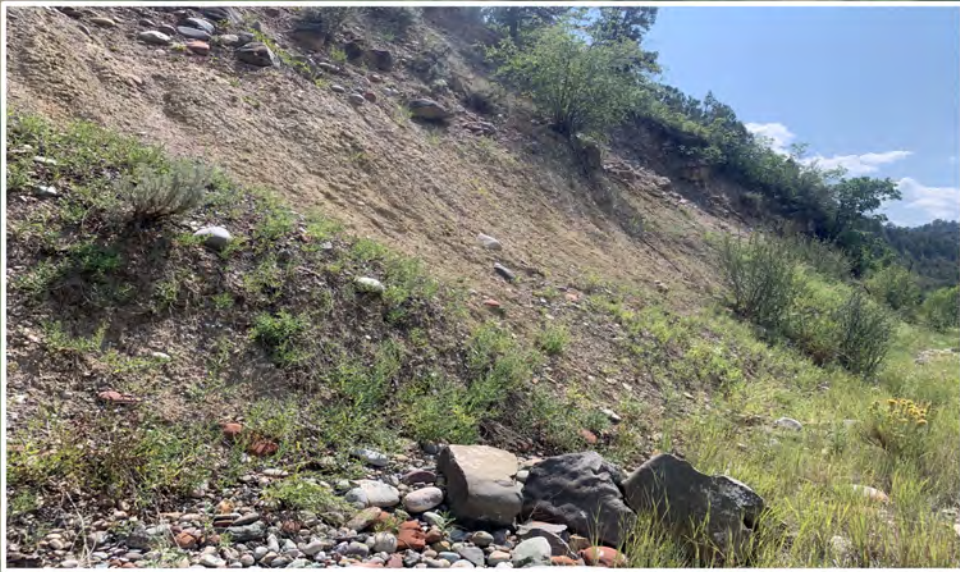
View Looking west (down valley) at restoration priority area 2, MM 376.9. Steep slopes and poor vegetation establishment with potential for severe erosion activity. Recommend using the aggressive erosion control seed mix #4 with Hydraulic erosion control to stabilize slopes

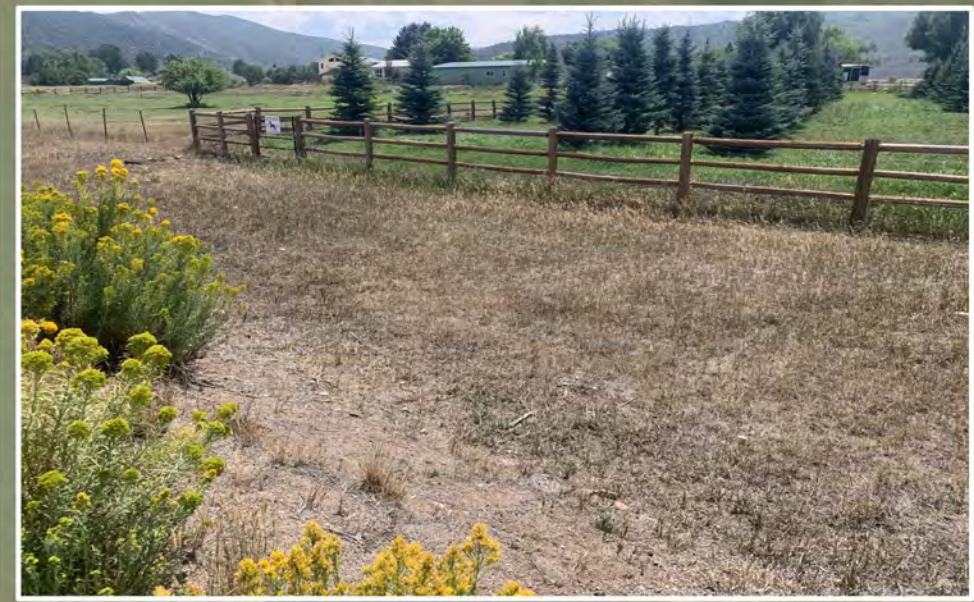
View of southern portion of restoration priority area 3, MM 381.5. Expansive ruderal vegetation, with smooth brome dominant and forming monocultures in areas. Isolated rabbitbrush establishment along trail edge. Opportunity restore native sagebrush communities.

Restoration Priority 3
 - Approximately 1030 linear ft.
 - Approximately 1.43 acres

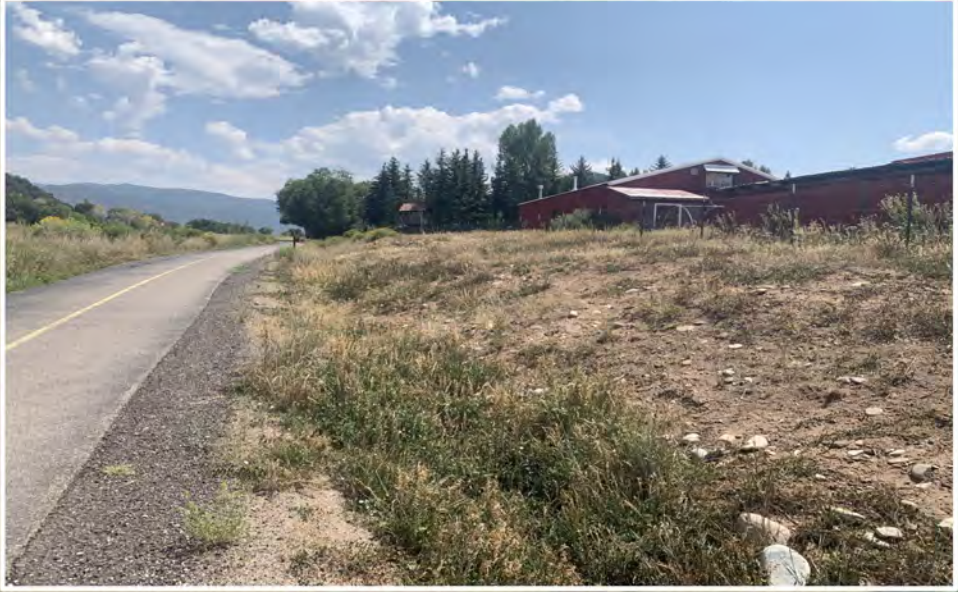
Restoration Priority 4
 - Approximately 410 linear ft.
 - Approximately 0.53 acres

View of moderately sloping southern slope of restoration priority area 4, MM 381.5. Ruderal vegetation with high densities of noxious vegetation on adjacent property. Close proximity to priority area #3 provides opportunity to further expand extent of sagebrush community restoration.

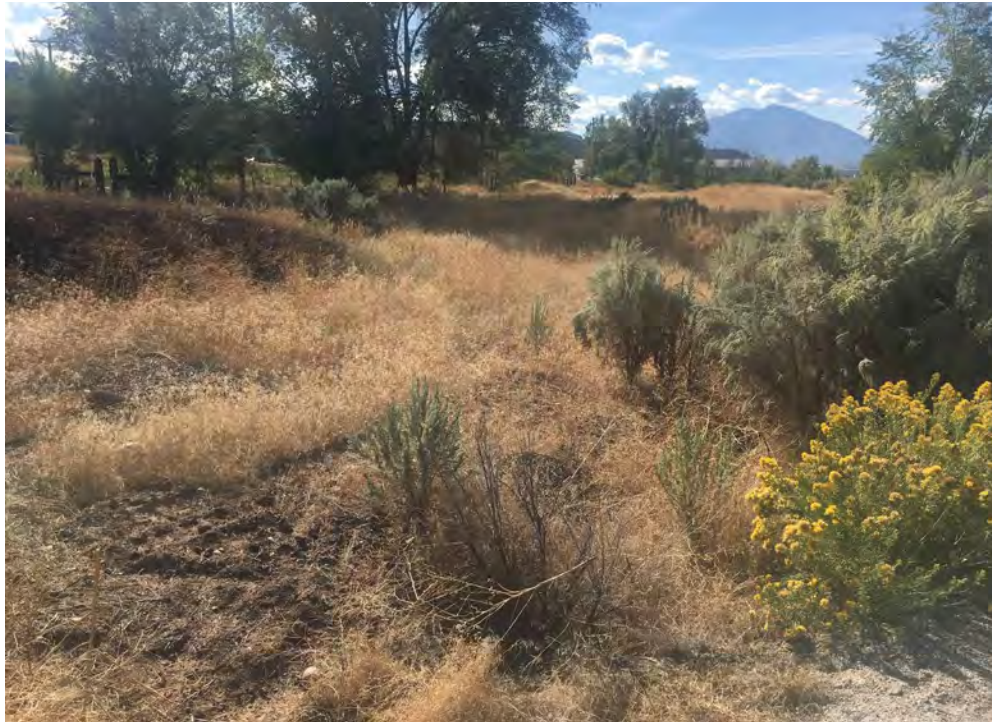
1. View looking SE at significant impairment area. Scattered sagebrush and rabbit brush with cheatgrass and annual mustards dominating the understory. Bare soils present.

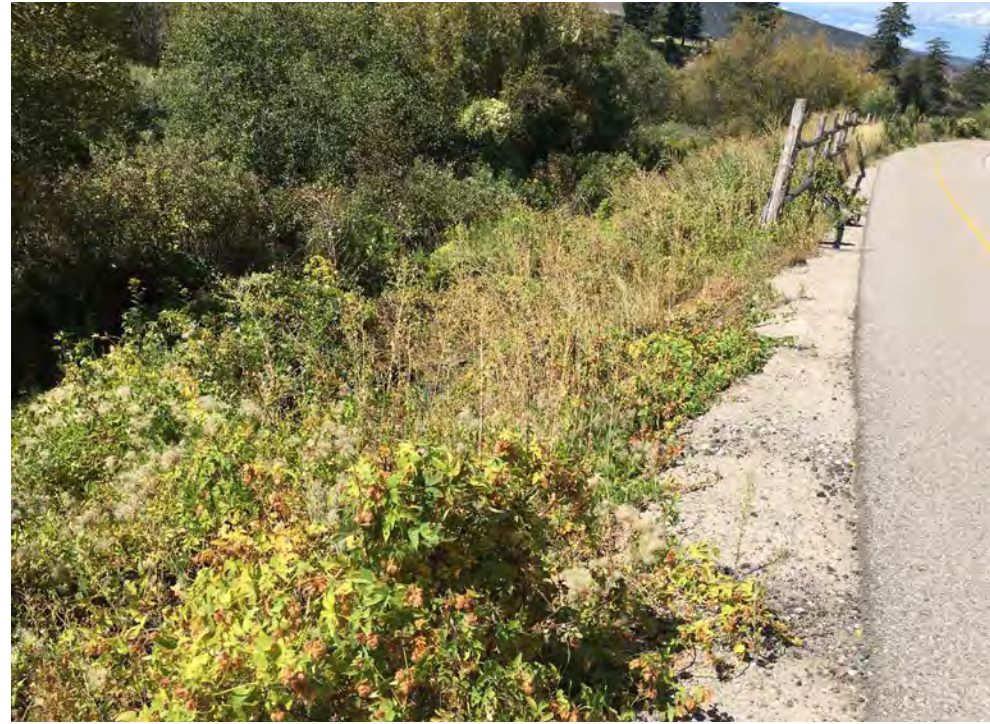
2. View looking W at area of significant impairment, high densities of noxious vegetation, including Canada thistle and common tansy along steep slope to irrigation ditch.

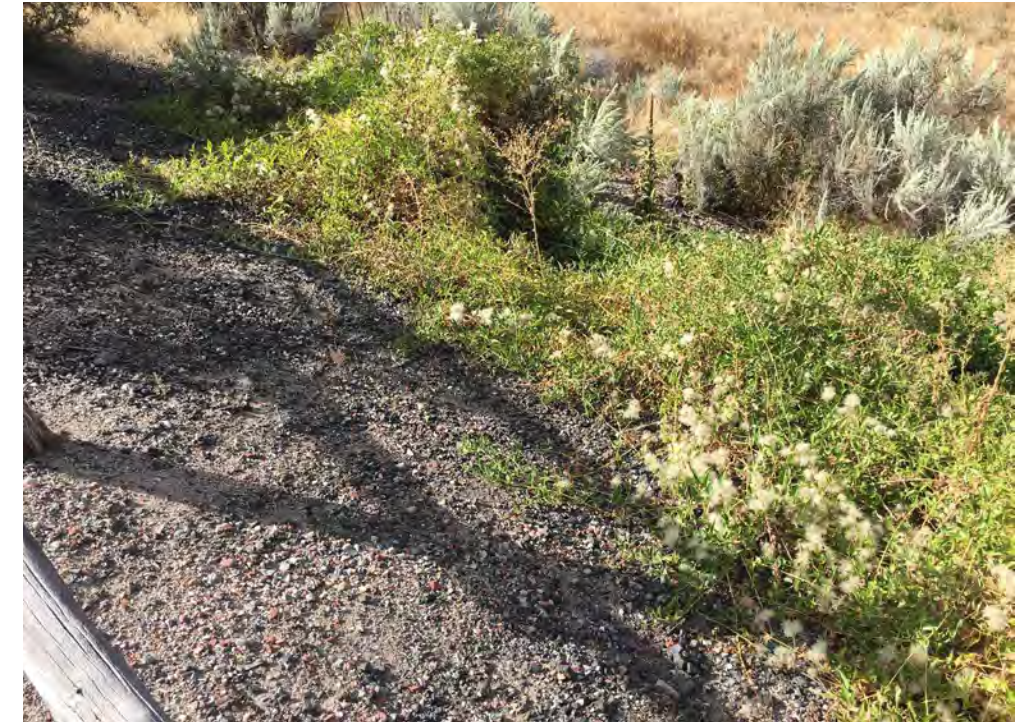
3. View looking W at area of significant impact. Steep slope to Cattle Creek, with moderate shrub cover but limited graminoid and forb cover with poor top soil conditions.

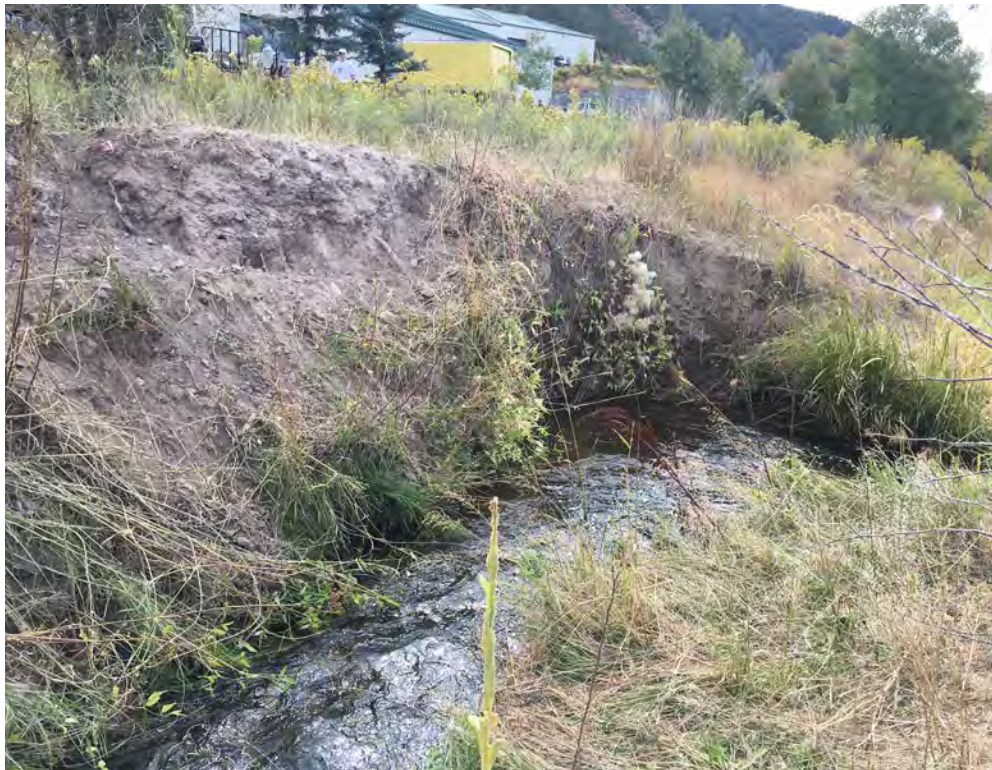
4. View looking N at area of significant impairment. Evidence of erosion and poor vegetation establishment along steep bank of irrigation ditch.

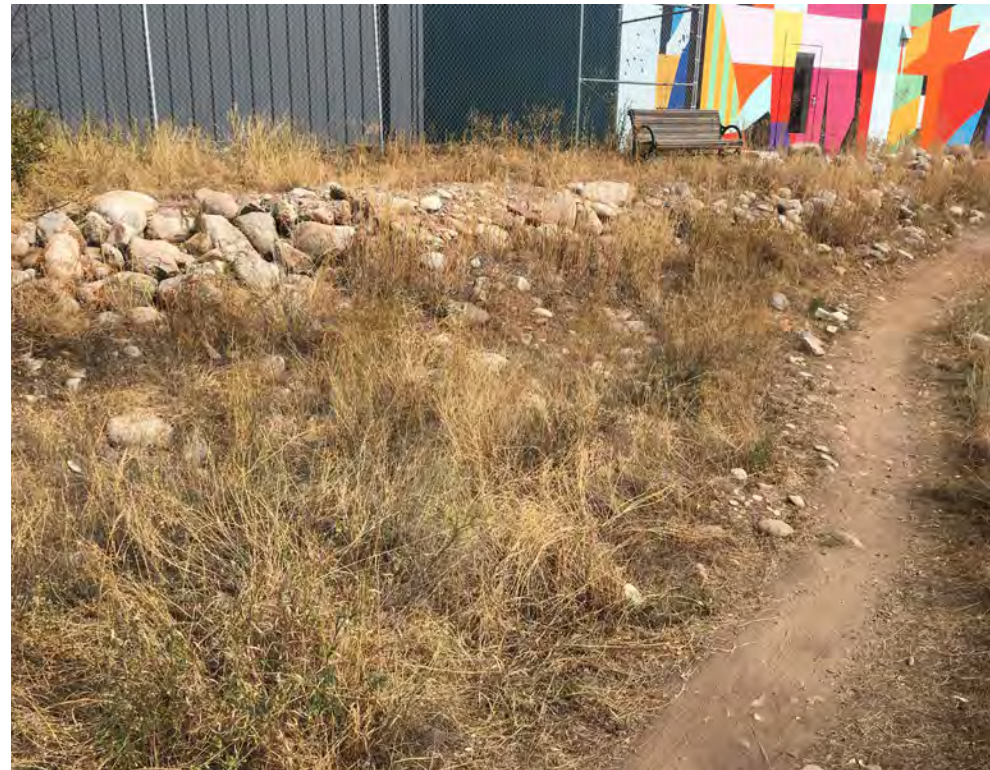
5. View looking NE at area of significant impairment. Area of high disturbance and non-native forbs and graminoids not consistent with native vegetation communities

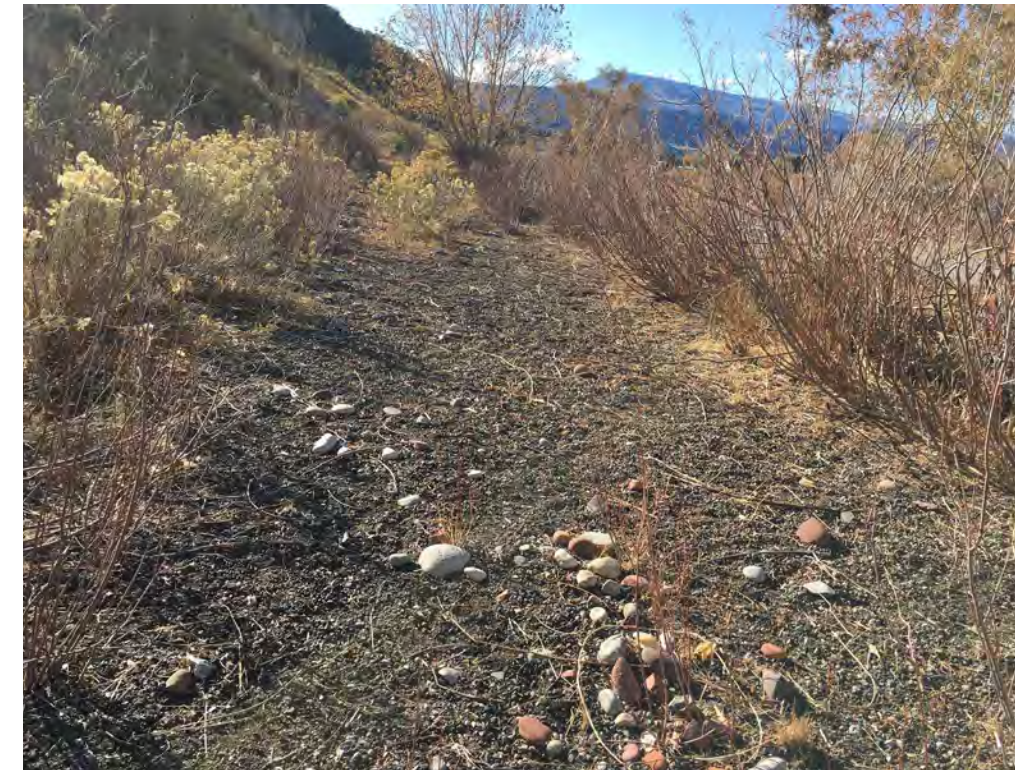
6. View looking W at area of significant impairment. Sagebrush shrubland community with large areas of bare soil with minimal vegetation establishment.

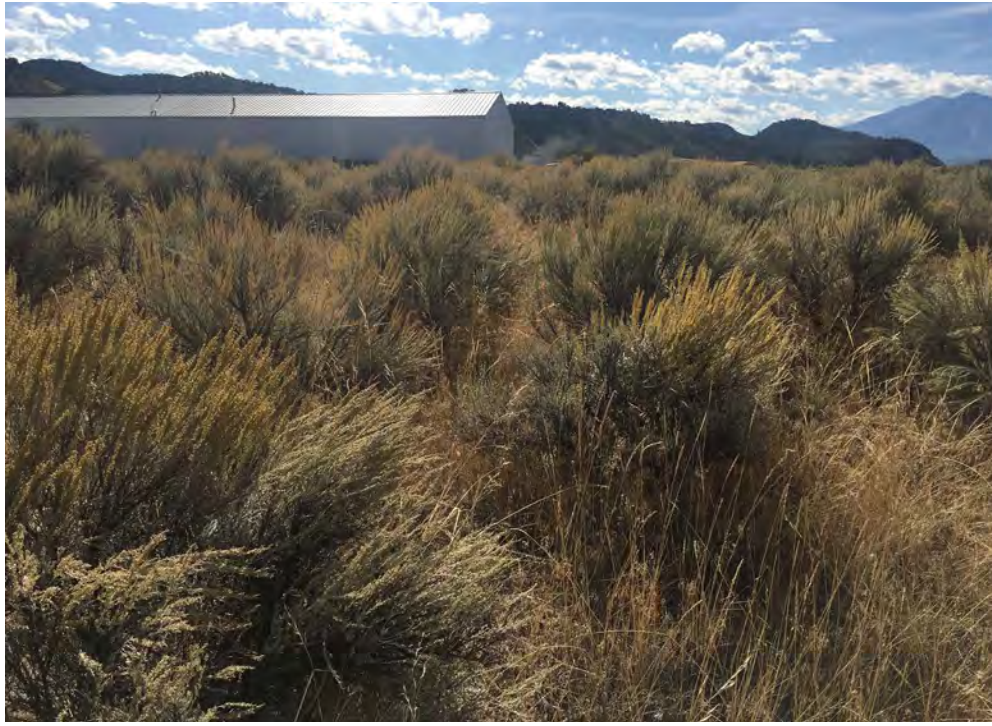
1. View looking W at area of moderate impairment. Good sage cover with high densities of annual weedy species, including cheatgrass.

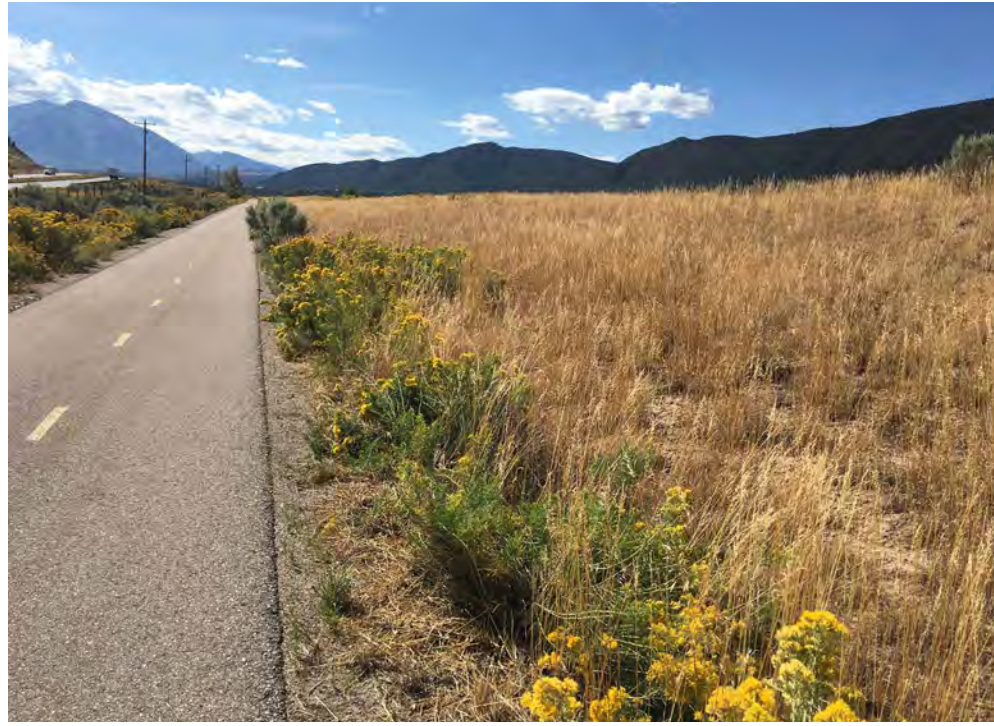
2. View looking S at moderate impairment area, increase plant diversity and shrub cover through seeding effort.

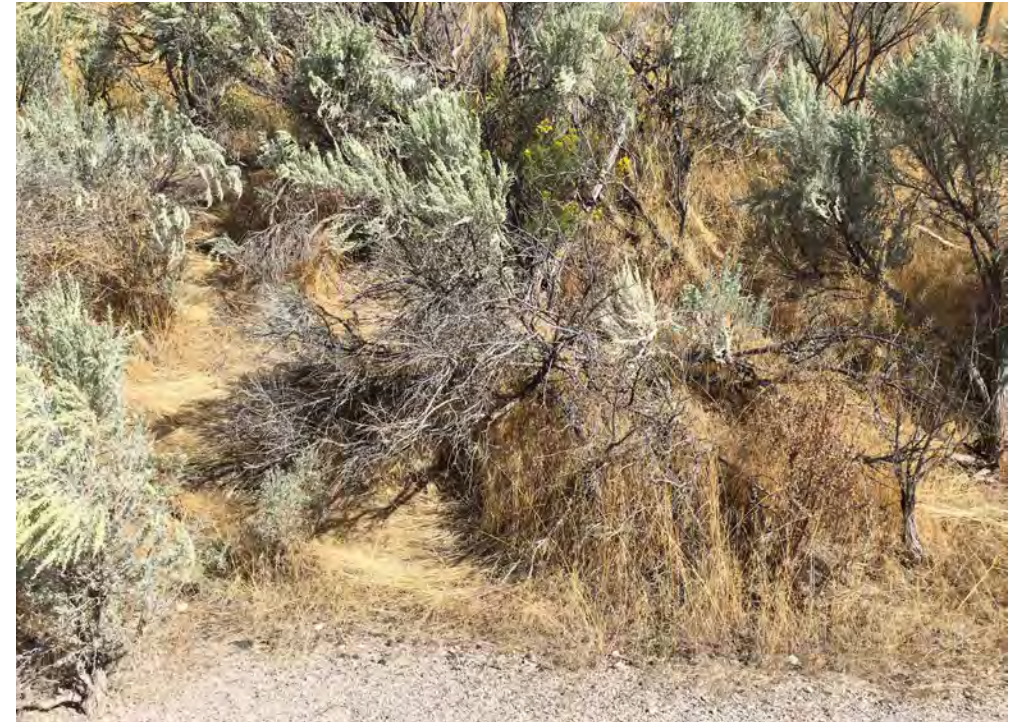
3. View looking E at area of moderate impairment. Well established sagebrush cover with poor understory vegetation consisting of annual weeds.

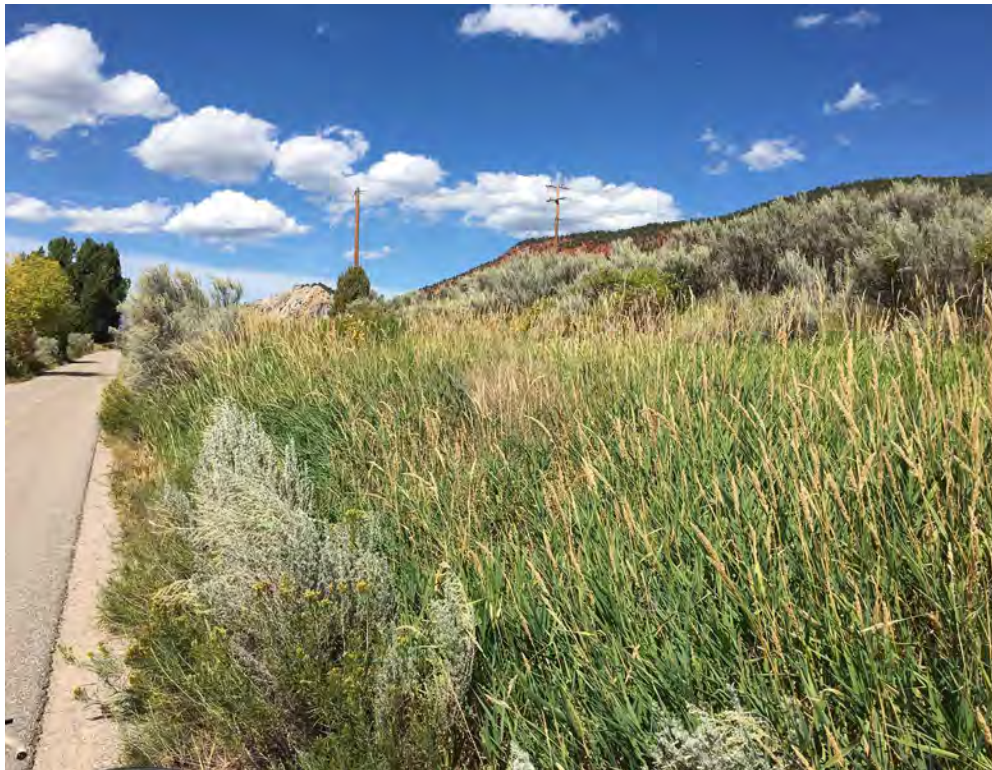
4. View looking N at area of moderate impairment. Good vegetation cover, but poor vegetation composition and diversity with high densities of reed canary grass along irrigation ditch.

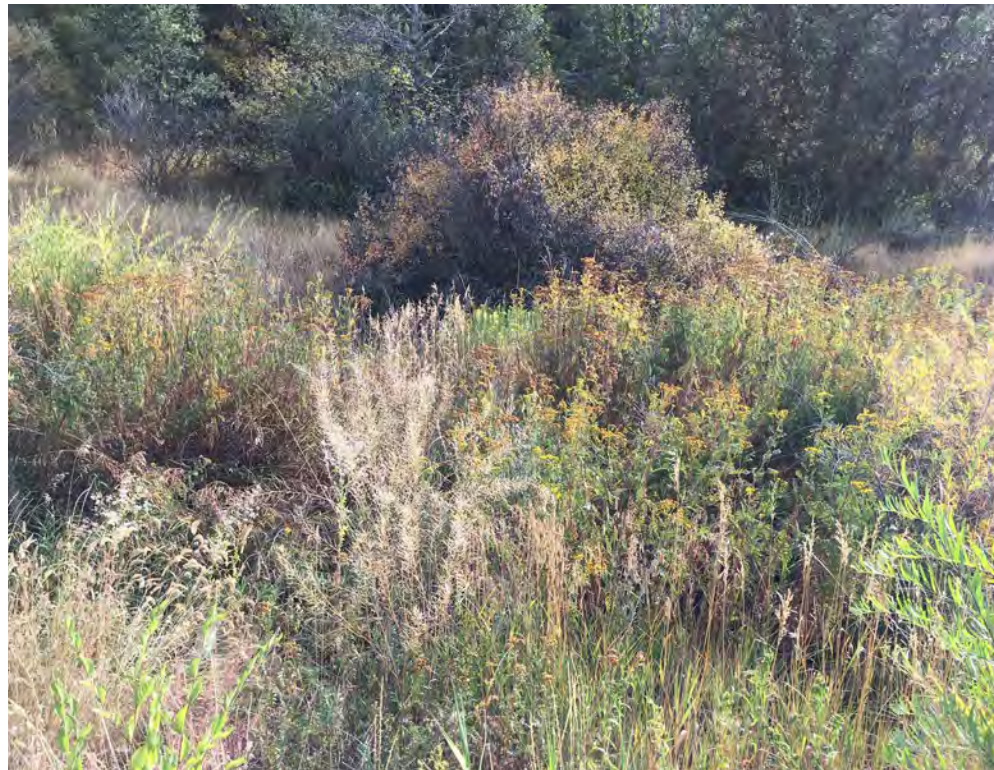
5. View looking S at area of moderate impairment. Well established tree, shrub and graminoid forb layer with high densities of noxious vegetation (common tansy).

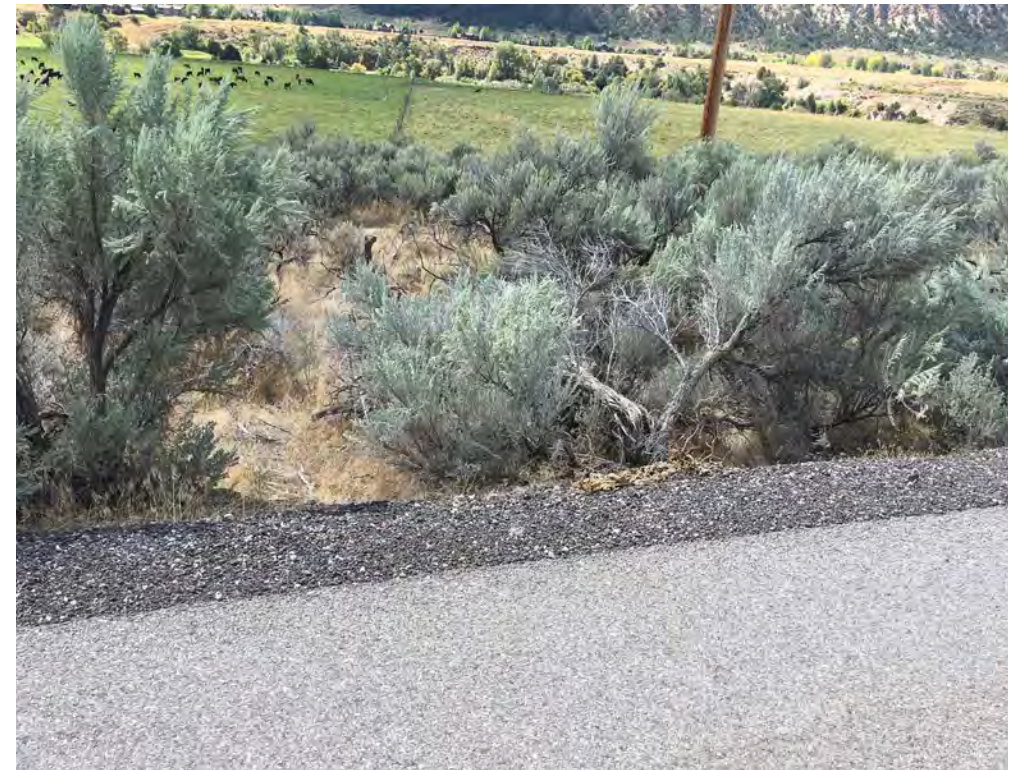
6. View looking W at area of moderate impairment. Well established sagebrush cover with poor understory vegetation consisting of annual weeds.

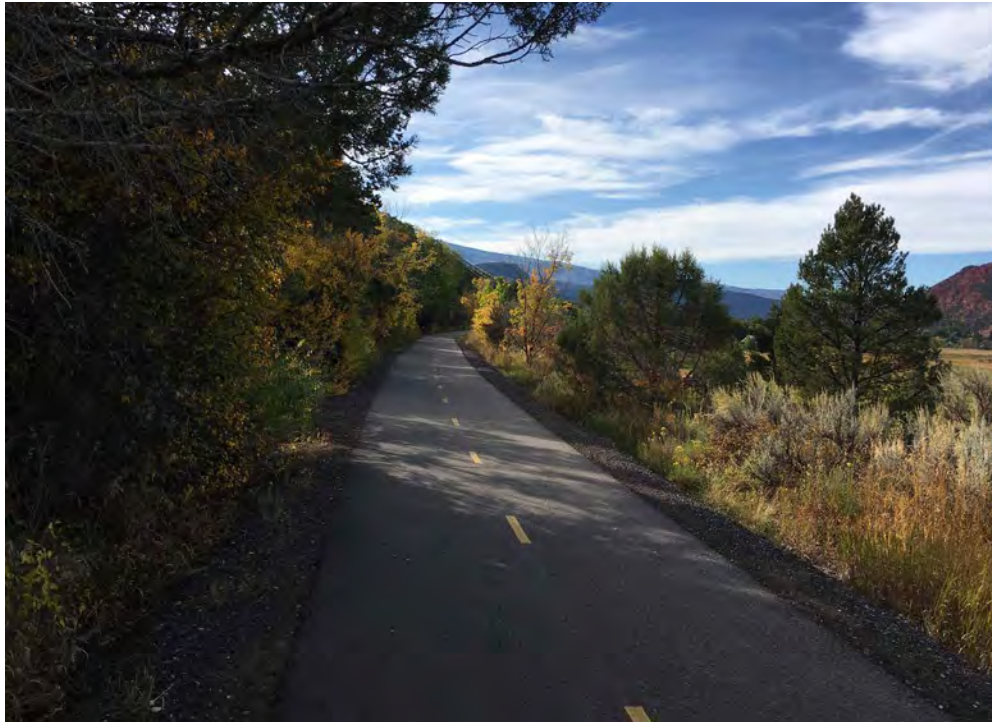
1. View looking E at area of low impairment. Minimal disturbances to natural vegetation consistent with a mixed mountain shrubland. Good vegetation cover and composition.

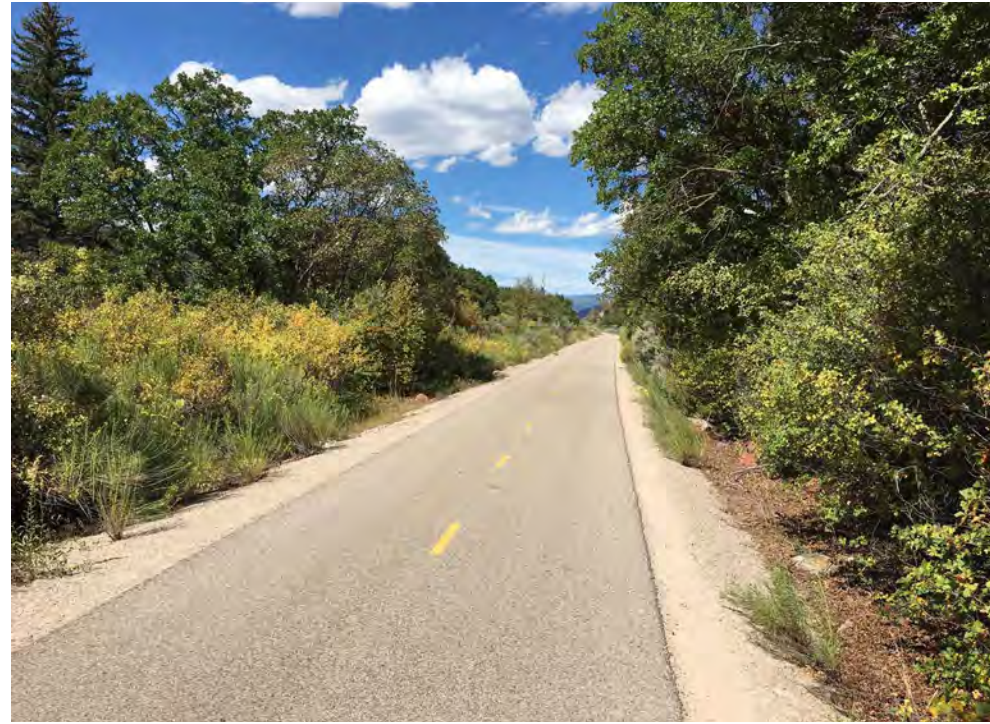
2. View looking NE at area of low impairment. Good native vegetation establishment consistent with a mixed shrubland community.

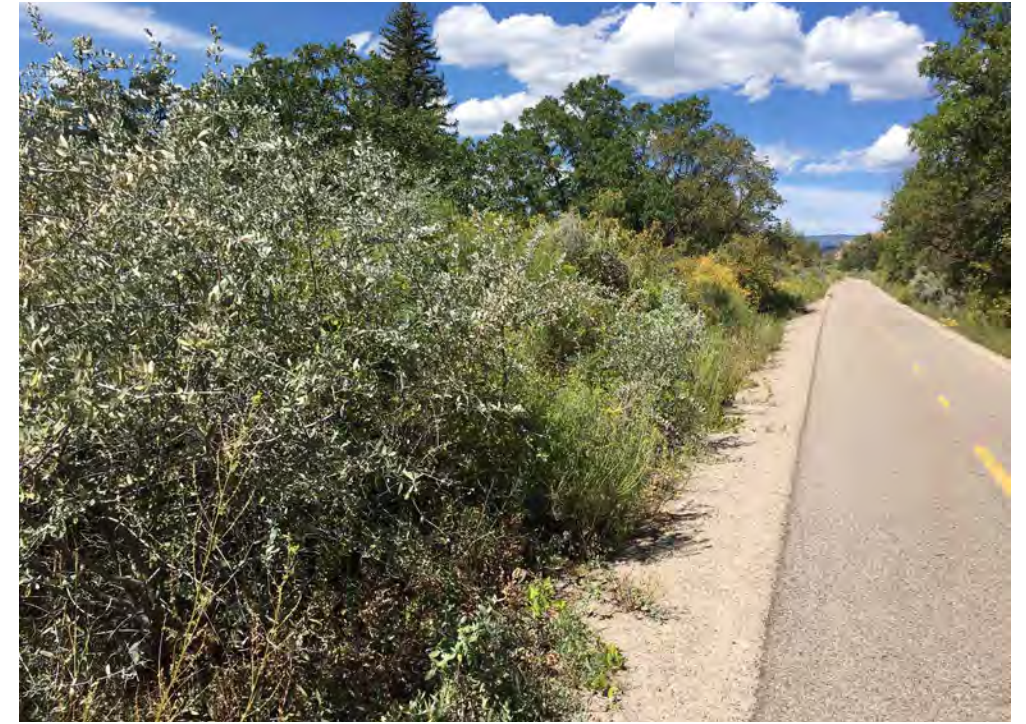
3. View looking NE at area of low impairment. Good native vegetation establishment consistent with a mixed shrubland community.

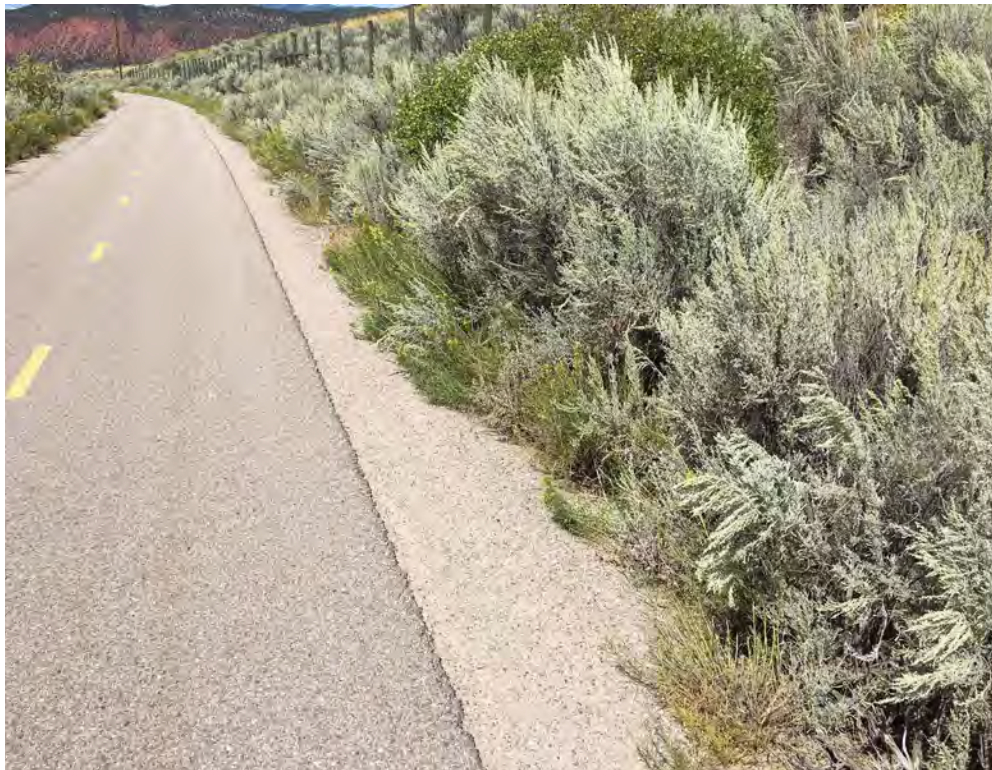
4. View looking north west at area of low impairment. Good sagebrush establishment and vegetation structure consistent with sagebrush shrubland communities.

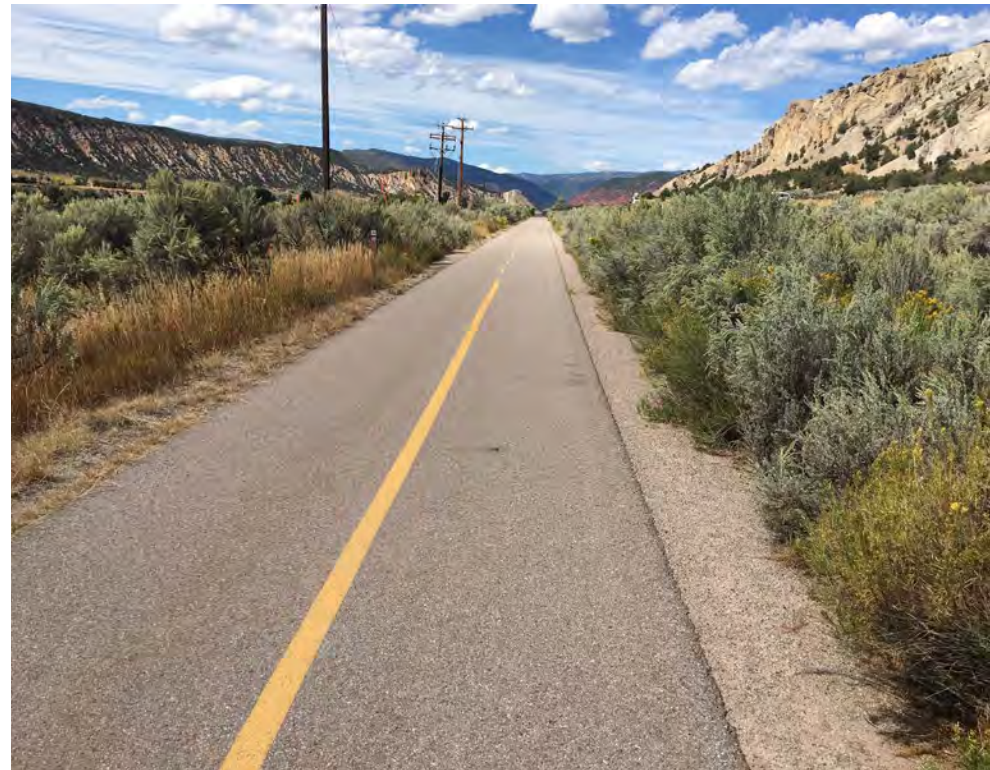
5. View looking NW at area of low impairment. Good establishment of native vegetation consistent with a sagebrush shrubland community.

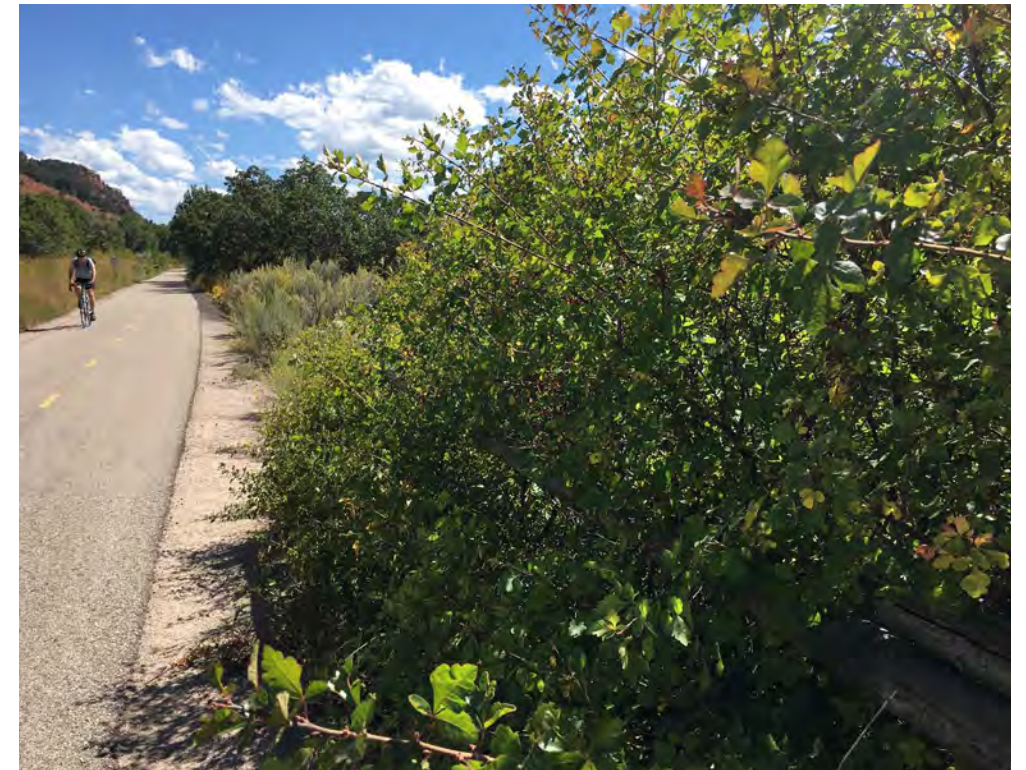
6. View looking SE at area of low impairment. Good vegetation establishment consistent with a mixed shrubland community.
