Roaring Fork Transportation Authority *Rio Grande Trail Restoration Seeding Plan*

Mile Post 360 -382

Glenwood Springs to Emma

**JANUARY
2022**

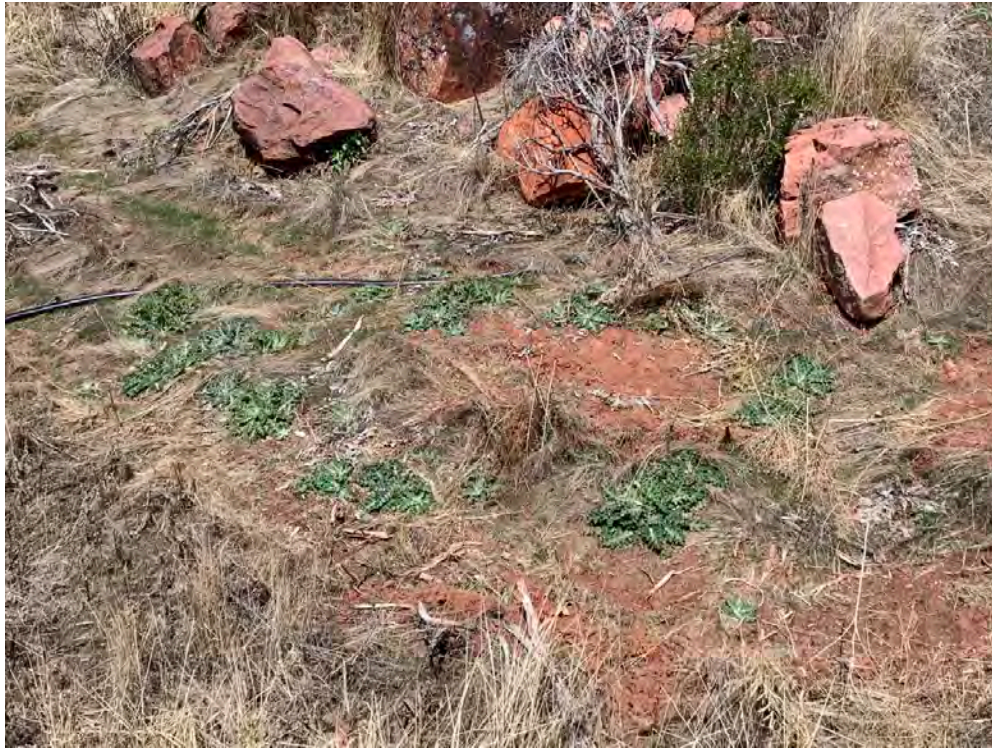
PHOTO 1: View looking N at area of significant impairment (MM 366.1). Highly disturbed area associated with access for ditch maintenance. bare, compacted ground with high densities of noxious vegetation.

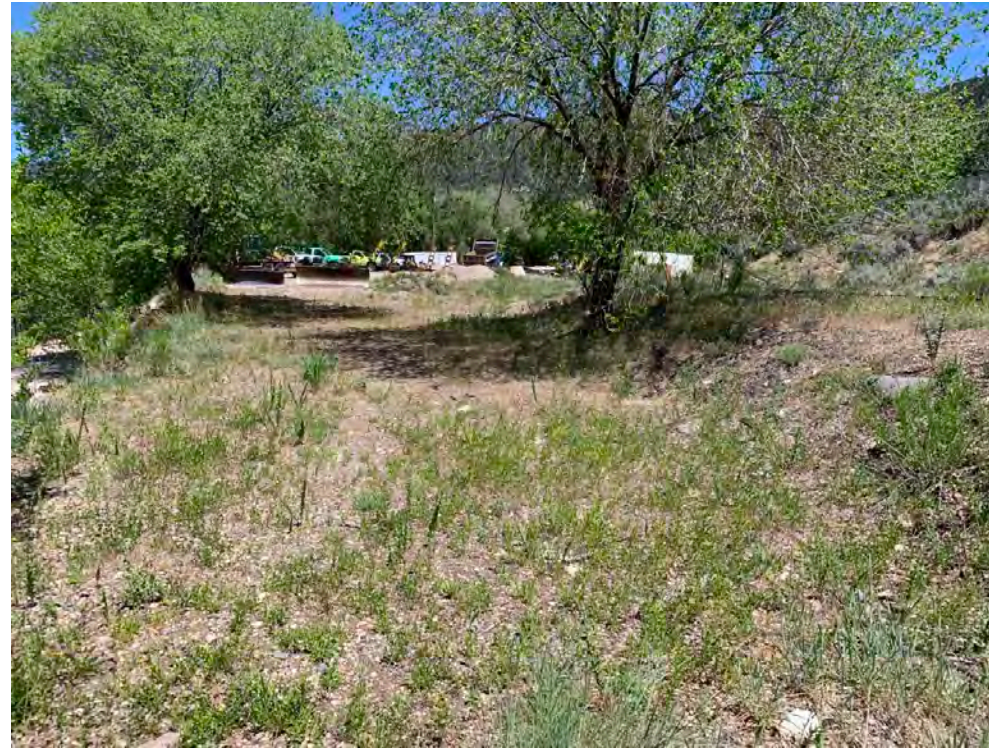
PHOTO 2: View looking NE at area of significant impairment (MM 360.6). Area of high disturbance and noxious vegetation, including yellow toadflax, thistles, cheatgrass and weedy annual mustard species.

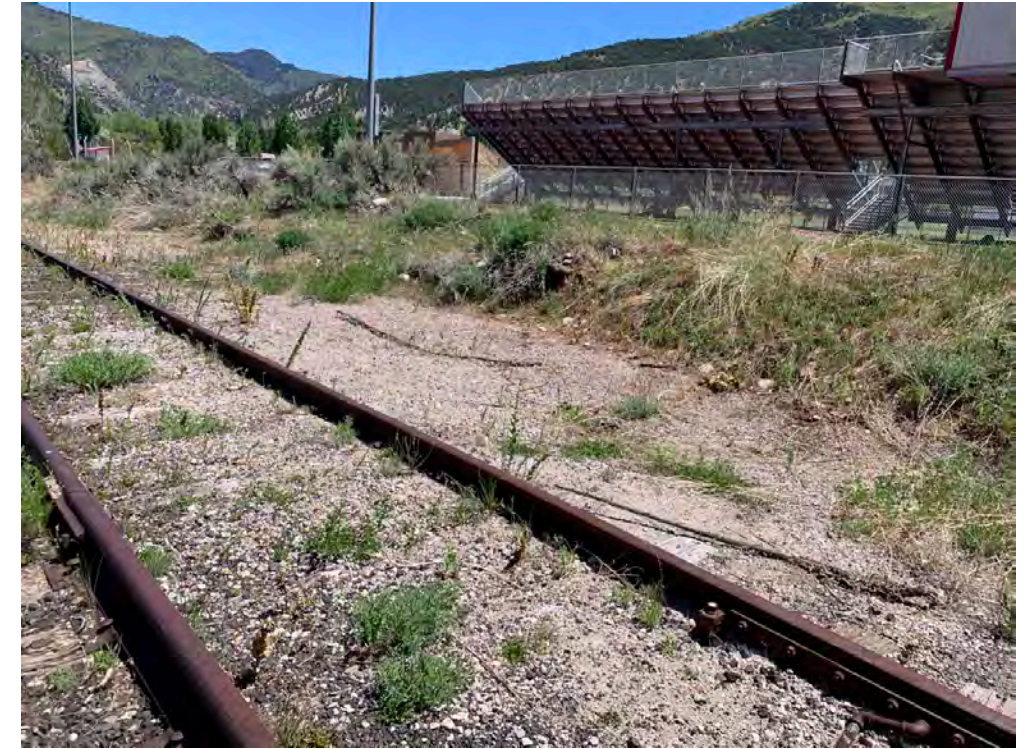
PHOTO 3: View looking E at area of significant impairment (MM361.25). Area of high disturbance between trail and school field. Contains non-native forbs and graminoids not consistent with native vegetation communities.

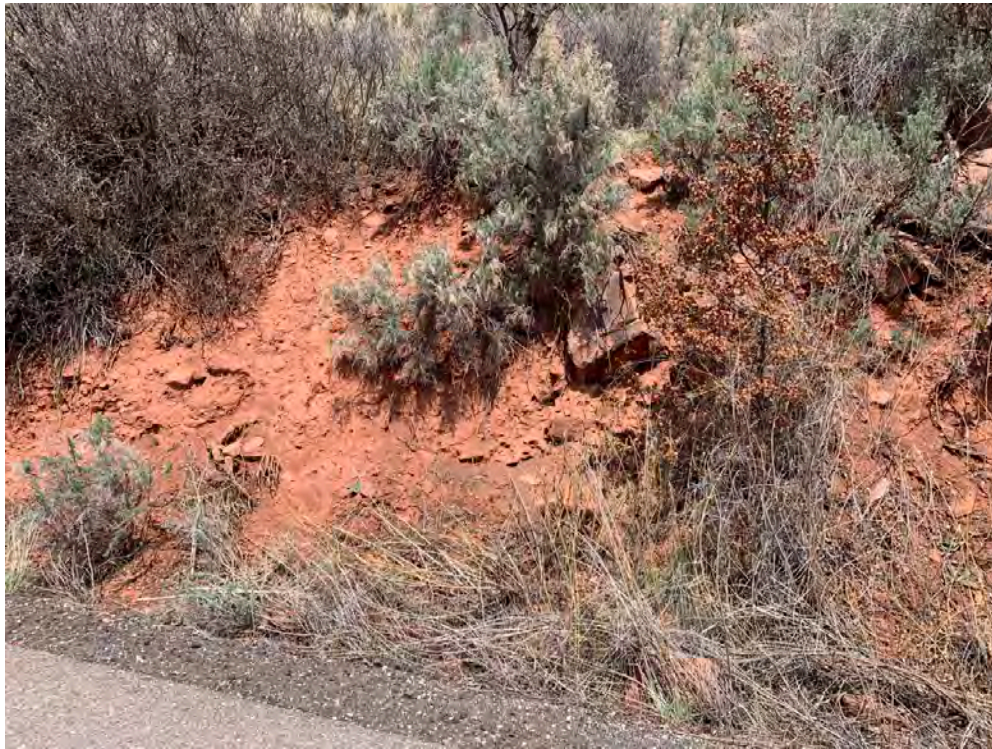
PHOTO 4: View looking N at area of significant impairment (MM 366). Steep slope with bare ground present - high potential for erosion. Impairment associated with irrigation that parallels the trail in this section.

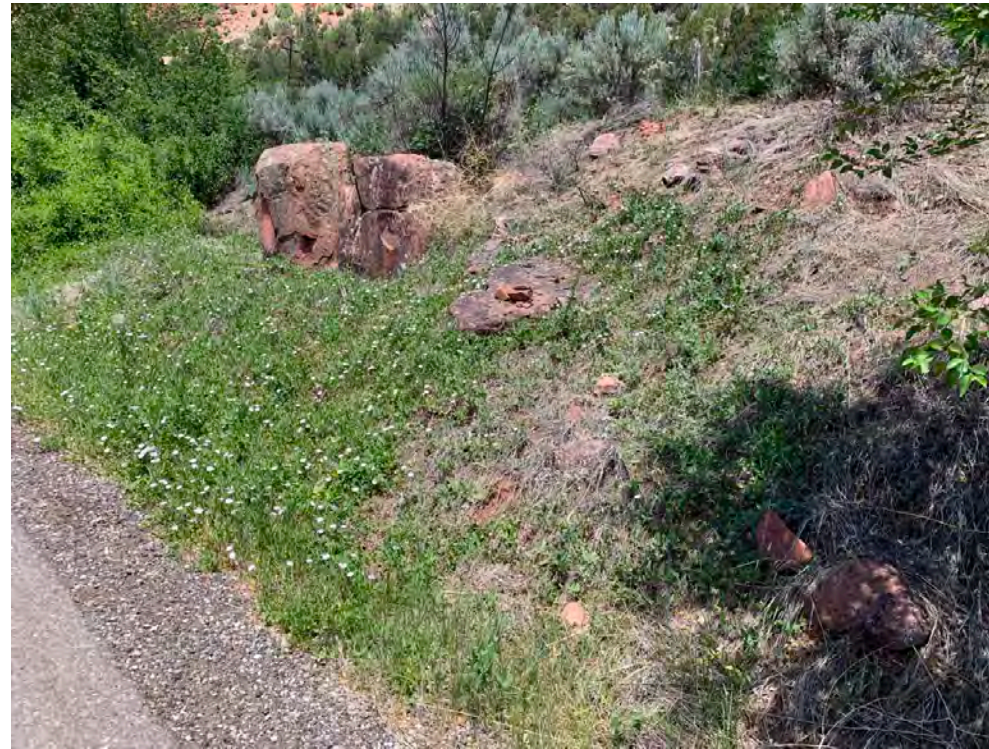
PHOTO 5: View looking NE a area of significant impairment (MM 363.75). Moderate slope with high densities of bindweed and cheatgrass and patches of bare ground with potential for erosion.

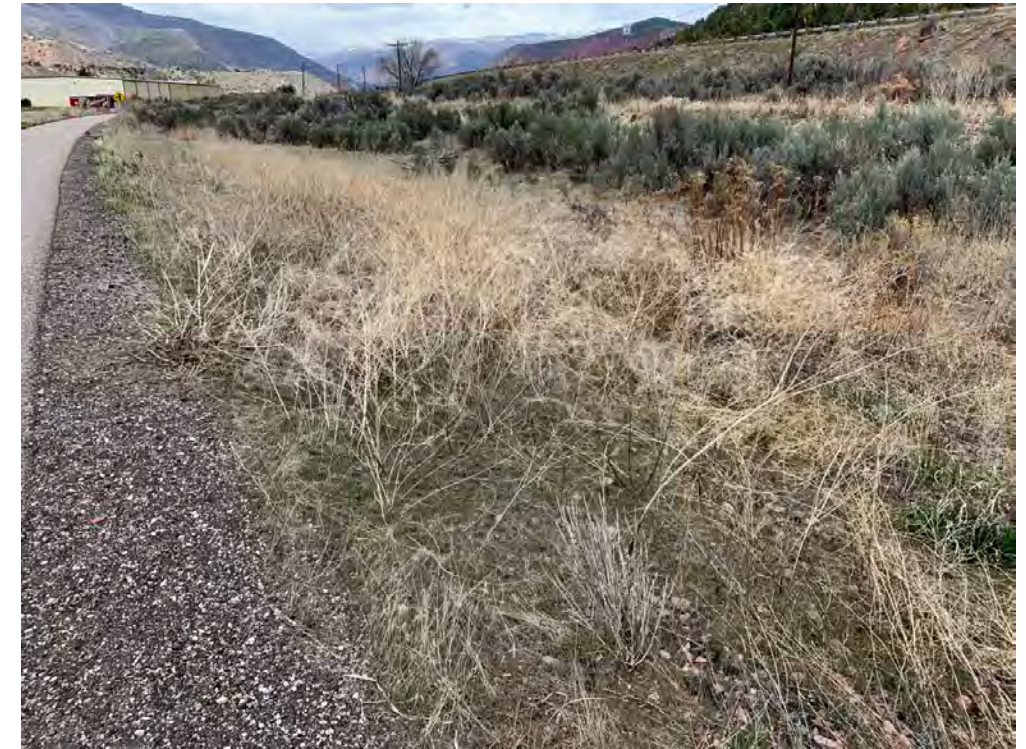
PHOTO 6: View looking N at area of significant impairment (MM 365.25). Large, disturbed opening in sagebrush community consisting of high density annual mustards, common tansy, cheatgrass, and bindweed.

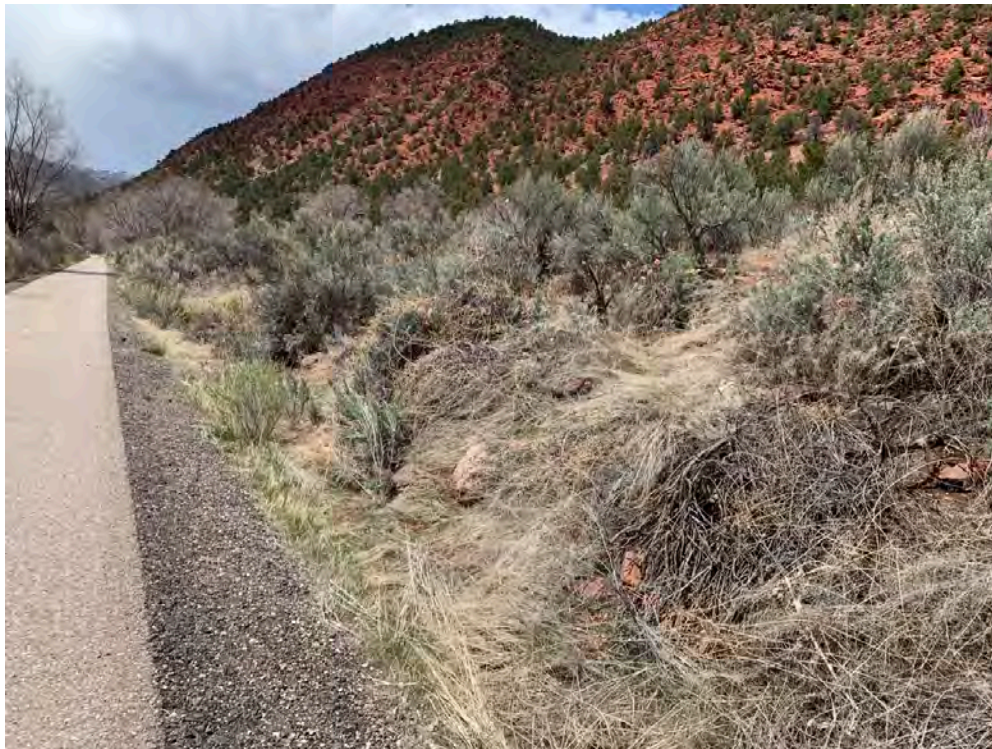
PHOTO 1: View looking NW at area of moderate impairment (MM 366.75). Established Sagebrush vegetative community with cheatgrass and annual mustards dominating understory

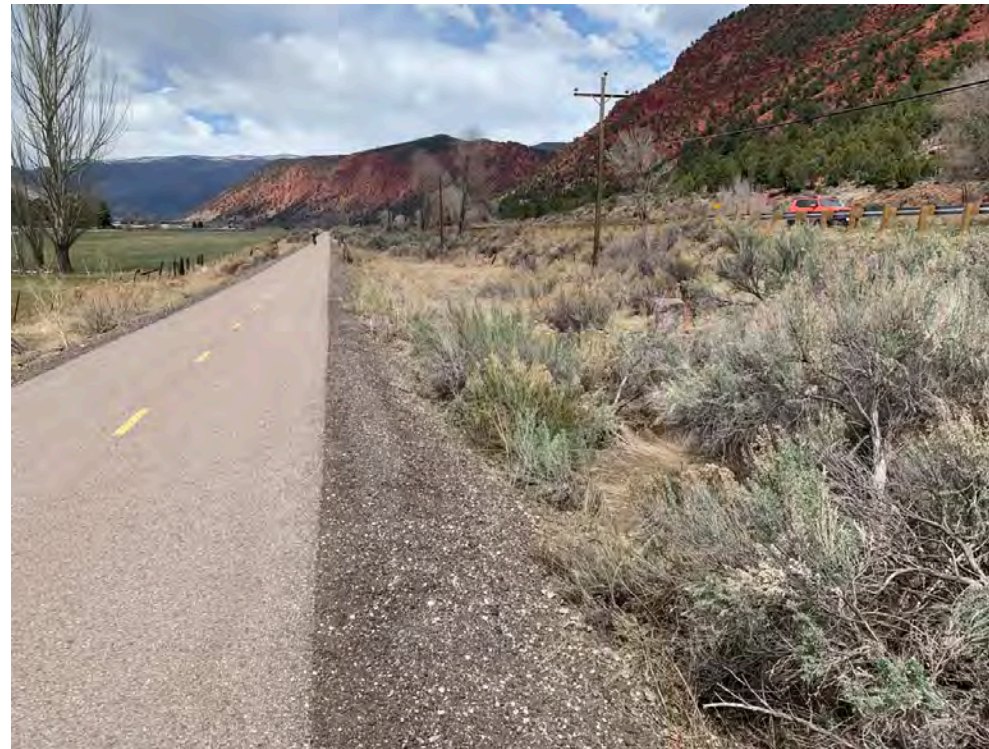
PHOTO 2: View looking N at area of moderate impairment (MM 366.5). Established Sagebrush vegetative community with cheatgrass and annual mustards dominating understory

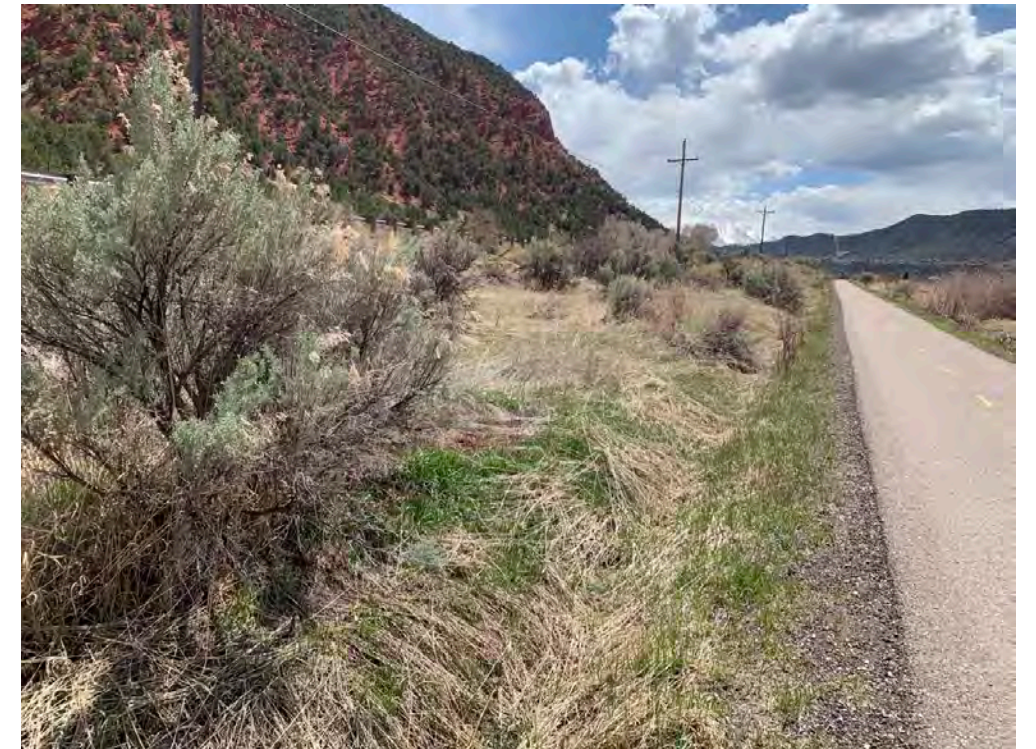
PHOTO 3: View looking SE at area of moderate impairment (MM 365).

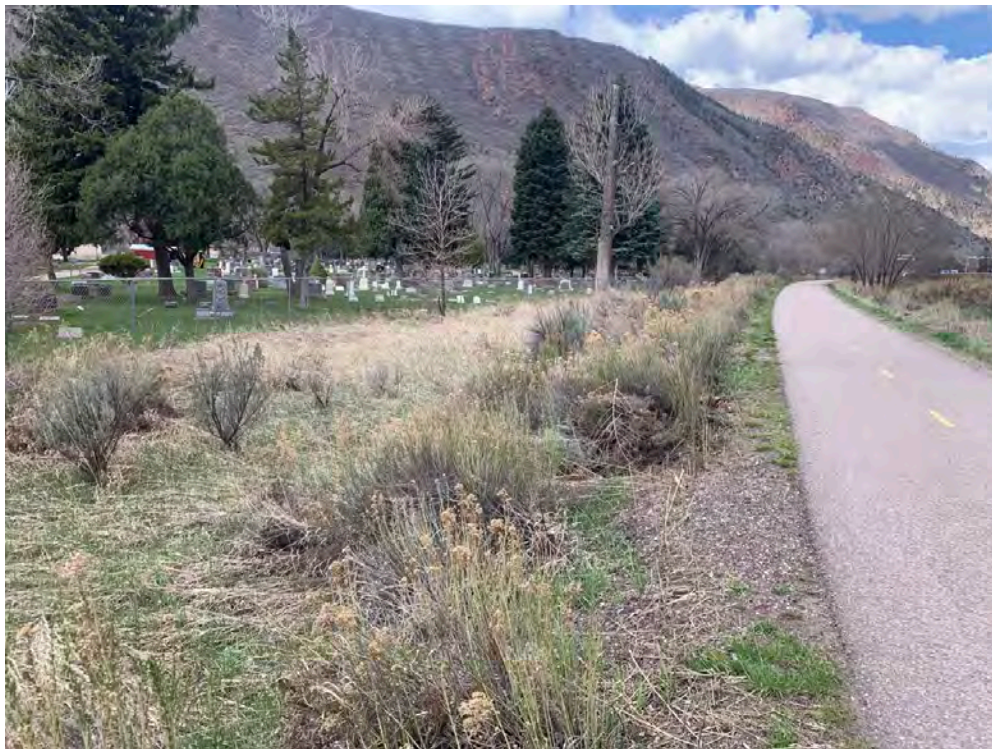
PHOTO 4: View looking NW at area of moderate impairment (MM 362.75). Sagebrush community dominated by smooth brome. Adequate vegetation cover, beneficial to reduce smooth brome populations and increase diversity.

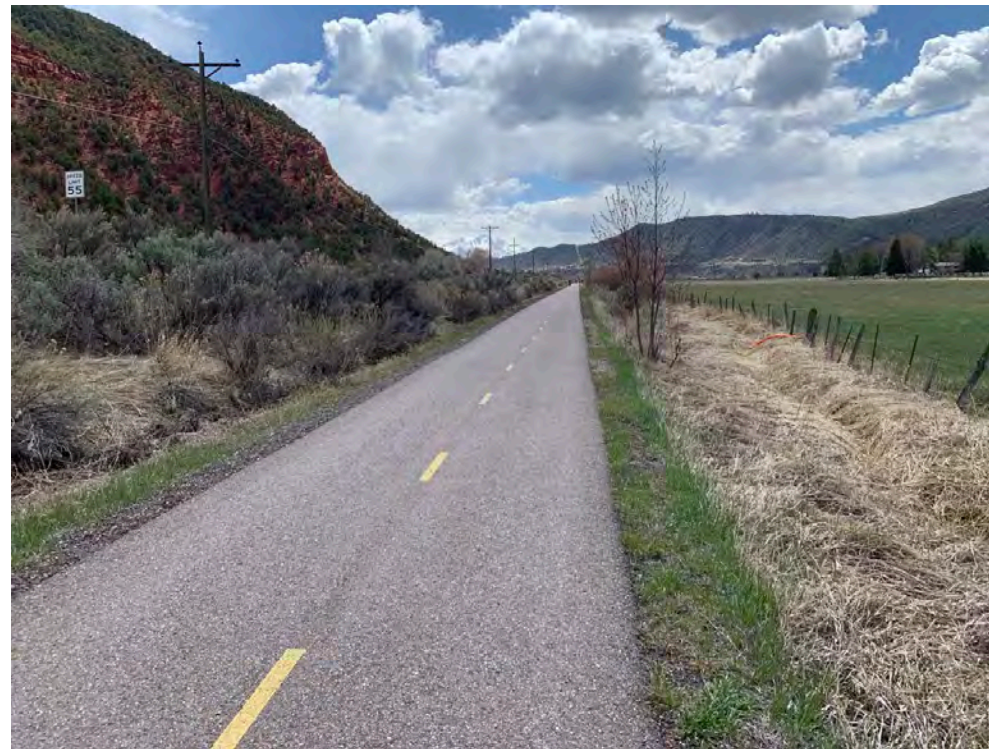
PHOTO 5: View looking SE at area of moderate impairment (MM 364.5). Vegetation on right strongly influenced by agricultural use. Established sagebrush with annual weeds present on the left.

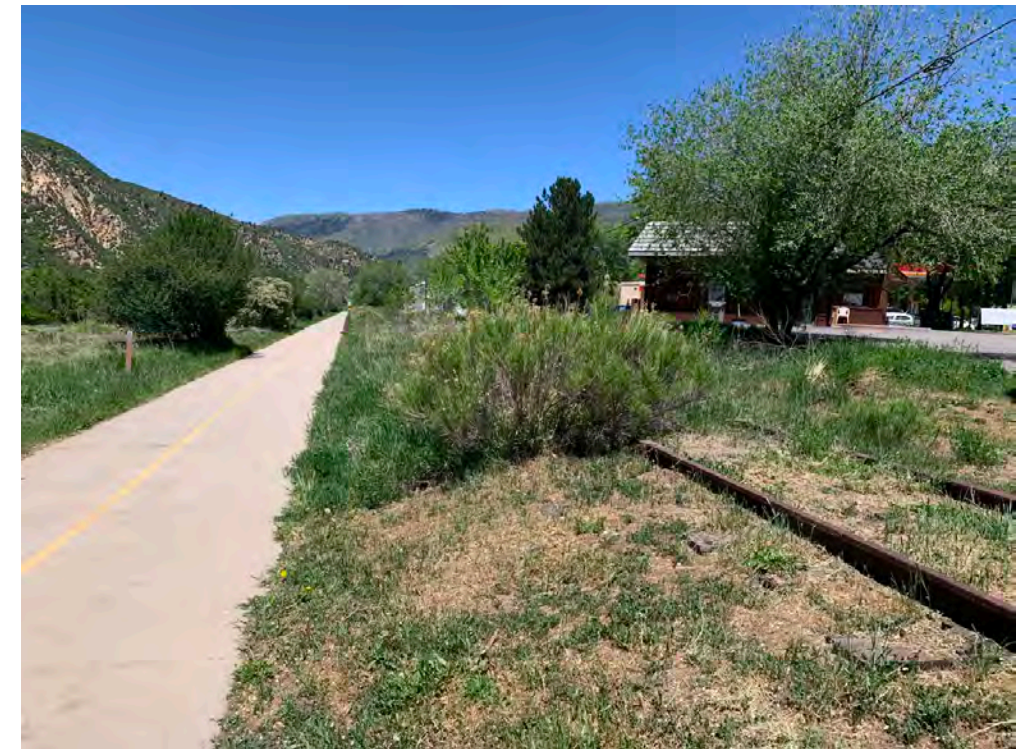
PHOTO 6: View looking N at area of moderate impairment (MM 361). Area lacking shrub cover consistent with sagebrush communities, but understory vegetation in adequate condition.

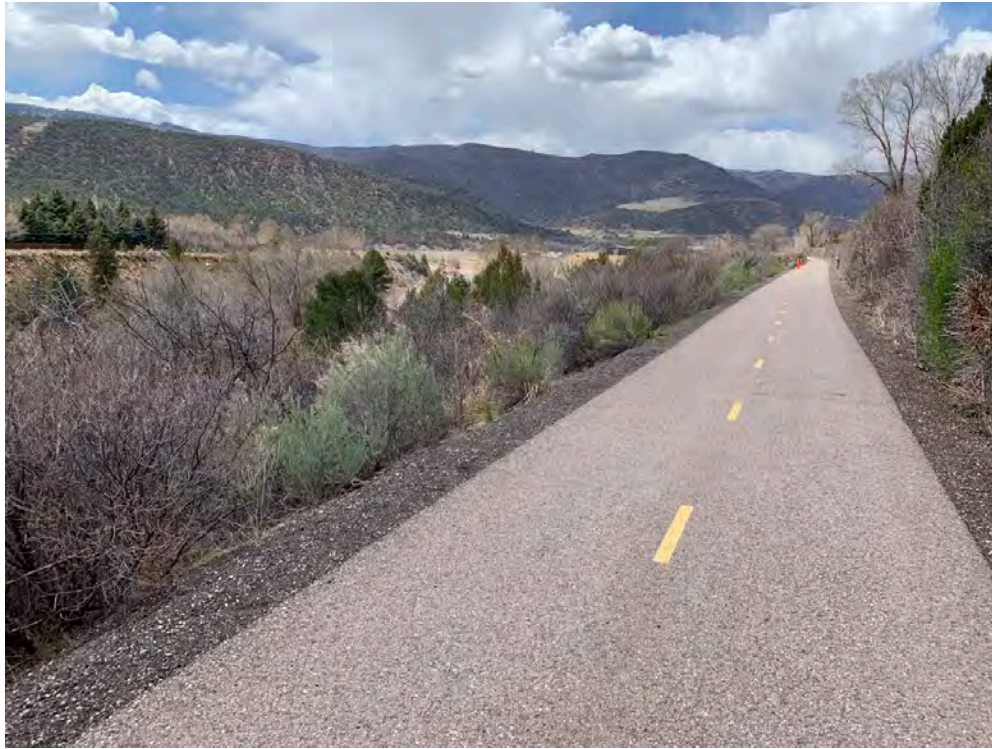
PHOTO 1: View looking N at area of low impairment a (MM 363.5). Minimal disturbance to natural vegetation consistent with lower montane shrublands. Good vegetation cover and diversity.

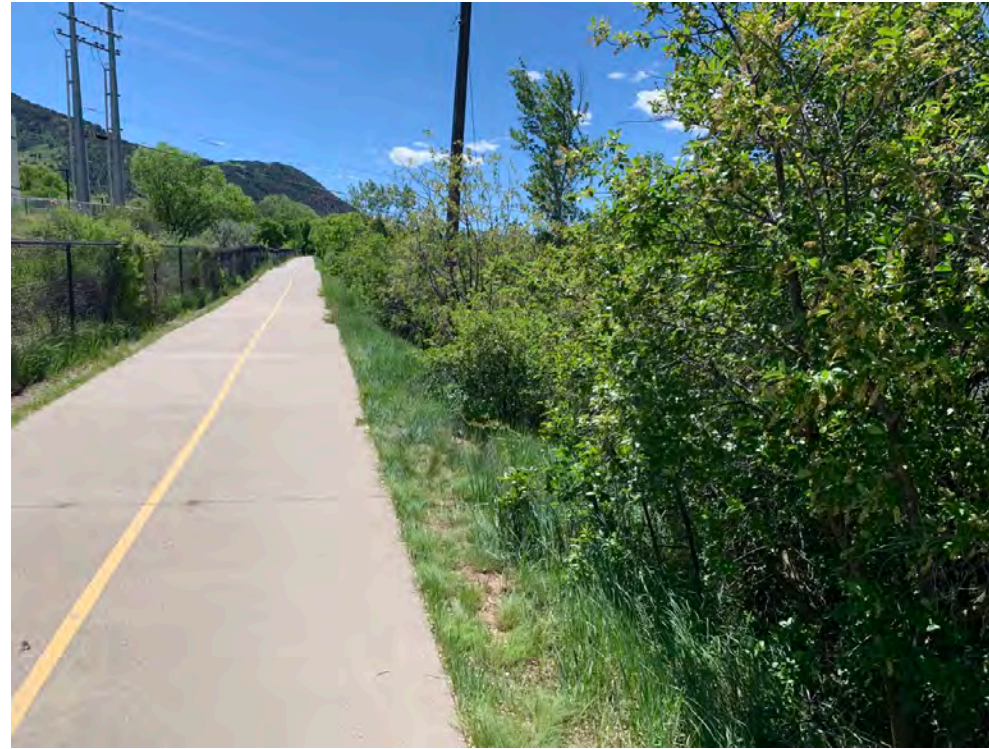
PHOTO 2: View looking S at area of low impairment (MM 361.5). Good native vegetation establishment and diversity consistent with mixed montane shrubland.

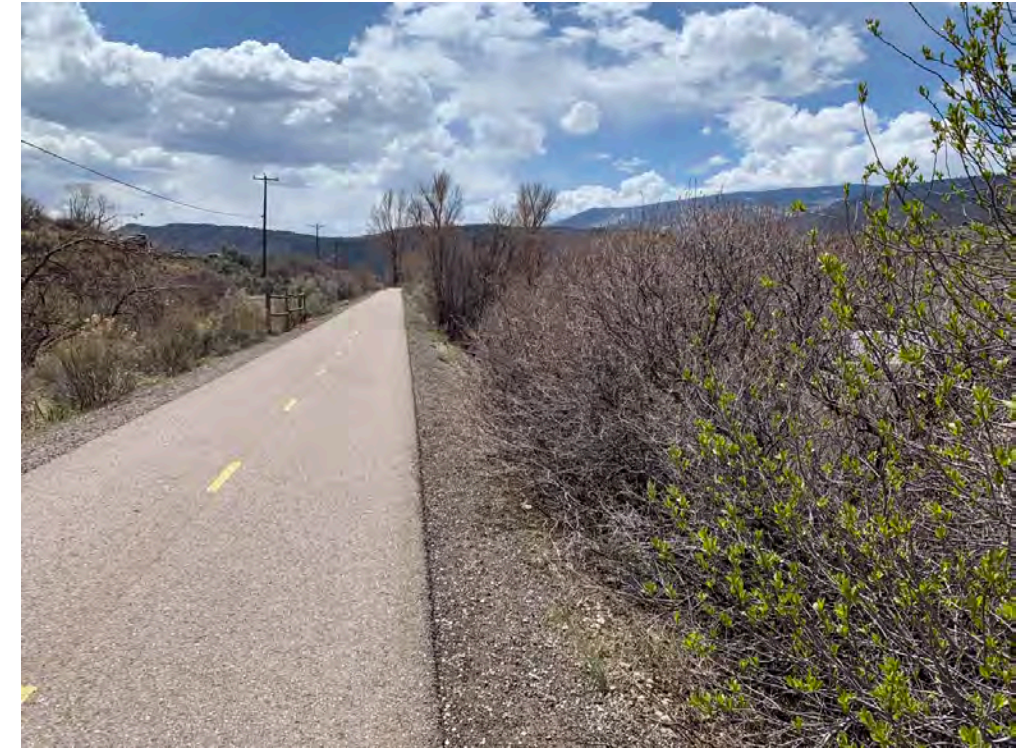
PHOTO 3: View looking S at area of low impairment (MM 363). Good native vegetation establishment and diversity consistent with mixed montane shrubland.

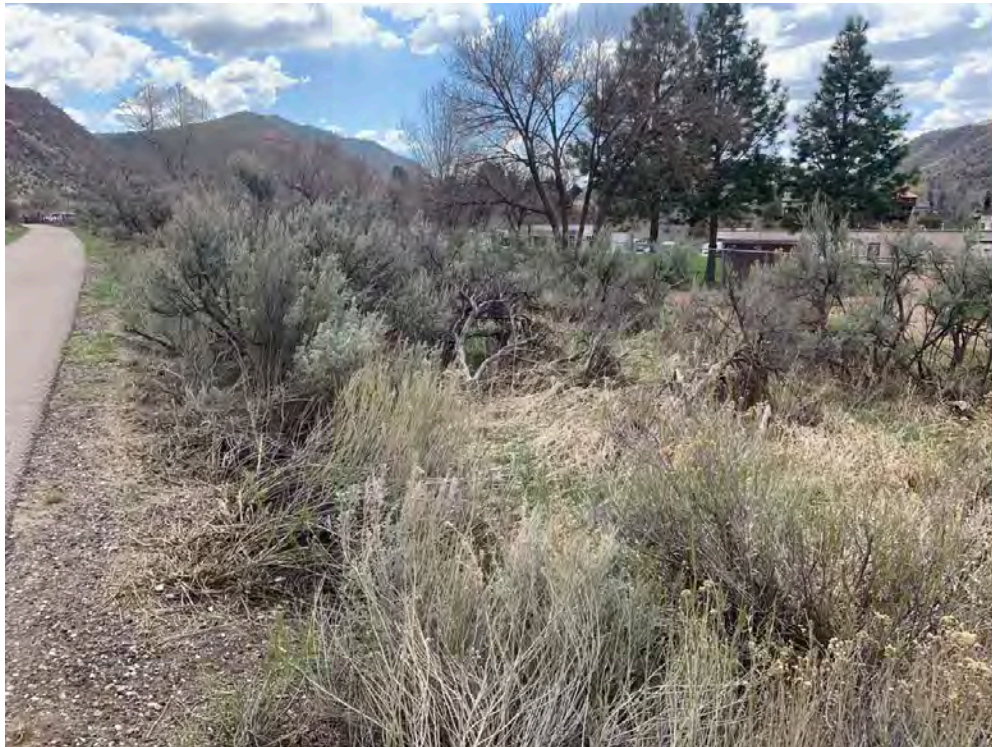
PHOTO 4: View looking S at area low impairment (MM362.75). Good native vegetation establishment and diversity consistent with sagebrush shrublands.

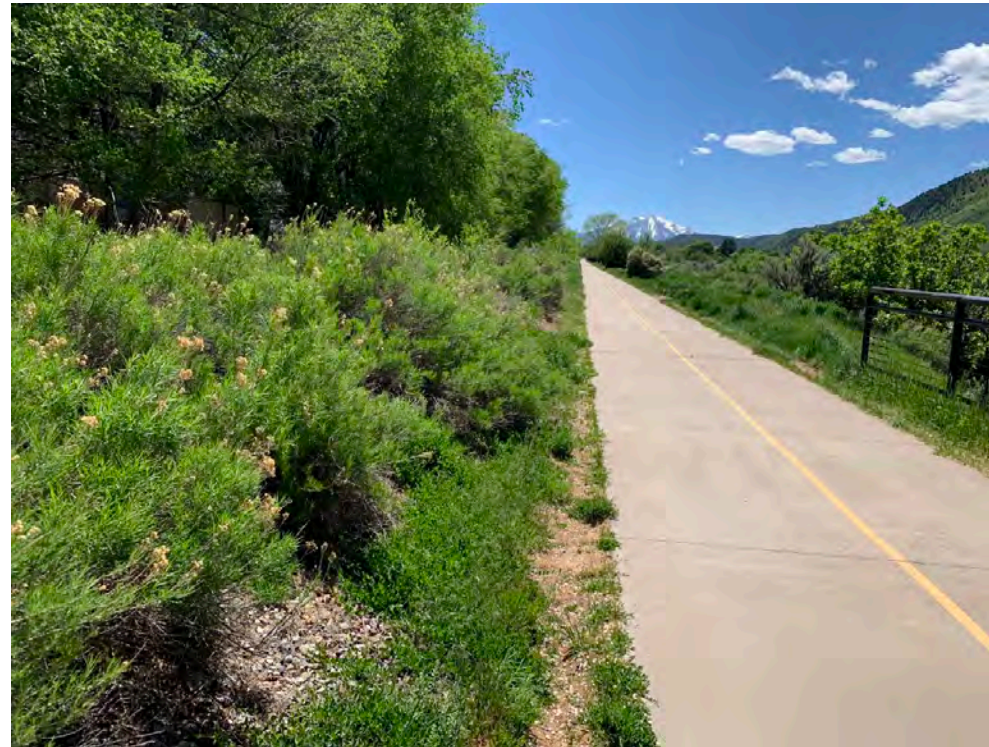
PHOTO5: View looking S at area of low impairment (MM 361.25). Good native vegetation establishment and diversity consistent with mixed montane shrubland.

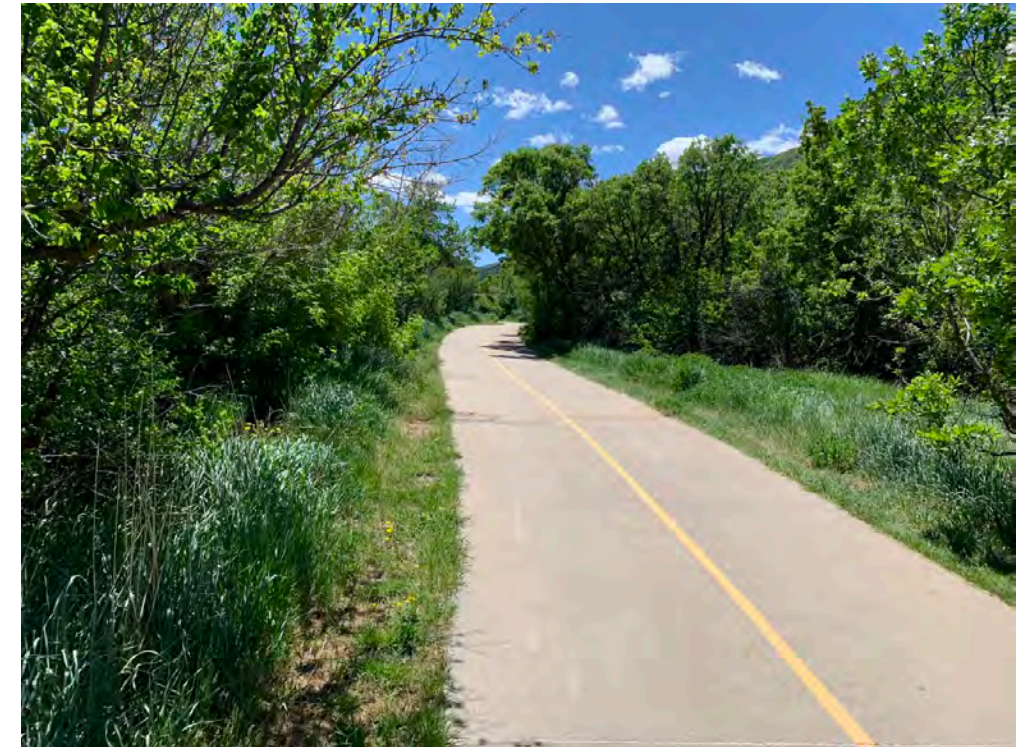
PHOTO 6: View looking S at area of low impairment (MM 361.25). Good native vegetation establishment and diversity consistent with mixed montane shrubland. Trees and large shrubs present suggesting mesic conditions.

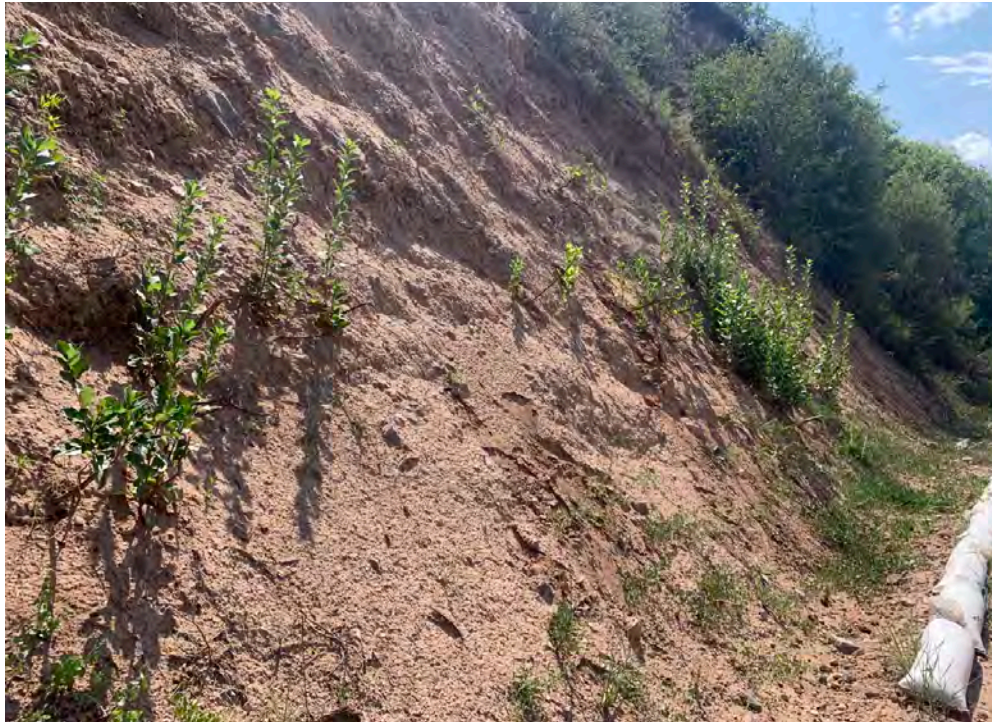
1. View looking west at significant impairment area. Steep bank with poor vegetation establishment with high erosion potential and issues.

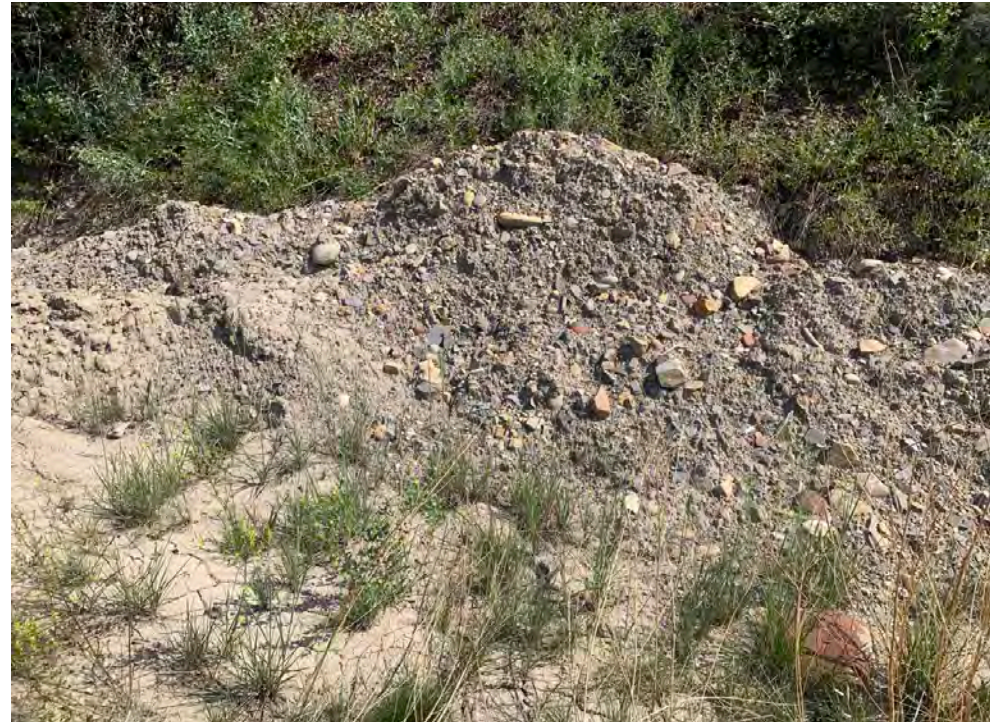
2. View significant impairment area along the south shoulder of the trail. Accumulated and piled fill material. Remove and seed area.

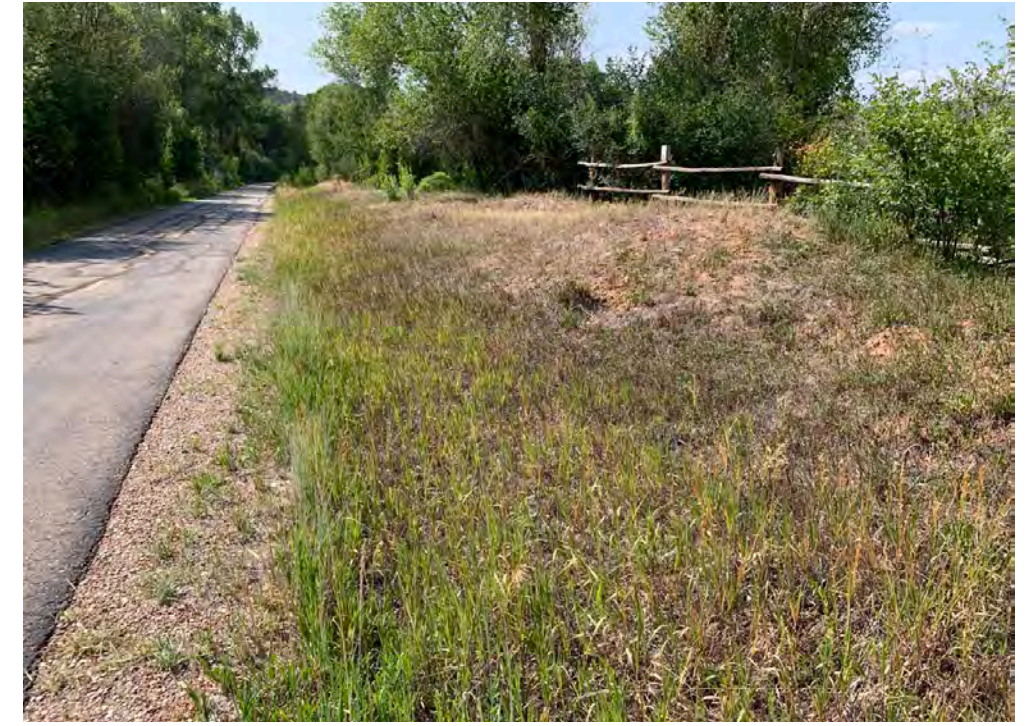
3. View looking west at area of significant impairment, near upper end of wilderness area. High densities of cheatgrass and poor vegetation establishment along small berm area.

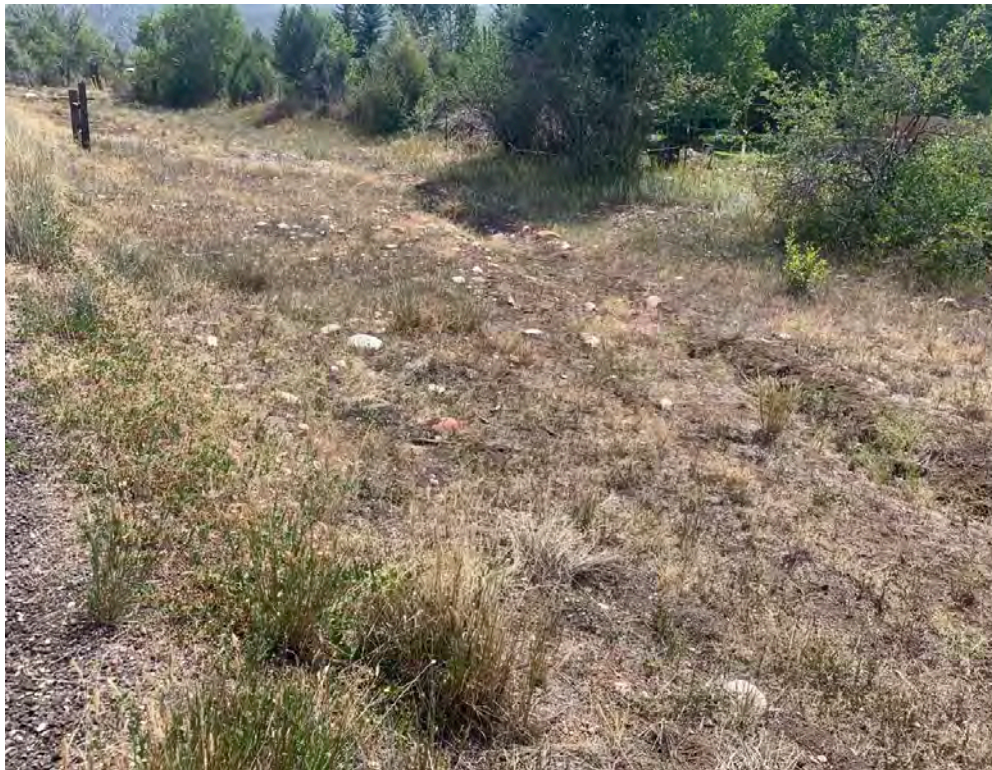
4. View looking west at area of significant impairment at upper end of trail, poor vegetation establishment and high densities of smooth brome.

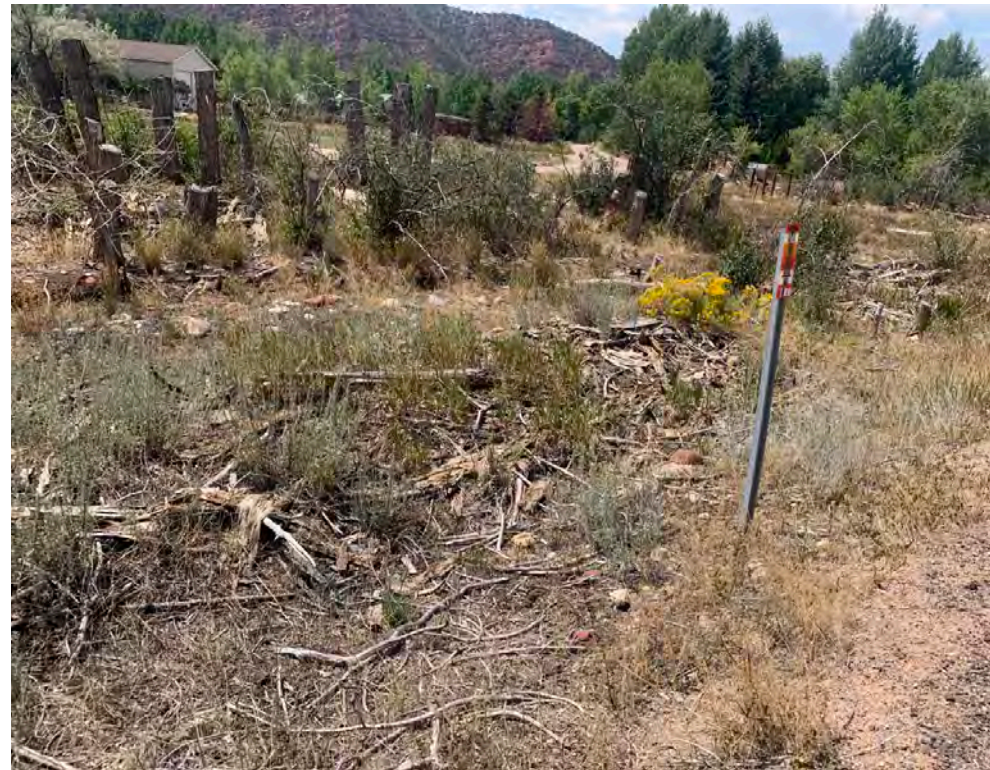
5. View looking west at area of significant impairment. Highly disturbed, with high densities of woody debris dead woody vegetation.

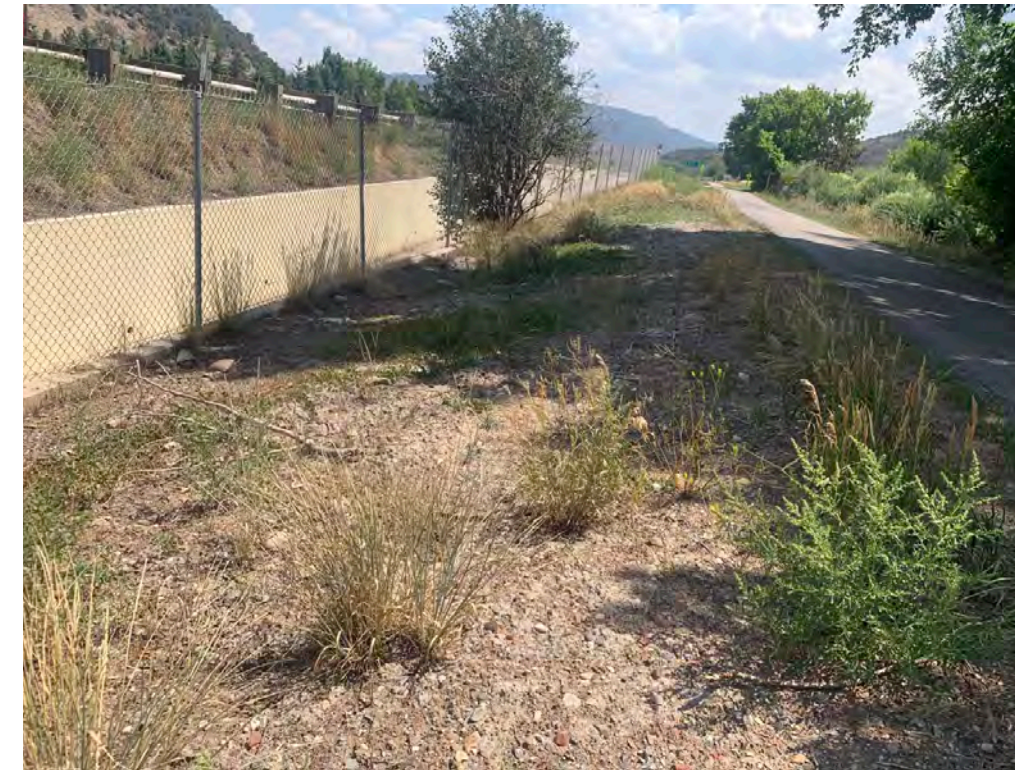
6. View looking east at area of significant impairment. Poor vegetation establishment with bare ground and scattered weed densities.

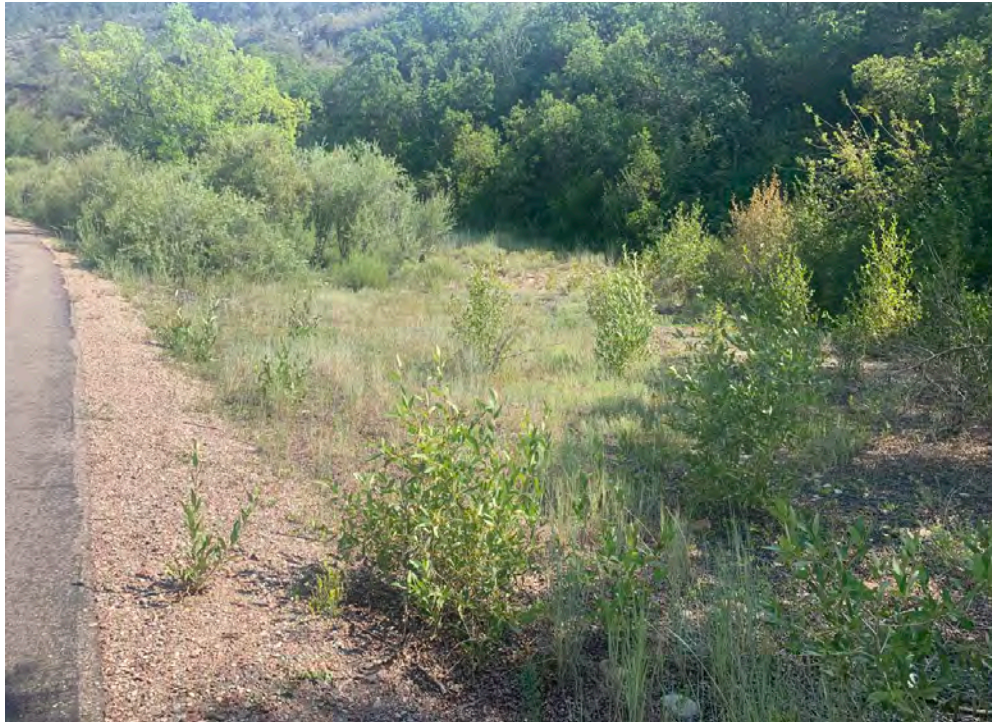
1. View looking east at area of moderate impairment. Open area within the forested riparian community. Regenerating woody vegetation evident, but scattered densities of non-native vegetation in the herbaceous layer.

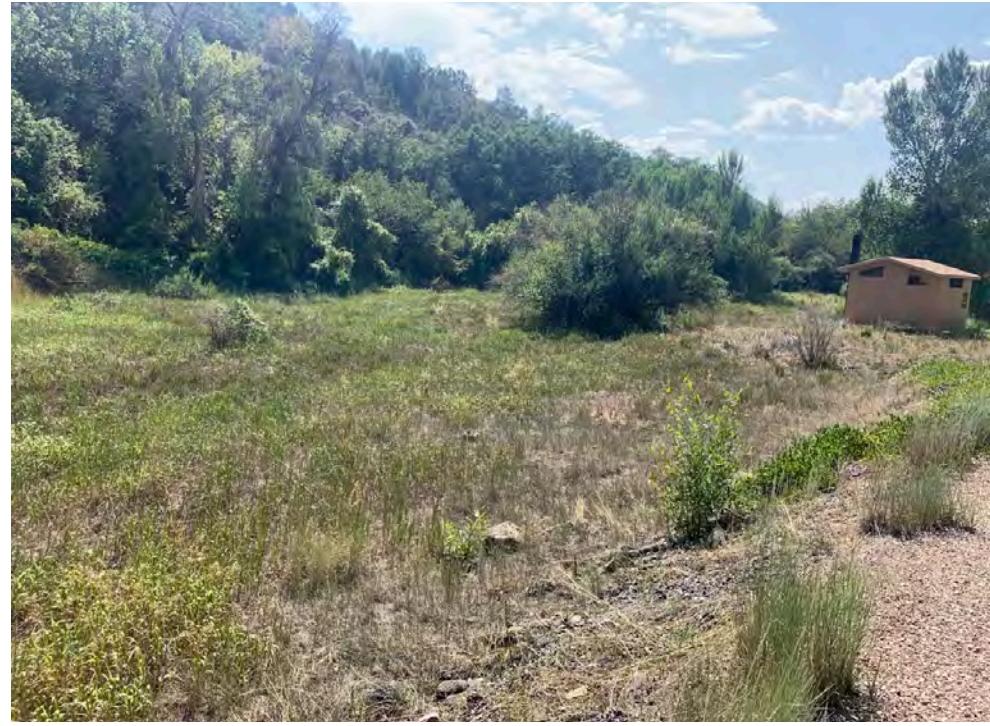
2. View looking west at area of moderate impairment. Large meadow, with varied vegetative conditions including matrix of native and non-native vegetation.

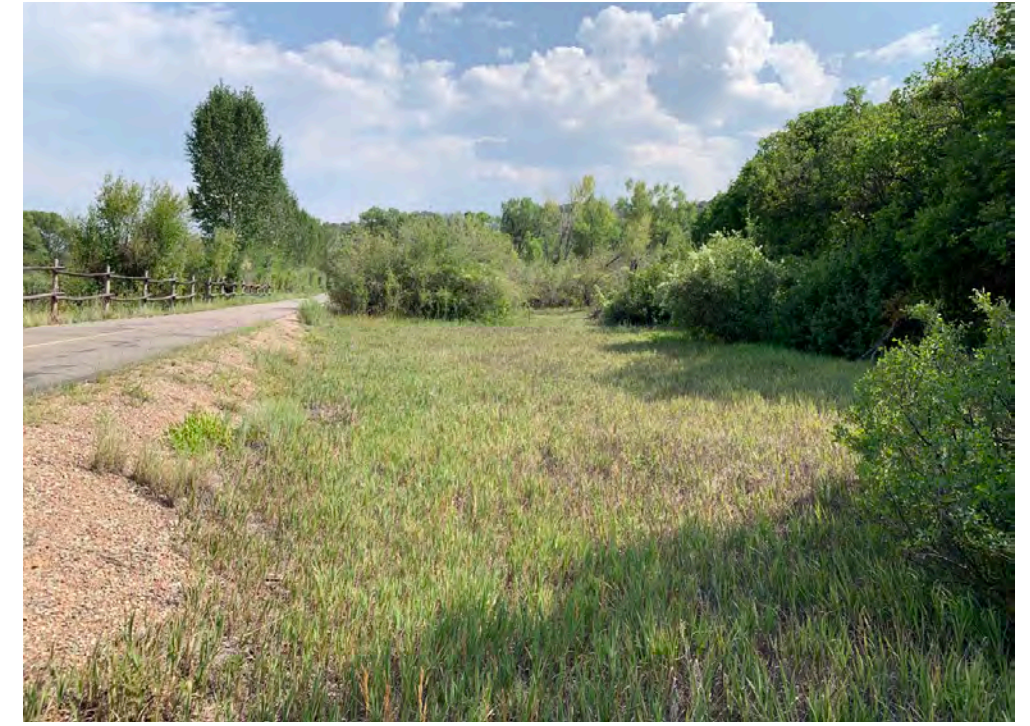
3. View looking E at area of moderate impairment. Open area within the forested riparian community. Good herbaceous establishment, but consists of high densities of smooth brome.

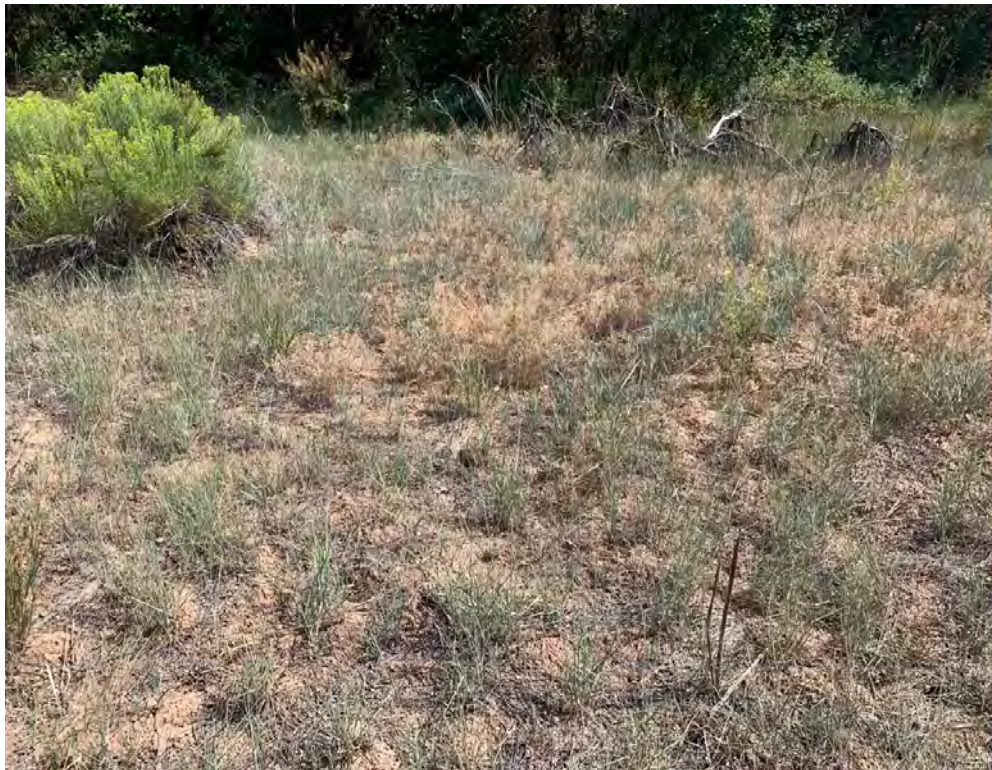
4. View looking at area of moderate impairment. Native bunch grass establishment with scattered densities of cheatgrass.

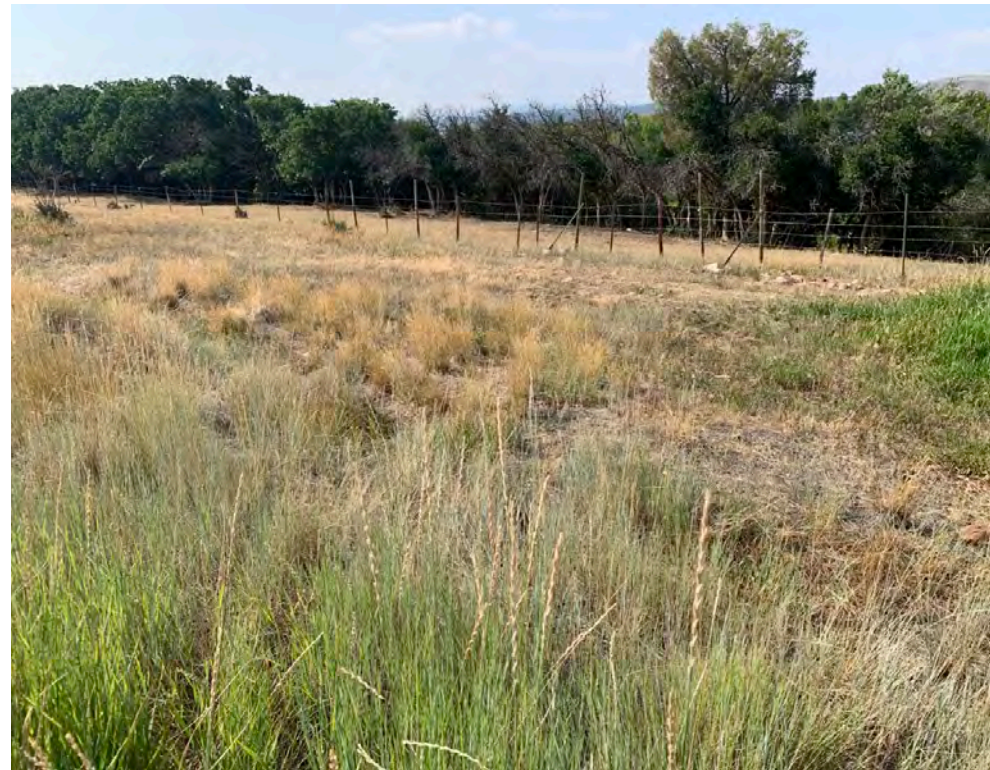
5. View of moderate impairment area. Established western wheatgrass and other native grasses, with intermixed annual mustards, cheatgrass and other weedy species.
