Roaring Fork Transportation Authority *Rio Grande Trail Restoration Seeding Plan*

Mile Post 360 -382

Glenwood Springs to Emma

**JANUARY
2022**

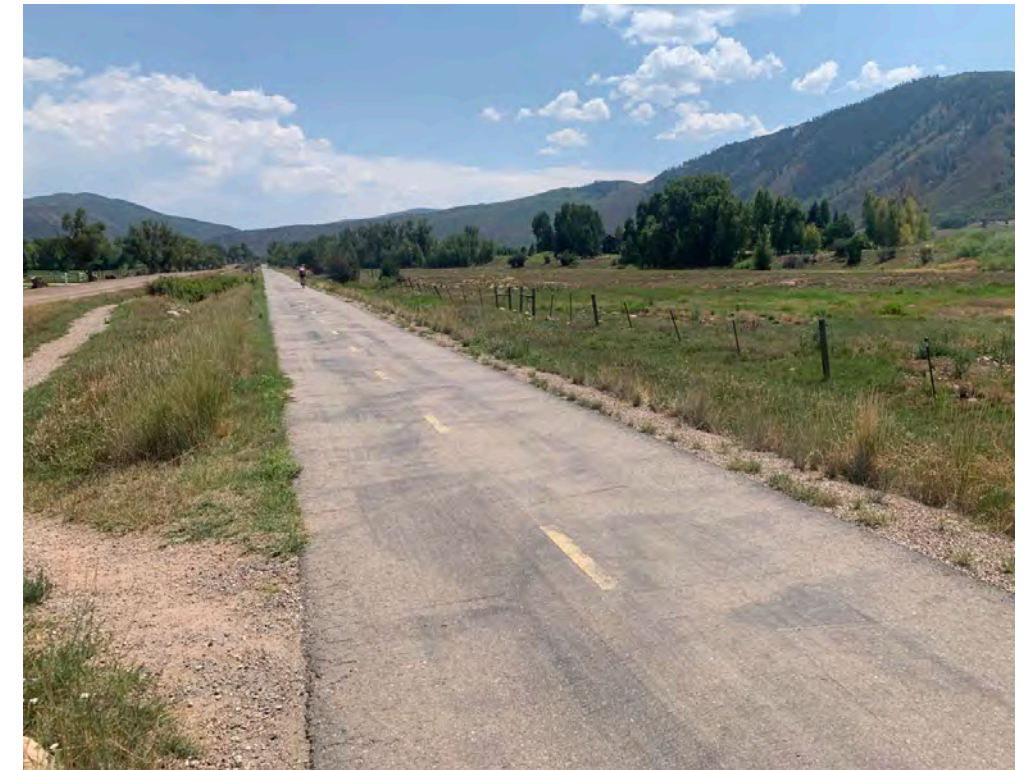
6. View looking east at large expanse of moderately impaired area along Hooks Spur Rd. area of high pedestrian/recreational traffic and additional dirt trail.

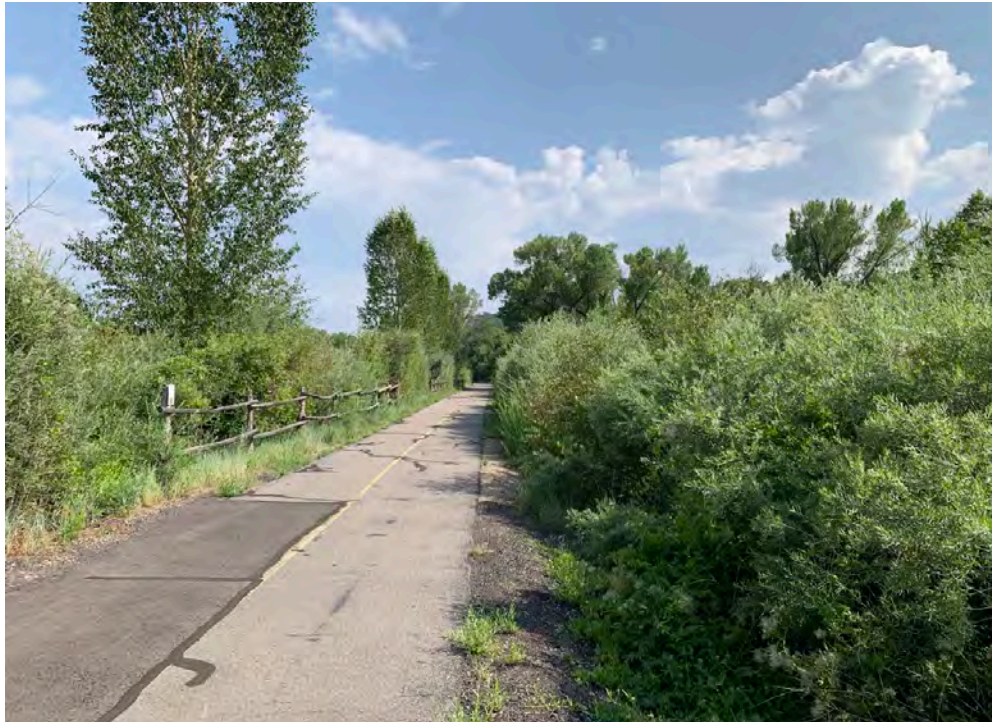
1. View looking east at large expansive riparian community within the wilderness area, with low impairment through out.

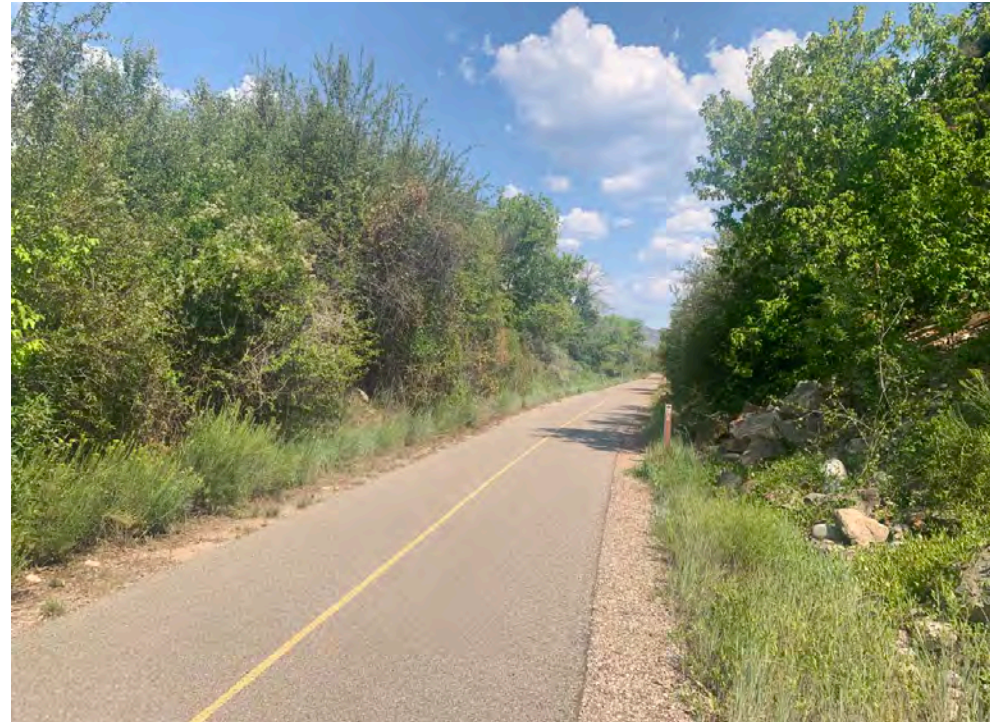
2. View looking east at large expansive riparian community within the wilderness area, with low impairment through out.

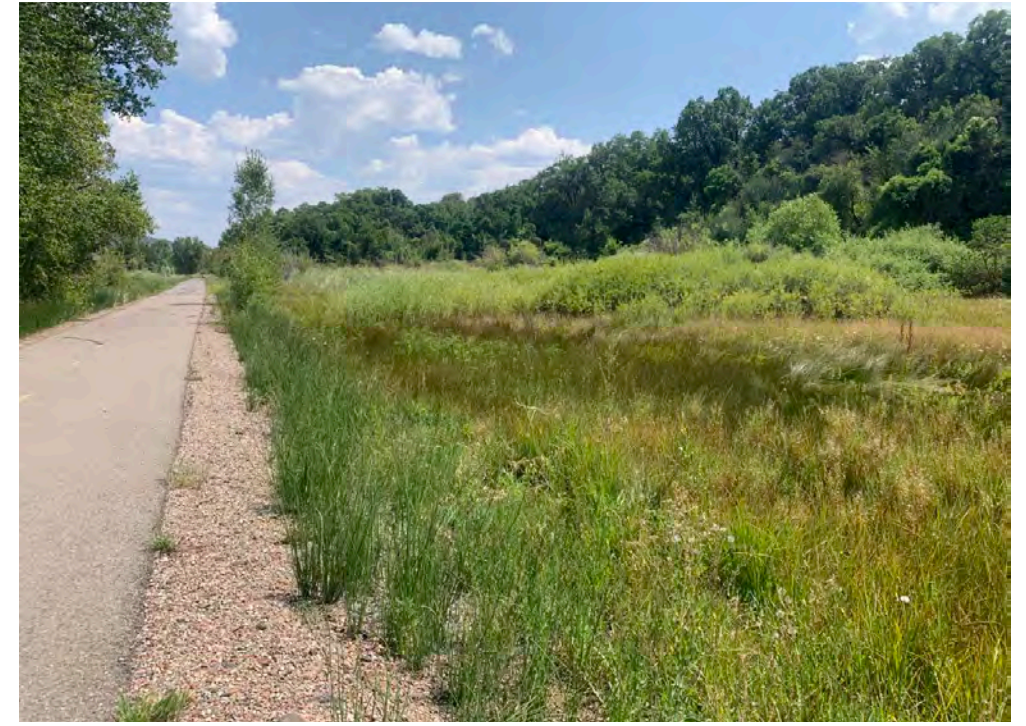
3. View looking east at emergent and scrub shrub wetland community at just outside of the wilderness area at the upper end of the trail.
