ROARING FORK RAILROAD CORRIDOR CONSERVATION AREA ASSESSMENT

FINAL REPORT

Prepared For:
Covenant Enforcement Commission
Roaring Fork Transportation Authority

NEWLAND PROJECT RESOURCES, INC.

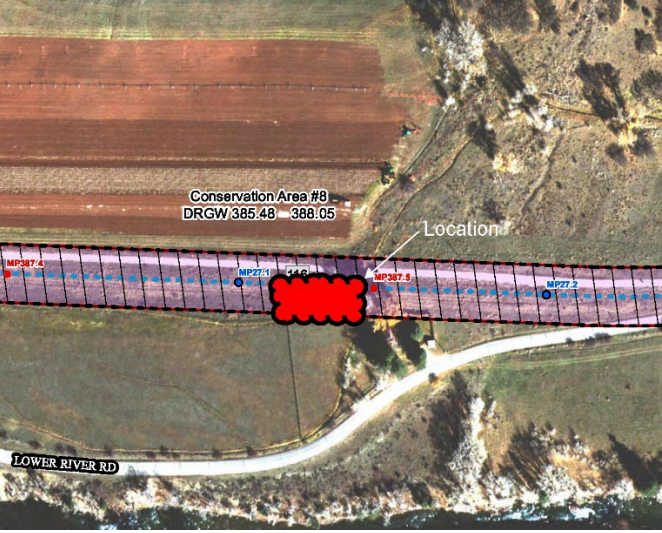
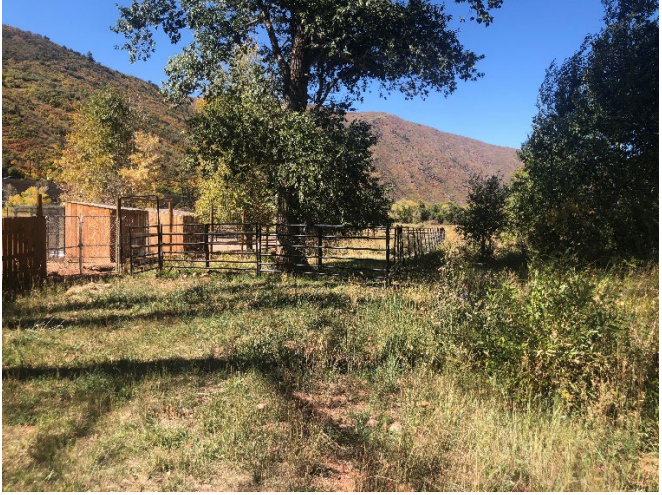
DATE	September 27, 2023	ENCROACHMENT #1
MILEPOST	27.21	
CONSERVATION AREA	Yes, #8	
NEW/EXISTING	New	
TYPE OF ENCROACHMENT	Temporary stockyard placed adjacent to corridor	
BACKGROUND	<p>Black, temporary metal fencing placed in corridor adjacent to existing horse paddocks.</p> <div style="text-align: center;">

</div>	
RECOMMENDED REMEDY	<p>Approach and discuss this with property owner: 964 Lower River Road WHEATLEY TRACT 2 LLC 555 NE 185TH ST #201 MIAMI FL 33179</p>

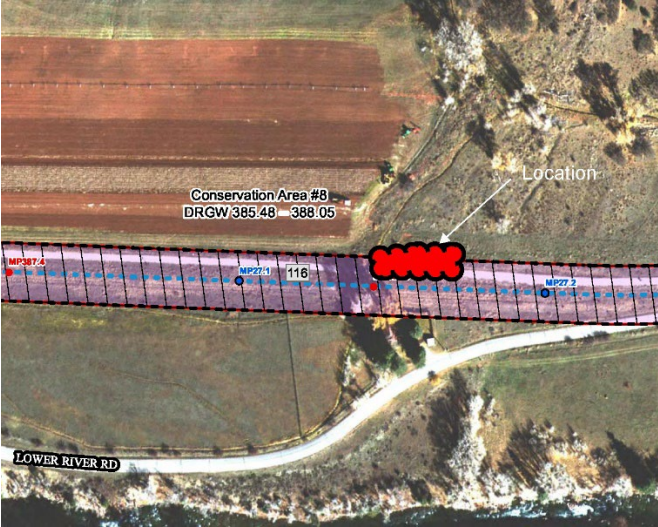
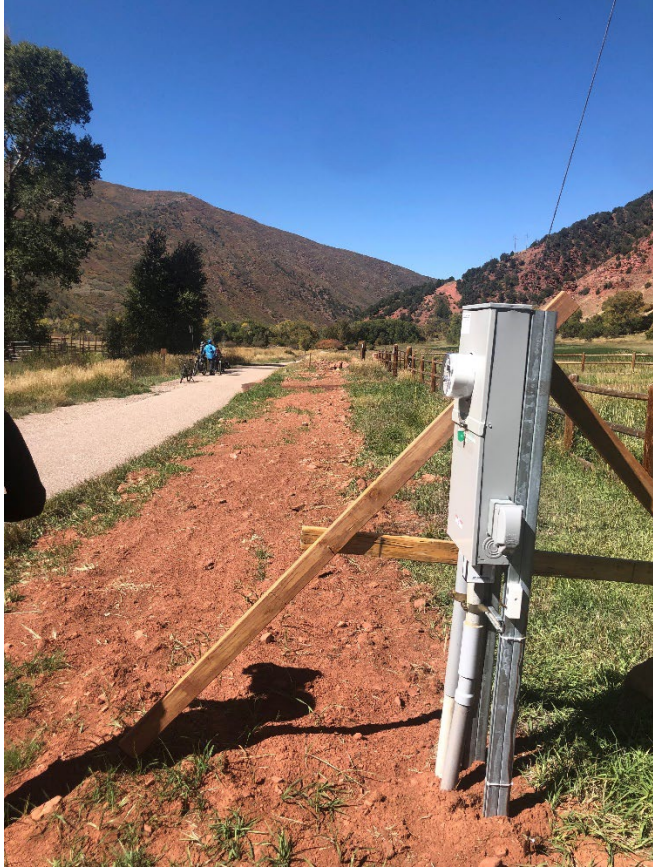
DATE	September 27, 2023	ENCROACHMENT #2
MILEPOST	27.21	
CONSERVATION AREA	Yes, #8	
NEW/EXISTING	New	
TYPE OF ENCROACHMENT	Electric Utility line buried in corridor. No revegetation applied to covered trench	
BACKGROUND	<p>Utility line is buried from pole to location of new irrigation pump.</p> <div style="text-align: center;">

</div>	
RECOMMENDED REMEDY	<p>Approach and discuss this with property owner: Wheatley Tract Pitkin County Open Space And Trails 530 E. Main St Aspen, Co 81611</p>

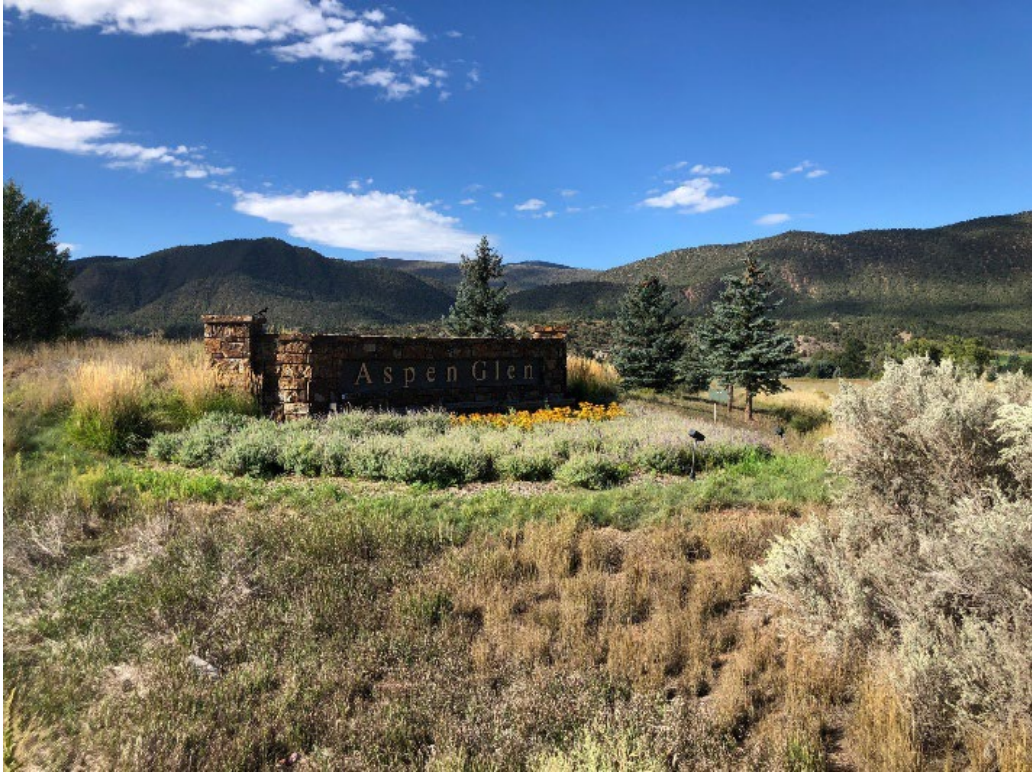
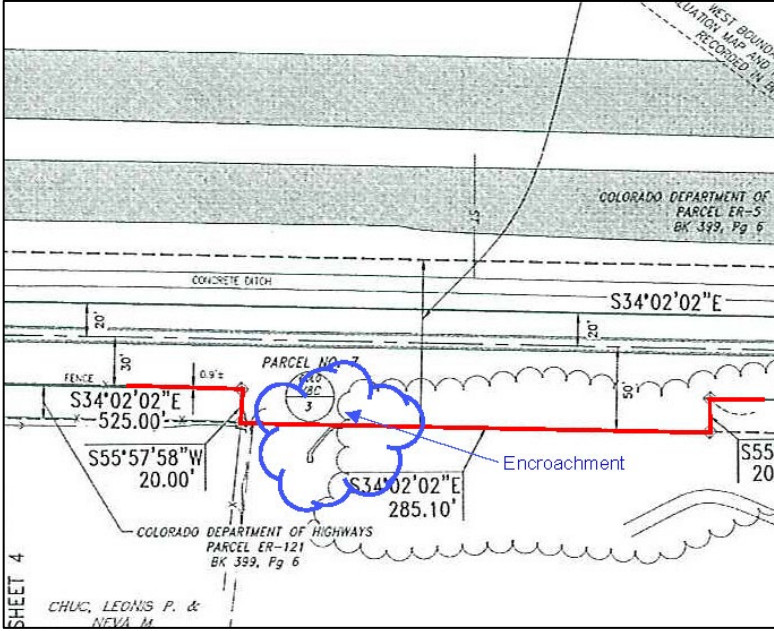
DATE	September 26, 2023	ENCROACHMENT #3
MILEPOST	9.37	
CONSERVATION AREA	Outside of Conservation Area	
NEW/EXISTING	Existing since 2019	
TYPE OF ENCROACHMENT	New landscaping around the "Aspen Glen" sign

BACKGROUND	<p>Upon researching this possible encroachment, it appears to be within the 100-foot wide right-of-way owned by RFTA. The plantings have matured and spread over the entire landscaped area, which takes up approximately 500 square feet of the RFTA corridor. Irrigation and lighting contained within the landscaped area are also encroaching in the corridor.</p> <div style="text-align: center;">

</div>	
RECOMMENDED REMEDY	Contact Aspen Glen to discuss planted material.

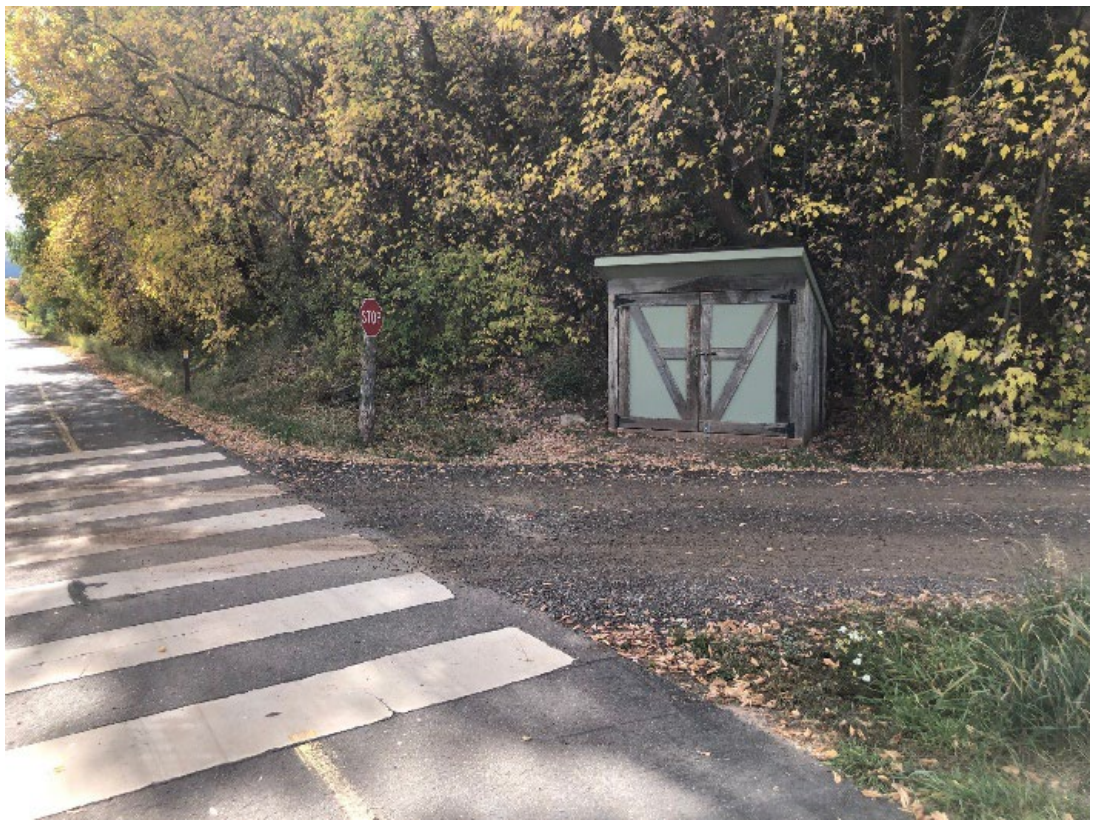
DATE	September 26, 2023	ENCROACHMENT	#5
MILEPOST	18.71		
CONSERVATION AREA	Yes Conservation Area #6:		
NEW/EXISTING	Existing		
TYPE OF ENCROACHMENT	Trash Storage Shed within corridor at driveway for 1126 Hooks Spur Lane.

BACKGROUND Although previously listed as being remedied, the shed continues to exist in the corridor.

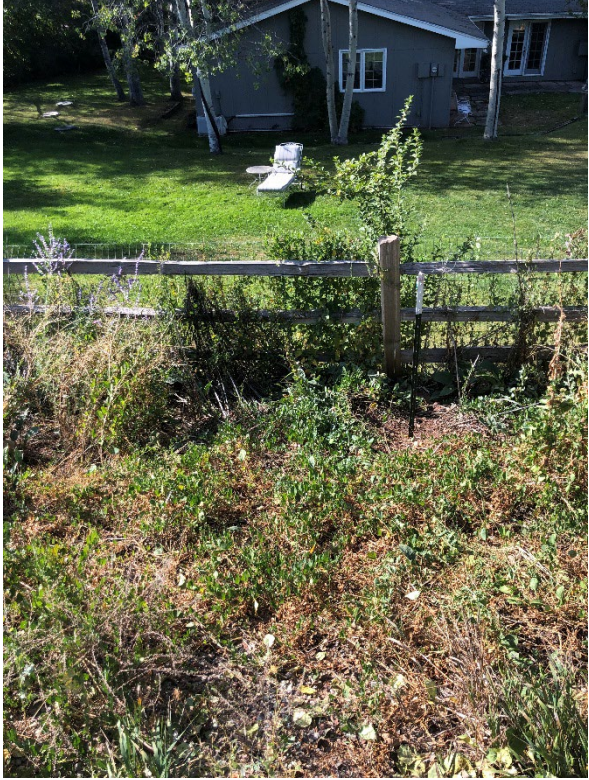
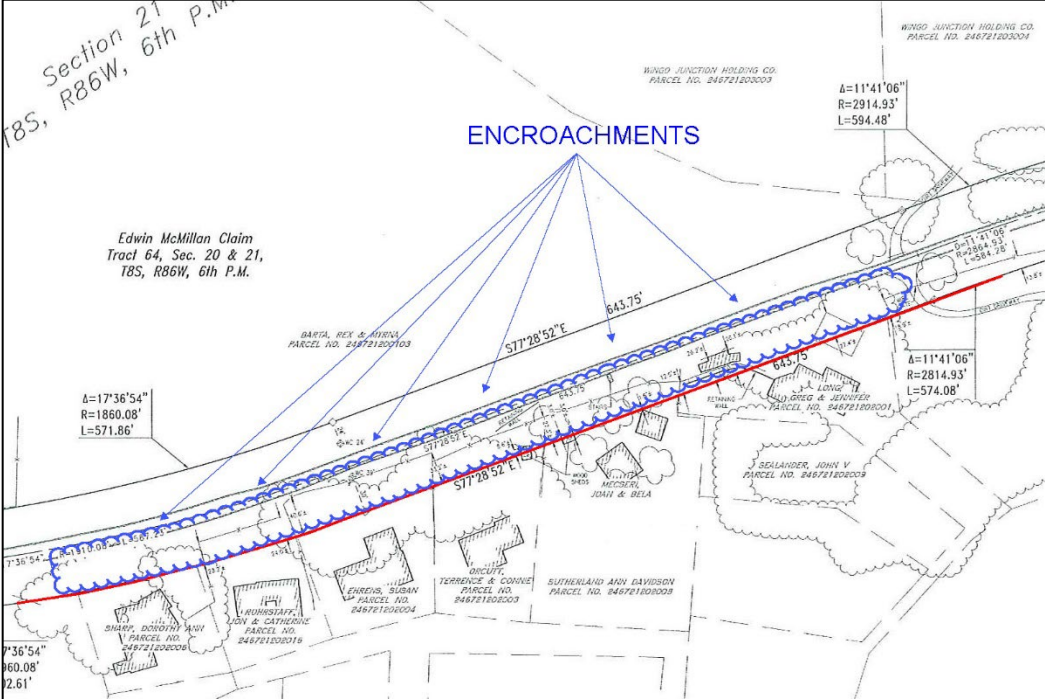
DATE	September 27, 2023	ENCROACHMENT #8
MILEPOST	25.32 – 25.49	
CONSERVATION AREA	Not in Conservation Area	
NEW/EXISTING	Existing	
TYPE OF ENCROACHMENT	<p>Lawn Encroachments into Rail Corridor</p>

BACKGROUND	<p>Upon researching these possible encroachments, it appears to be within the 100-foot wide right-of-way owned by RFTA. Most of the lots have lawns encroaching and some have storage buildings encroaching.</p>

RECOMMENDED REMEDY	Contact property owners to discuss options for compliance.

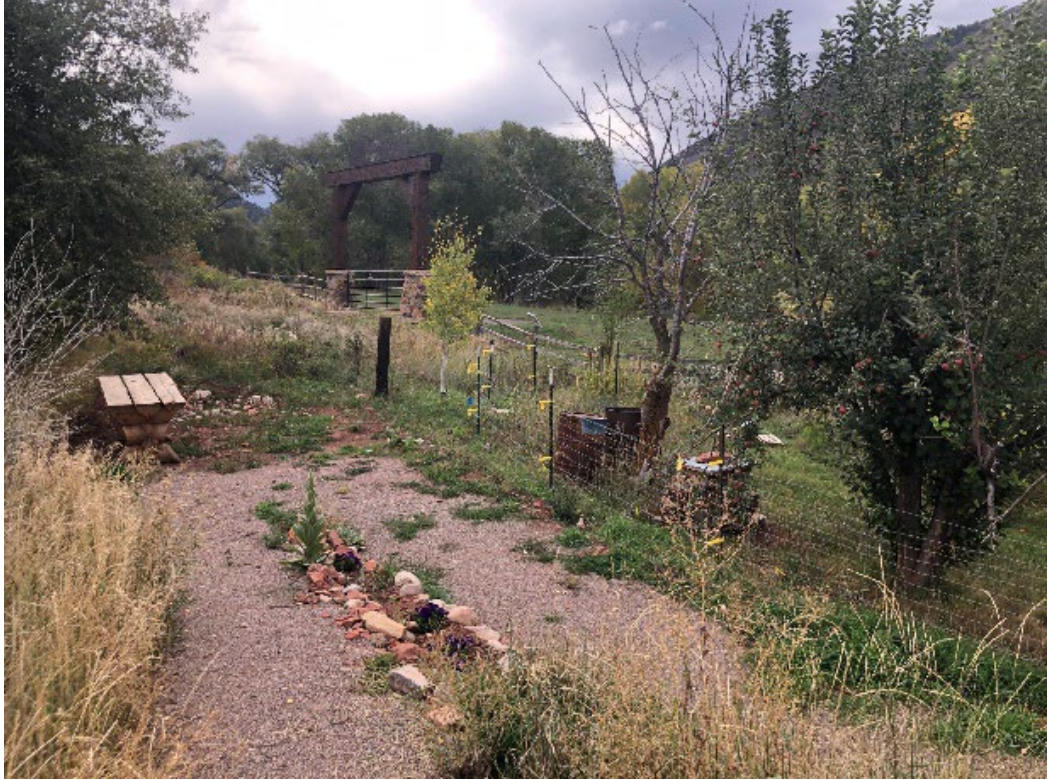
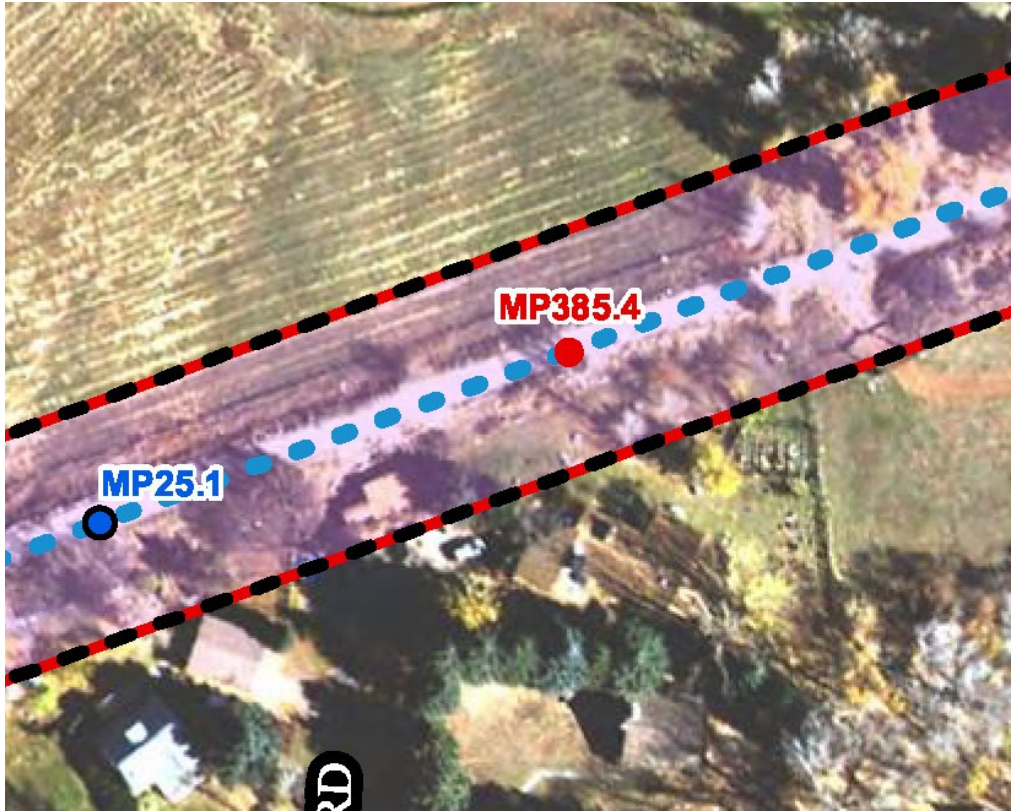
DATE	September 27, 2023	ENCROACHMENT #9
MILEPOST	25.45	
CONSERVATION AREA	Not in Conservation Area	
NEW/EXISTING	Existing since 2021	
TYPE OF ENCROACHMENT	<p>Private pathway in corridor. This pathway is more substantial than the typical private trail placed to access the Rio Grande trail. The area of disturbance within the corridor is about 800 – 1,000 square feet.</p>

BACKGROUND	<p>Upon researching this possible encroachment, it appears to be within the corridor.</p>

RECOMMENDED REMEDY	<p>Contact property owner to discuss issues surrounding the private access, which include the safety of all trail users.</p>
